Lagoon TH Condominium Association, Inc.
700 Meadow Creek Drive
Frisco, CO 80443

Level 1, Platinum Reserve Analysis

Report Period – 07/01/15 – 06/30/16

Final Draft
Version

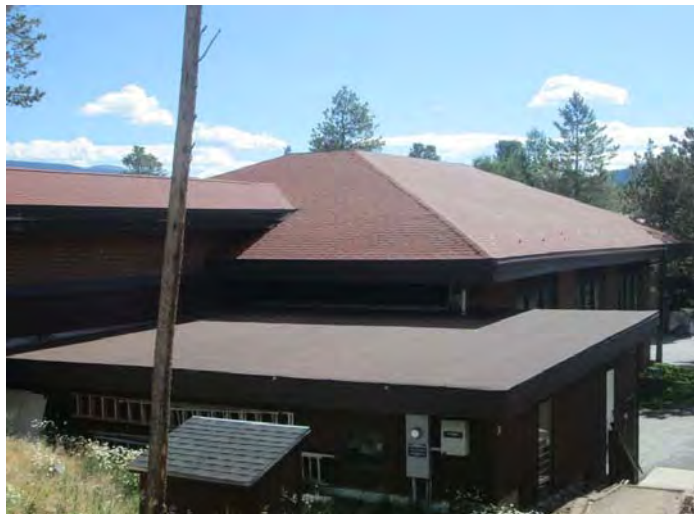
Comp #: 105 Asphalt Shingle/EPDM Roof (1)- Replace

- The roofs appeared to be in good to fair condition with little to no advanced deterioration noted during observations.
- All roofs were inspected by The Roofing Company in 2013. Please see the inspection report for more specific information, please see the inspection reports relating to these roofs.
- As roof's age, it is recommended they are inspected on a regular basis to identify potential failures. The recommended repairs should be addressed with funding for this work coming from the operating account.

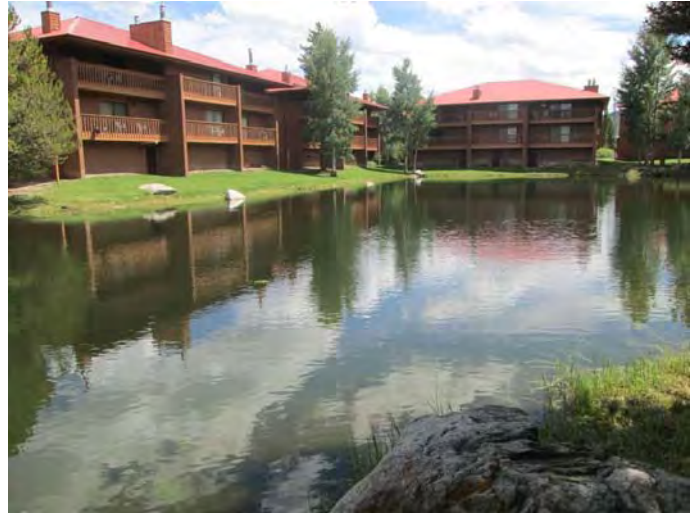
Comp #: 108 Metal Roofs (Phase 2) - Replace

- Outside of standard annual roof repairs associated with this type of roof, i.e. tightening of loose screws and caulking of exposed seals, these roofs appeared to be in good to fair condition at time of observation.
- As per the commissioned roof inspection, conducted by The Roofing Company, performed in 2013, it is recommended that all regular roof repairs are performed to ensure the longest possible roof life of these assets.
- As roof's age, it is recommended they are inspected on a regular basis to identify potential failures. The recommended repairs should be addressed with funding for this work coming from the operating account.

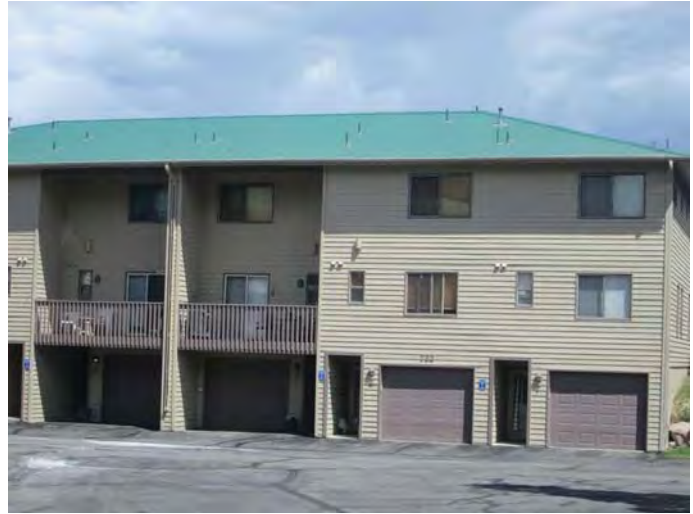
Comp #: 108 Metal Roofs (Phase 4) - Replace

- Outside of standard annual roof repairs associated with this type of roof, i.e. tightening of loose screws and caulking of exposed seals, these roofs appeared to be in good to fair condition at time of observation.
- As per the commissioned roof inspection, conducted by The Roofing Company, performed in 2013, it is recommended that all regular roof repairs are performed to ensure the longest possible roof life of these assets.
- As roof's age, it is recommended they are inspected on a regular basis to identify potential failures. The recommended repairs should be addressed with funding for this work coming from the operating account.

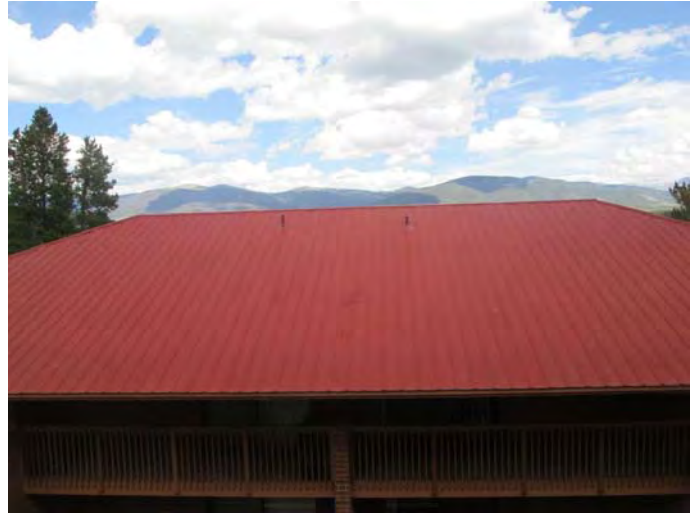
Comp #: 108 Metal Roofs (Phase 1) - Replace

- Outside of standard annual roof repairs associated with this type of roof, i.e. tightening of loose screws and caulking of exposed seals, these roofs appeared to be in good to fair condition at time of observation.
- As per the commissioned roof inspection, conducted by The Roofing Company, performed in 2013, it is recommended that all regular roof repairs are performed to ensure the longest possible roof life of these assets.
- As roof's age, it is recommended they are inspected on a regular basis to identify potential failures. The recommended repairs should be addressed with funding for this work coming from the operating account.

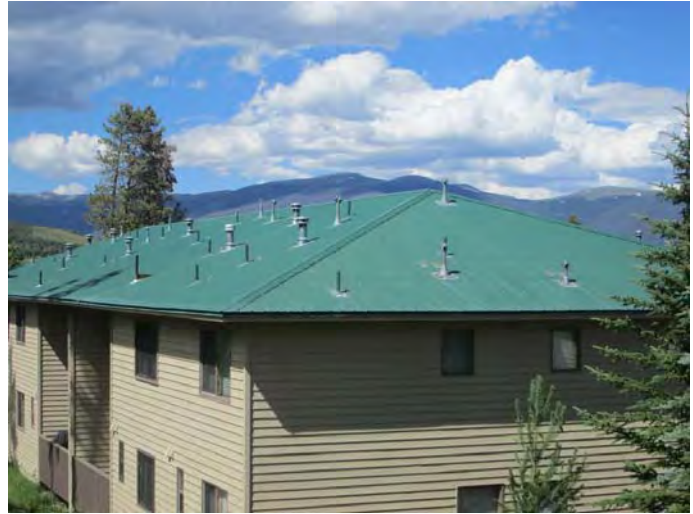
Comp #: 108 Metal Roofs (Phase 3) - Replace

- Outside of standard annual roof repairs associated with this type of roof, i.e. tightening of loose screws and caulking of exposed seals, these roofs appeared to be in good to fair condition at time of observation.
- As per the commissioned roof inspection, conducted by The Roofing Company, performed in 2013, it is recommended that all regular roof repairs are performed to ensure the longest possible roof life of these assets.
- As roof's age, it is recommended they are inspected on a regular basis to identify potential failures. The recommended repairs should be addressed with funding for this work coming from the operating account.

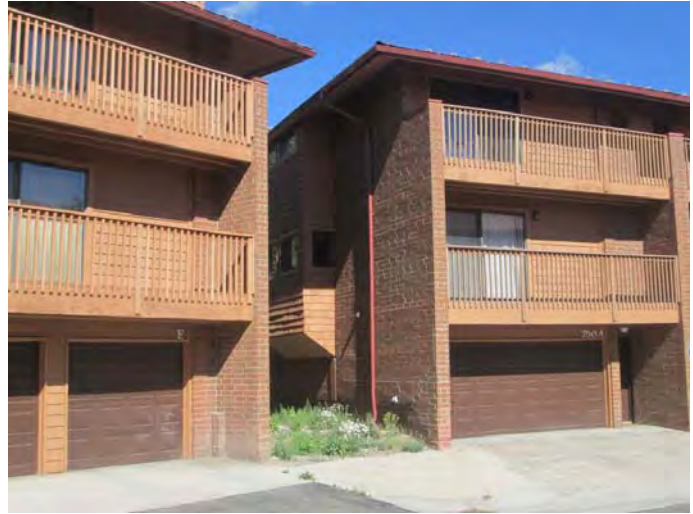
Comp #: 120 Gutters/Downspouts (Metal 2) - Replace

- It's recommended that all rain gutters and down-spouts are replaced when the roof is replaced.
- Gutters and downspouts should be inspected, with damaged sections being replaced, annually. Funding for this replacement, outside of the roof replacement, should be funded from the operating account.

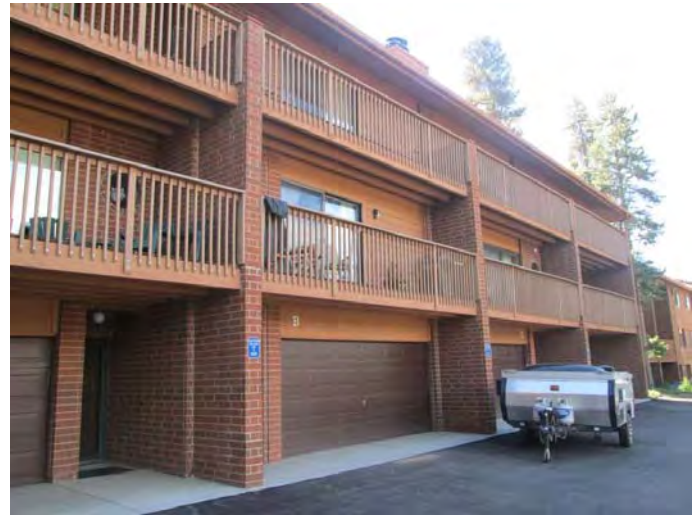
Comp #: 120 Gutters/Downspouts (Metal 1) - Replace

- It's recommended that all rain gutters and down-spouts are replaced when the roof is replaced.
- Gutters and downspouts should be inspected, with damaged sections being replaced, annually. Funding for this replacement, outside of the roof replacement, should be funded from the operating account.

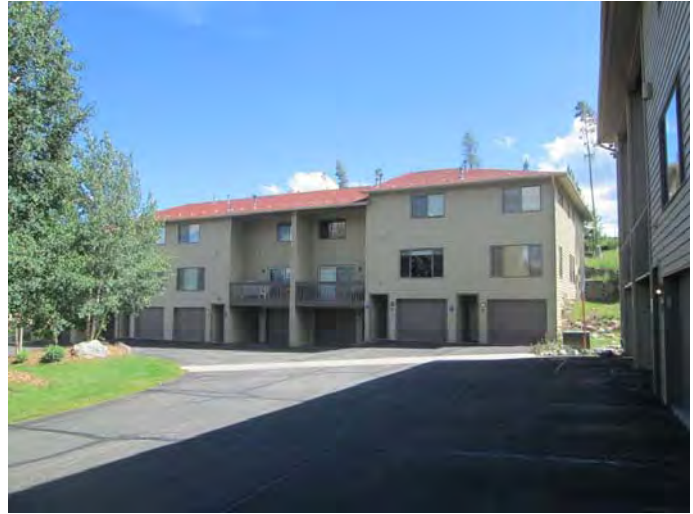
Comp #: 120 Gutters/Downspouts (Asphalt 1) - Replace

- It's recommended that all rain gutters and down-spouts are replaced when the roof is replaced.
- At the very least, it's recommended to budget for the work with the understanding that this work may not be needed.
- Gutters and downspouts should be inspected, with damaged sections being replaced, annually. Funding for this replacement, outside of the roof replacement, should be funded from the operating account.

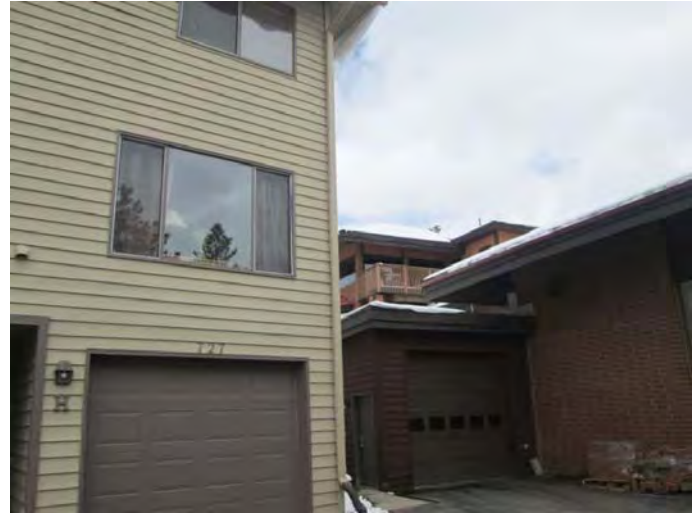
Comp #: 120 Gutters/Downspouts (Metal 3) - Replace

- It's recommended that all rain gutters and down-spouts are replaced when the roof is replaced.
- Gutters and downspouts should be inspected, with damaged sections being replaced, annually. Funding for this replacement, outside of the roof replacement, should be funded from the operating account.

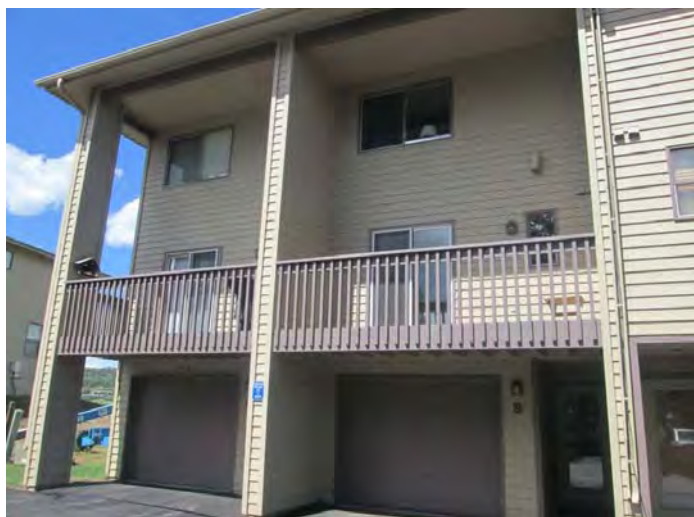
Comp #: 120 Gutters/Downspouts (Metal 4) - Replace

- It's recommended that all rain gutters and down-spouts are replaced when the roof is replaced.
- Gutters and downspouts should be inspected, with damaged sections being replaced, annually. Funding for this replacement, outside of the roof replacement, should be funded from the operating account.

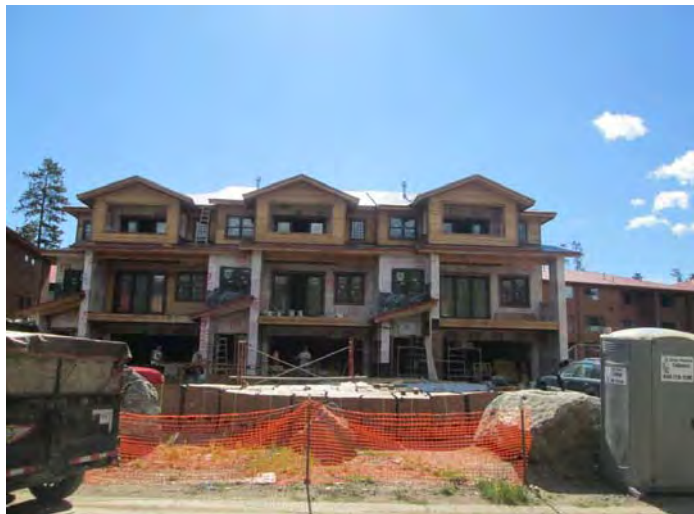
Comp #: 120 Gutters/Downspouts (Metal 5) - Replace

- It's recommended that all rain gutters and down-spouts are replaced when the roof is replaced.
- Gutters and downspouts should be inspected, with damaged sections being replaced, annually. Funding for this replacement, outside of the roof replacement, should be funded from the operating account.

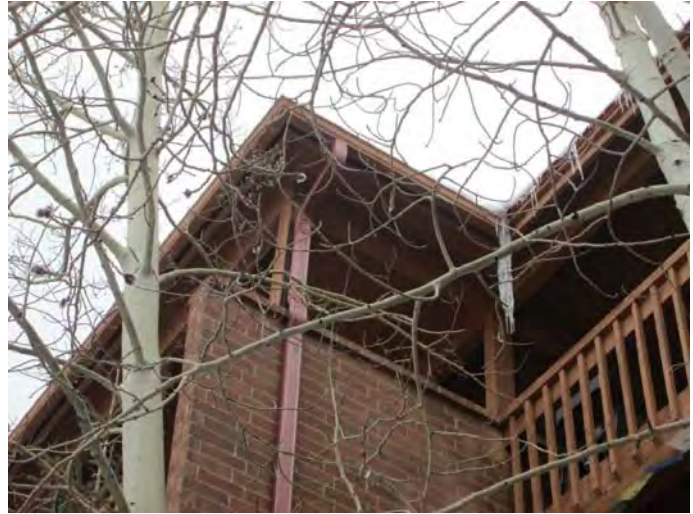
Comp #: 120 Gutters/Downspouts (Asphalt 2) - Replace

- It's recommended that all rain gutters and down-spouts are replaced when the roof is replaced.
- At the very least, it's recommended to budget for the work with the understanding that this work may not be needed.
- Gutters and downspouts should be inspected, with damaged sections being replaced, annually. Funding for this replacement, outside of the roof replacement, should be funded from the operating account.

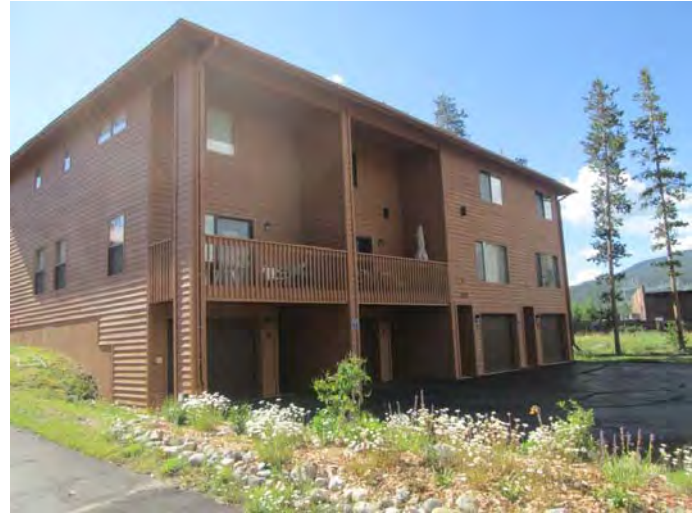
Comp #: 204 Building Exterior Surfaces (Phase 1) - Repaint

- The exteriors of these buildings, in general, were in fair to poor condition with higher exposures showing more deterioration due to constant freeze/thaw cycles during the winter months and constant UV degradation.
- Due to the accelerated deterioration associated with the aforementioned conditions, it's recommended the association paint these exteriors at a minimum of every 6 years.
- This includes all painted/stained surfaces on the exteriors of these buildings as well as regular prepping associated with paint projects, i.e. pressure washing, scraping/brushing, and applying primer & caulk.

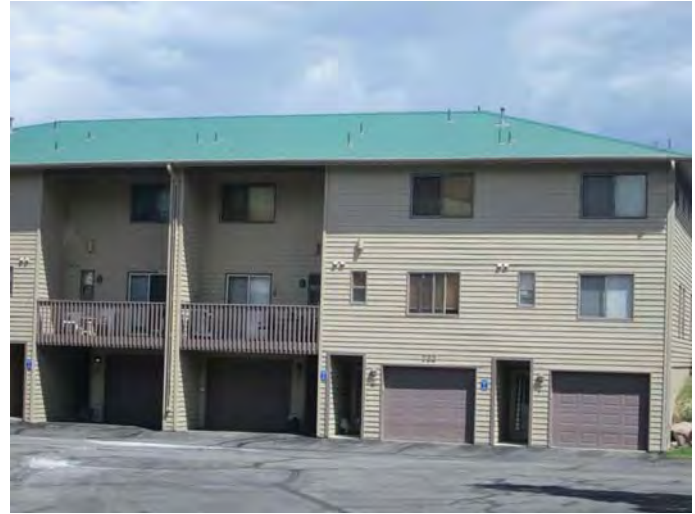
Comp #: 205 Building Exterior Surfaces (Phase 2) - Repaint

- The exteriors of these buildings, in general, were in good condition with higher exposures showing little fading on high exposures and no advanced deterioration (peeling or chipping paint, exposed wood surfaces, etc.)
- Due to the accelerated deterioration associated with the aforementioned conditions, it's recommended the association paint these exteriors at a minimum of every 6 years.
- This includes all painted/stained surfaces on the exteriors of these buildings as well as regular prepping associated with paint projects, i.e. pressure washing, scraping/brushing, and applying primer & caulk.

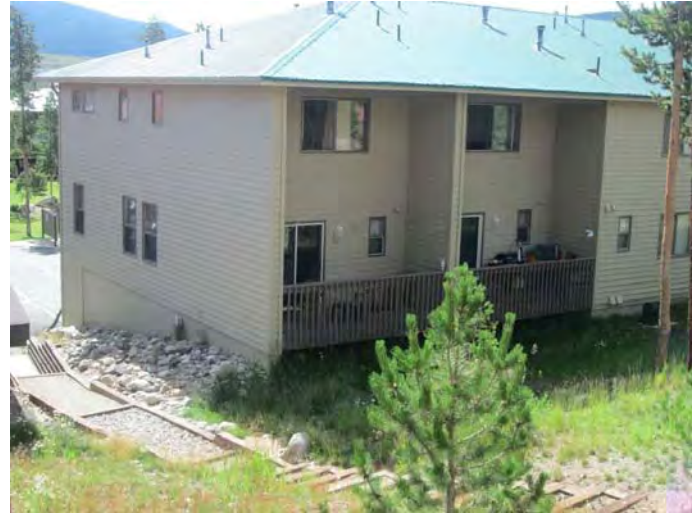
Comp #: 206 Building Exterior Surfaces (Phase 3) - Repaint

- These buildings, having been recently painted, appeared to be in good condition at time of observation.
- The painting schedule recommended is based on reports the association feels the current paint product will provide a longer than expected useful life and the reserve providers desire to align painting schedules and associated repairs with other work throughout the property.
- This includes all painted/stained surfaces on the exteriors of these buildings as well as regular prepping associated with paint projects, i.e. pressure washing, scraping/brushing, and applying primer & caulk.

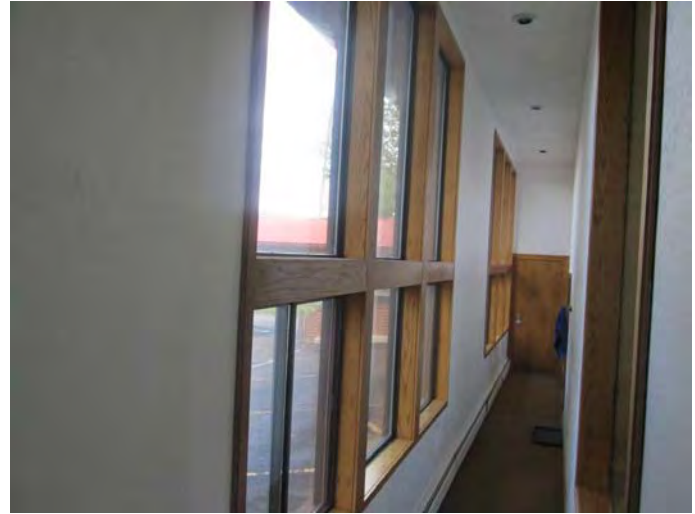
Comp #: 216 Clubhouse Interior Surfaces - Repaint

- Numerous scuffs and repaired surfaces were visible during time of observation.
- To provide a uniform appearance, and to allow colors to align with current design trends, it's recommended funding be provided to repaint all regularly used interior surfaces on a regular basis.
- This work has been aligned with other trades to ensure interior renovations are aligned for the best cost estimates.

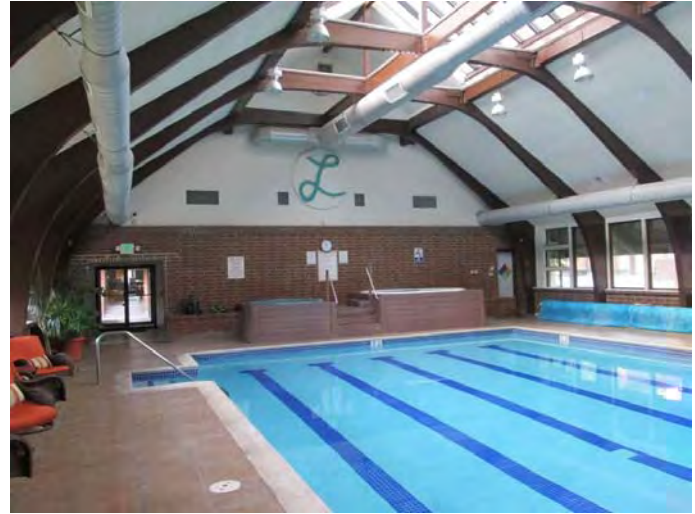
Comp #: 216 Poolhouse Interior Surfaces - Repaint

- The interior surfaces appeared to be in good condition, during observation, considering the environment in the building.
- It's recommended that all interior surfaces are painted on a regular basis to prevent deterioration from the high humidity levels in this building throughout the year.
- All damaged/deteriorating surfaces should be replaced prior to painting.

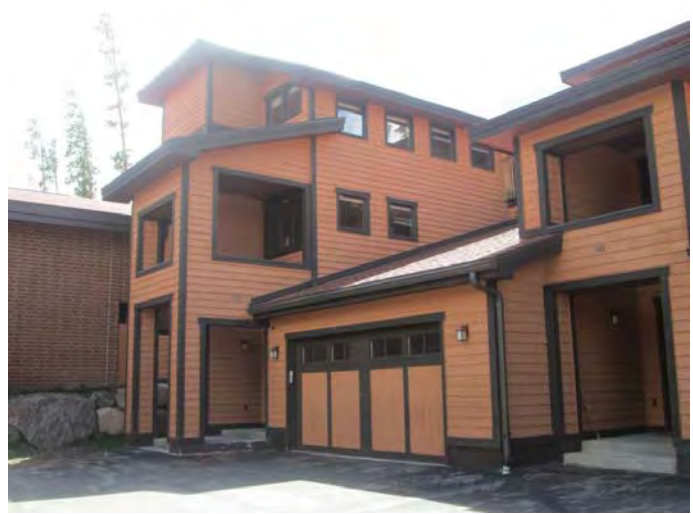
Comp #: 303 Cedar/Wood Siding (Phase 3) - Repair

- The building exteriors were, as a whole, good during observation with high exposure areas (southern exposures and areas near drip lines) beginning to show some advanced deterioration (cracking/peeling of paint).
- It's recommended funding be provided to replace a portion of the siding every other paint cycle to replace boards experiencing advanced deterioration.
- Outside of this replacement scheduled, repairs to extremely deteriorated boards should be handled with operating funds as needed. Otherwise, the prepping typically associated with painting will allow for replacement of a few boards during the regularly scheduled painting cycles.

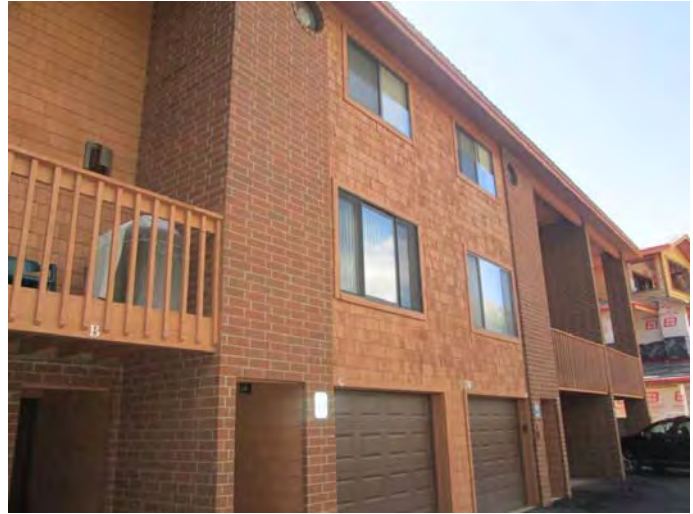
Comp #: 303 Cedar/Wood Siding (Phase 2) - Repair

- The building exteriors were, as a whole, good during observation with high exposure areas (southern exposures and areas near drip lines) beginning to show some advanced deterioration (cracking/peeling of paint).
- It's recommended funding be provided to replace a portion of the siding every other paint cycle to replace boards experiencing advanced deterioration.
- Outside of this replacement scheduled, repairs to extremely deteriorated boards should be handled with operating funds as needed. Otherwise, the prepping typically associated with painting will allow for replacement of a few boards during the regularly scheduled painting cycles.

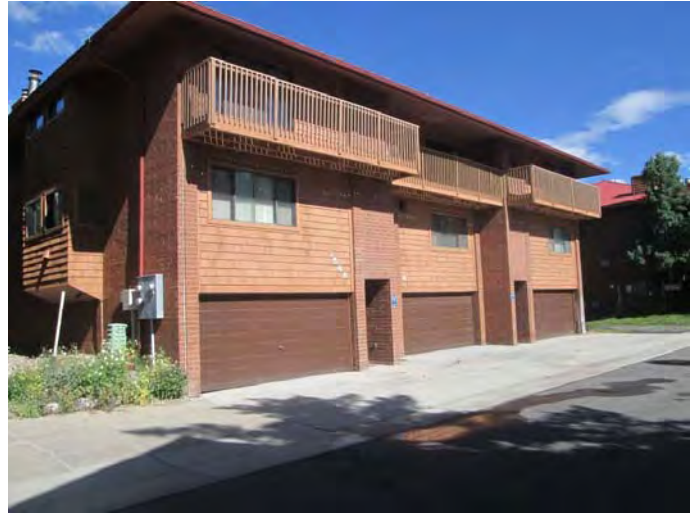
Comp #: 303 Cedar/Wood Siding (Phase 1) - Repair

- The building exteriors varied in condition, from good to fair, during observation with high exposure areas (southern exposures and areas near drip lines) showing some advanced deterioration.
- It's recommended funding be provided to replace a portion of the siding every other paint cycle to replace boards experiencing advanced deterioration.
- Outside of this replacement scheduled, repairs to extremely deteriorated boards should be handled with operating funds as needed. Otherwise, the prepping typically associated with painting will allow for replacement of a few boards during the regularly scheduled painting cycles.

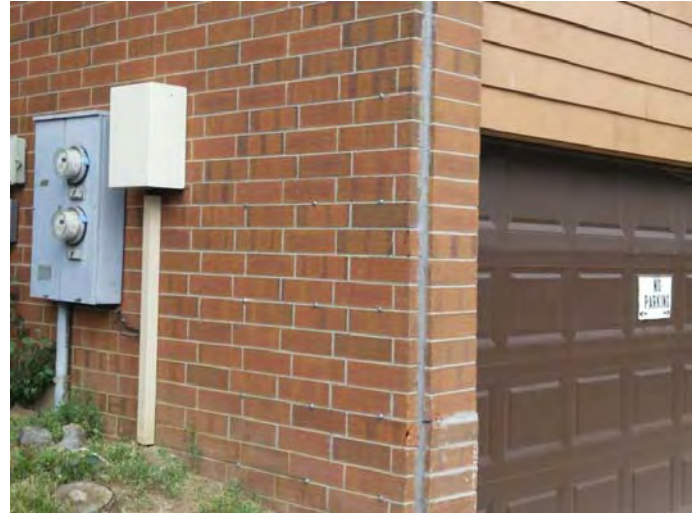
Comp #: 306 Brick - Replace

- Funding not recommended as this is currently being handled annually with operating funds.
- It was reported the association is currently experiencing some settling issues on some buildings. If the engineering analysis shows a bigger problem than expected, funding for this will need to be added to future studies.

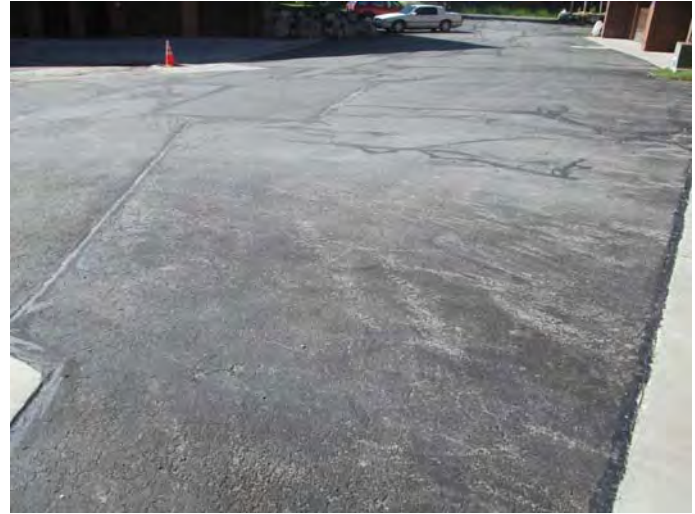
Comp #: 401 Asphalt (Lagoon) - Mill & Major Overlay

- In general, the asphalt surfaces appeared to be in good condition with few areas of advanced deterioration (signs of pooling water, large cracks, alligatoring, etc.) noted during observations.

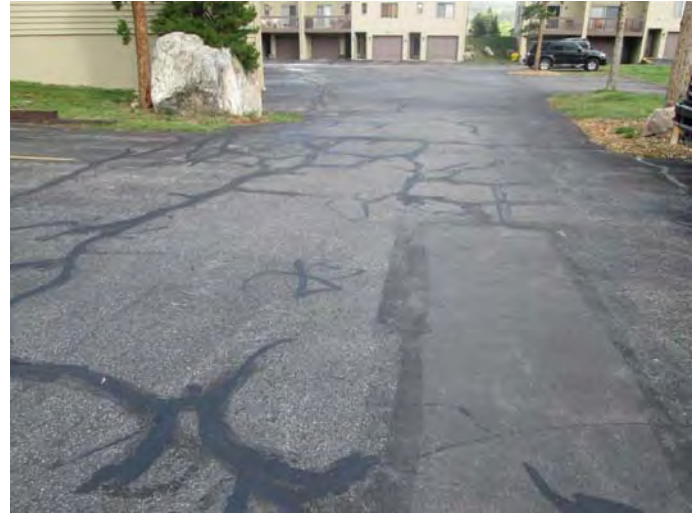
Comp #: 401 Asphalt (Meadows) - Mill & Major Overlay

- In general, the asphalt surfaces appeared to be in fair condition with signs of advanced deterioration (significant cracking, signs of pooling water, large cracks, alligatoring, etc.) noted during observations.

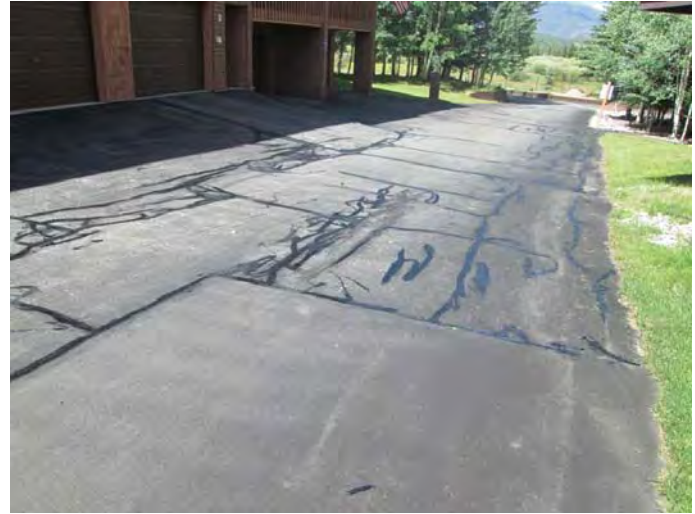
Comp #: 402 Asphalt (All) - Surface Application

- As noted in Components 401 (for both sections), the surface conditions varied from good to poor, throughout the property, depending on location and age of surface.
- In addition to the operational funding provided to seal cracks throughout the property on an annual basis, and the seal coating of all surfaces, this funding includes IR repairs to areas experiencing advanced deterioration. This work is necessary to ensure the longest possible useful life of this asset.
- Due to the large quantity of asphalt, and varying condition noted during observations, it's recommended funding be provided to perform surface applications to all asphalt surfaces on a regular basis.

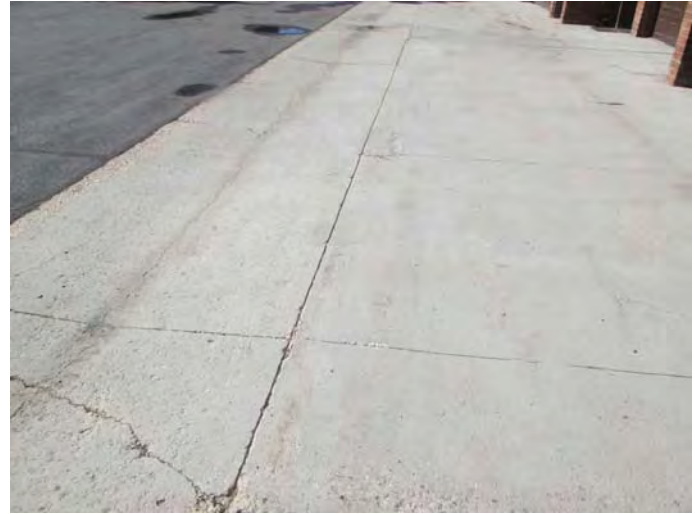
Comp #: 403 Drive Concrete - Repair/Replace

- The drive concrete varied in condition from new to poor during observations.
- As the useful life of concrete varies with installation location and quantity of traffic, it's difficult to anticipate when, and where, concrete will fail. You will find certain areas need replacement every other cycle, while others can go 50 years without needing to be replaced.
- It's recommended funding be provided to replace a portion of the concrete on a regular basis. Care should be taken to ensure all deteriorating areas are repaired before surface deterioration allows the substrate to be compromised.

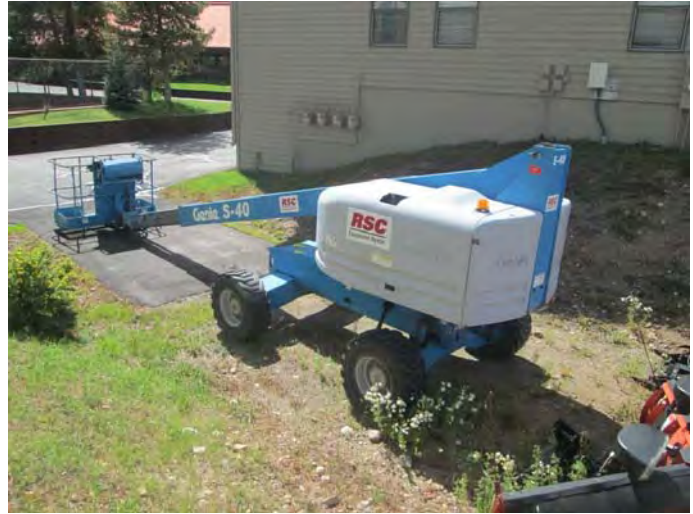
Comp #: 1905 Man Lift - Replace

- No funding, it has been reported that the association is selling this asset.
