CRITERIUM[®] ENGINEERS

Property: Lake Forest
Lake View Terrace-Frisco, CO

Service: Full Reserve Study

Site Inspection 10/17//17
INITIAL DRAFT submitted: 11/17/17
FINAL REPORT Submitted 4/1/18

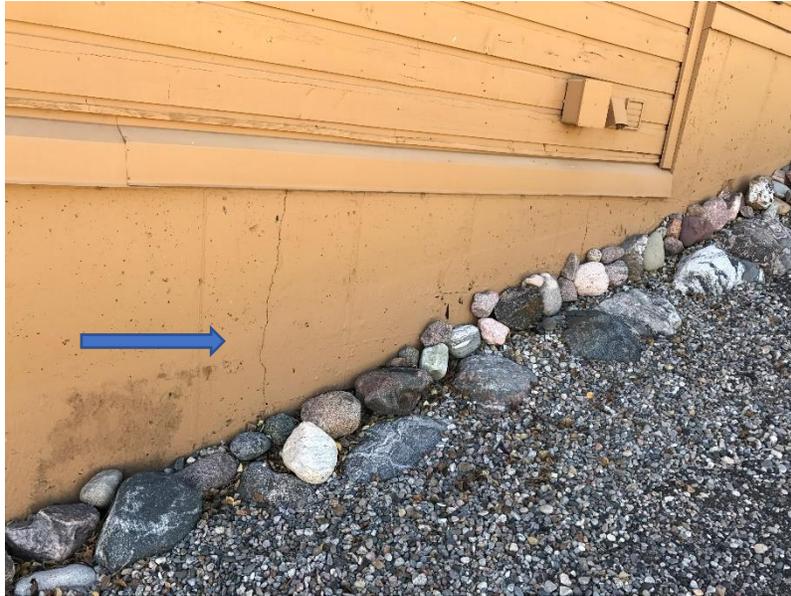
There was cracking evident in the foundation on the east side of building A. This foundation wall did not show any evidence of bulging or movement and the recommendation is to monitor with no repair required at this time. This cracking is insignificant and not an indication of foundation settlement issues.

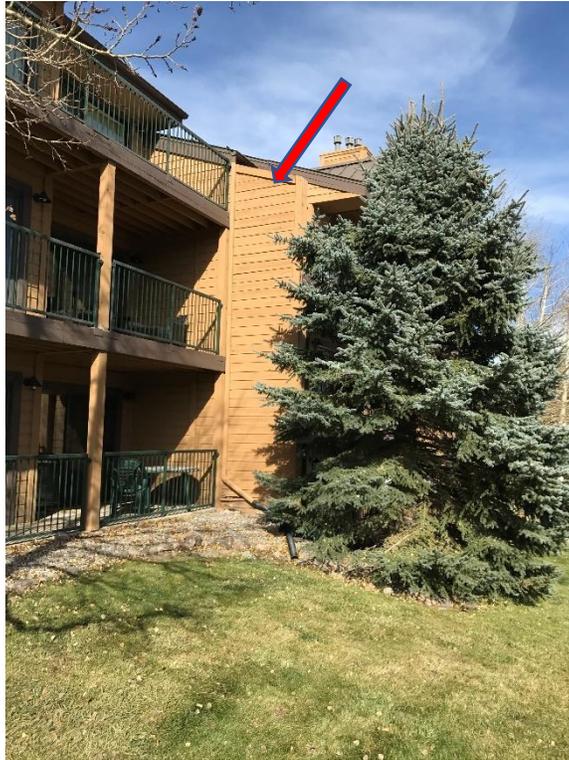
There are standing walls on the South side of building A and B that are not properly constructed and are open to the environment on top of the wall as shown in the following photo. These should be repaired and capped to prevent any further deterioration.

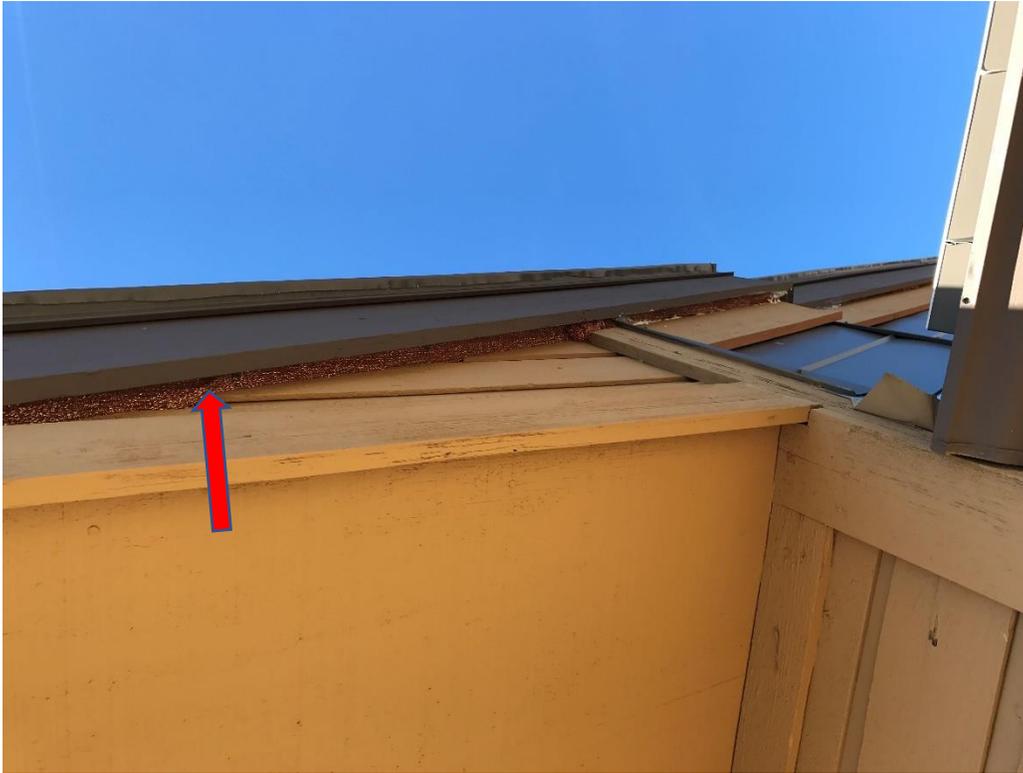
The buildings were originally constructed with gaps in the trim that allow bats to enter the attic spaces. Site maintenance has been closing these gaps with a mesh material as an ongoing project.

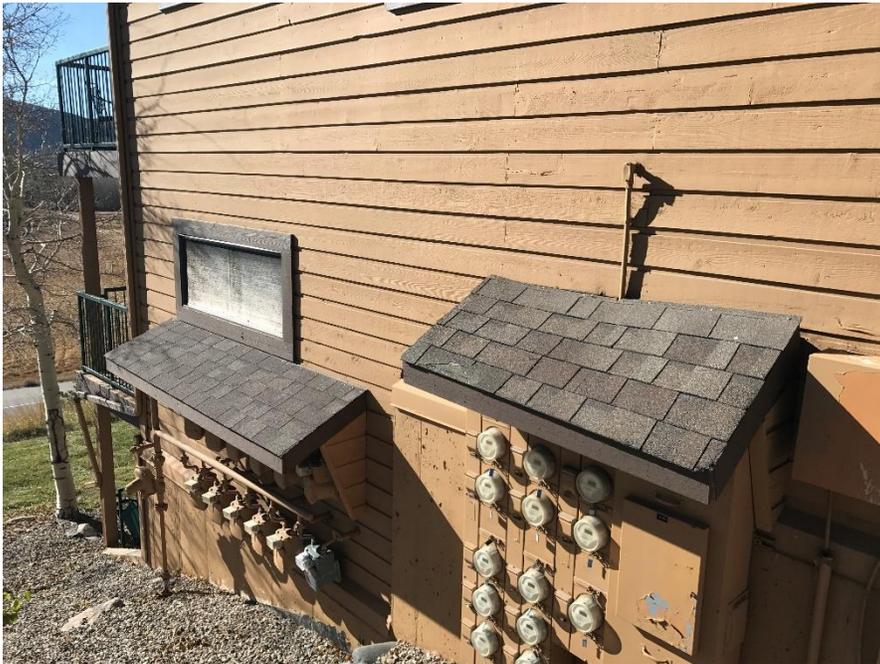
2

Description: Sloped roof over utility meters- needs to be properly attached and new flashing added. Flashing should be attached to wall and loose over top of roof.

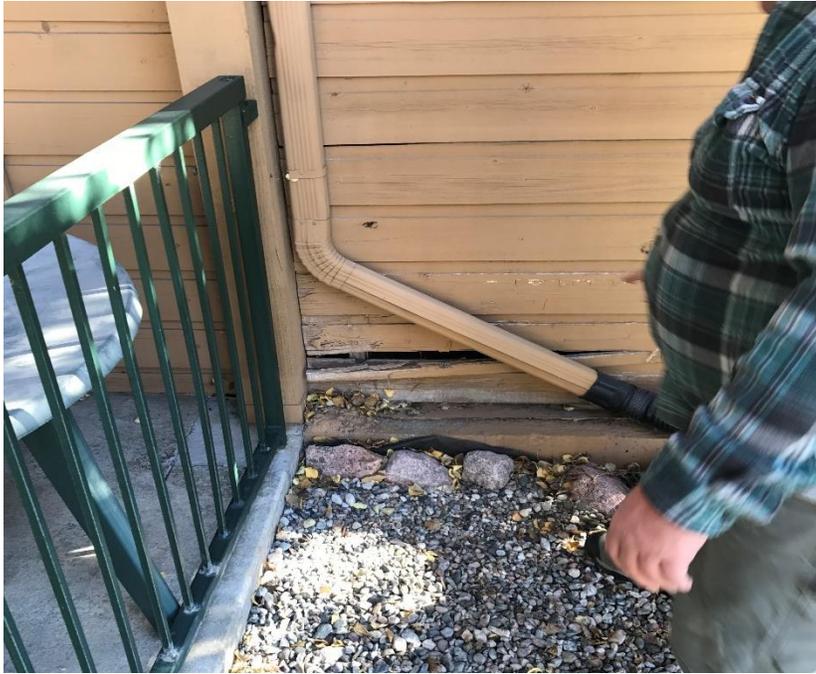
3

Description: Damage from uncapped standing wall as described in 4.3.2.

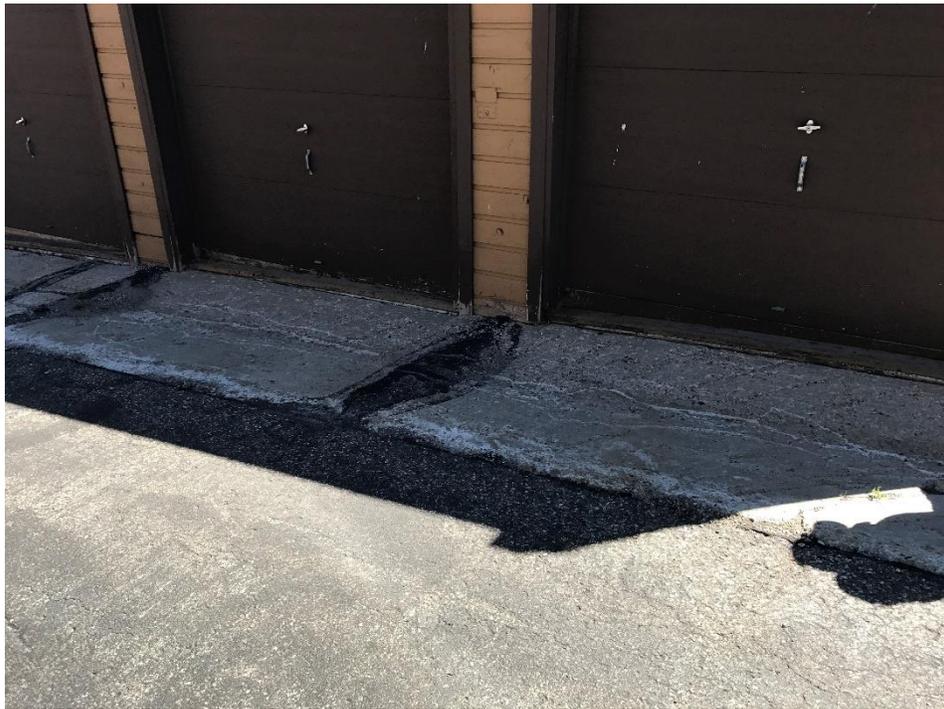
4

Description: Concrete drainage in front of B-building garages.

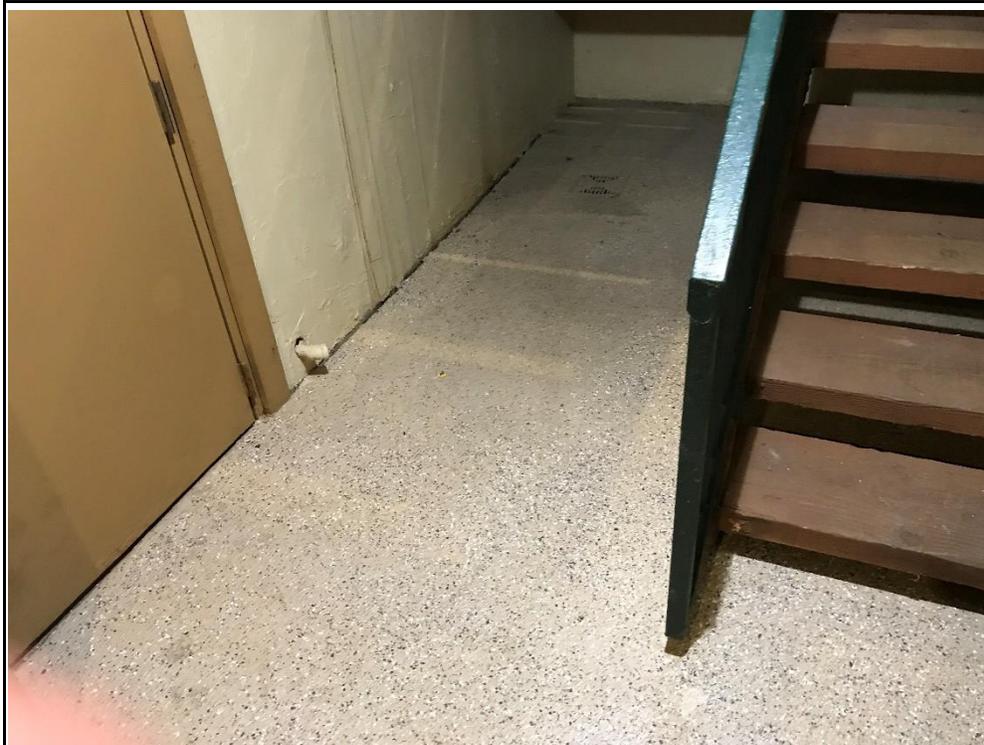
5

Description: Typical drain in floor of Building A-D. These drains are critical to remove any water that gets into the stairwell. Some drains were not functioning and there was no indication that they were draining outside the building.

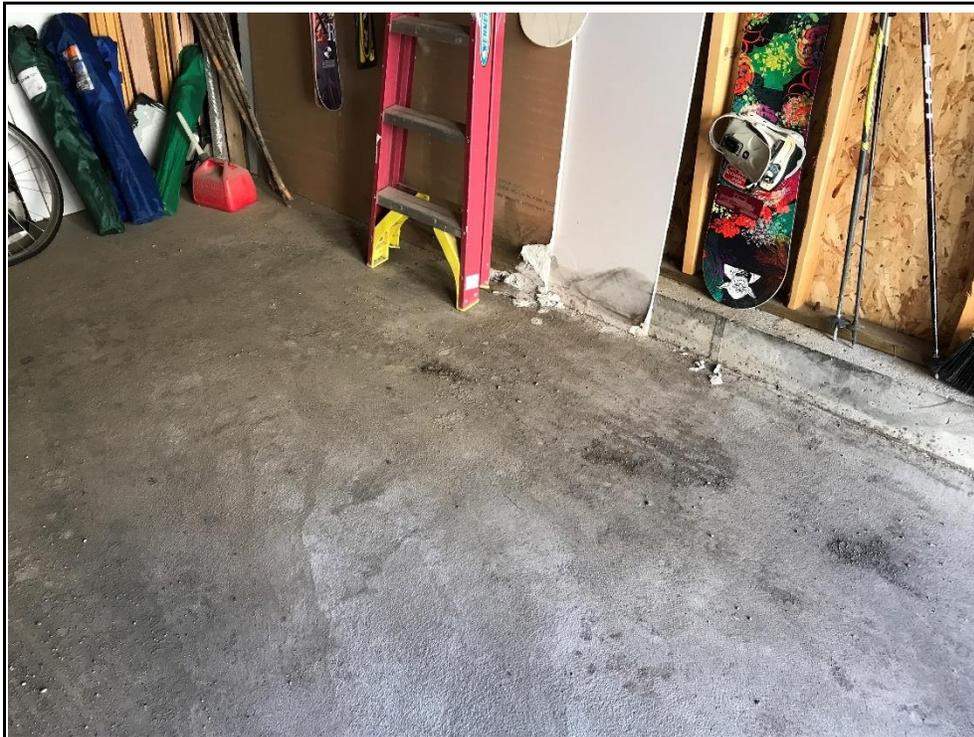
7

Description: Typical water damage in B-building garage. Water came in under door during rain event.

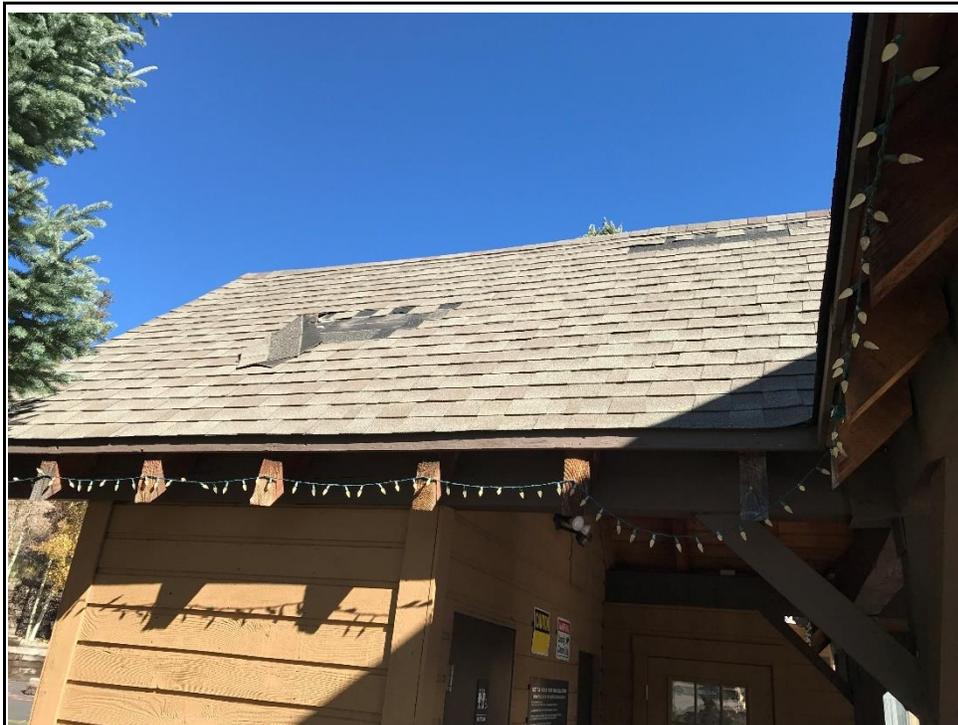
8

The sloped asphalt shingle roofs on the garages and the clubhouse are showing deterioration and need replacement in 2018. The clubhouse roof is currently missing shingles in 3 places and this should be repaired in 2017.

Description: Clubhouse roof damage

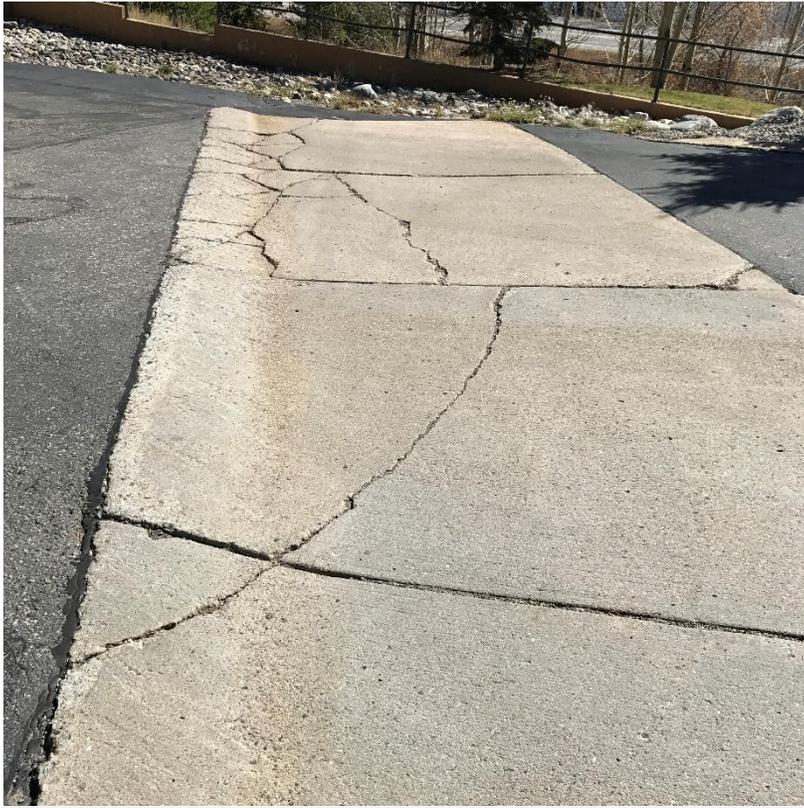
13

Description: Typical concrete damage.

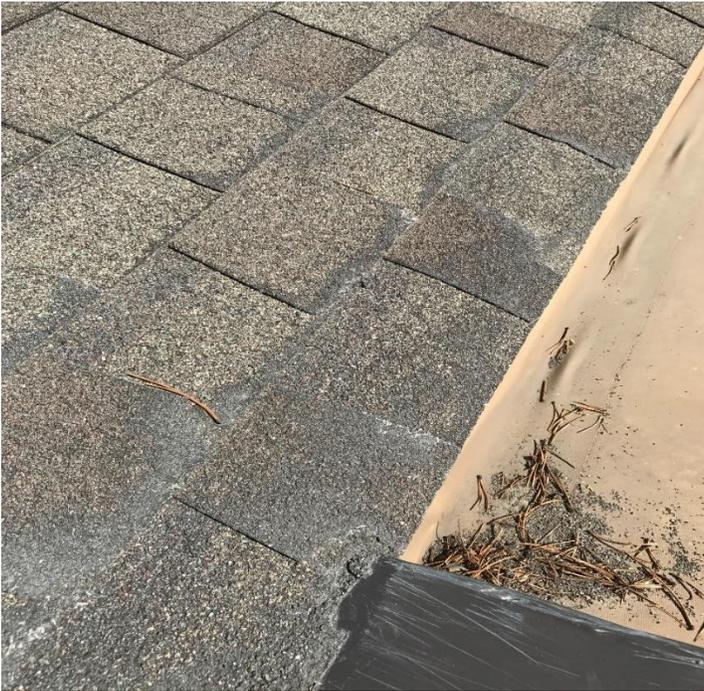
15

Description: Damage to asphalt shingle roof on garage from environmental wear and foot traffic.

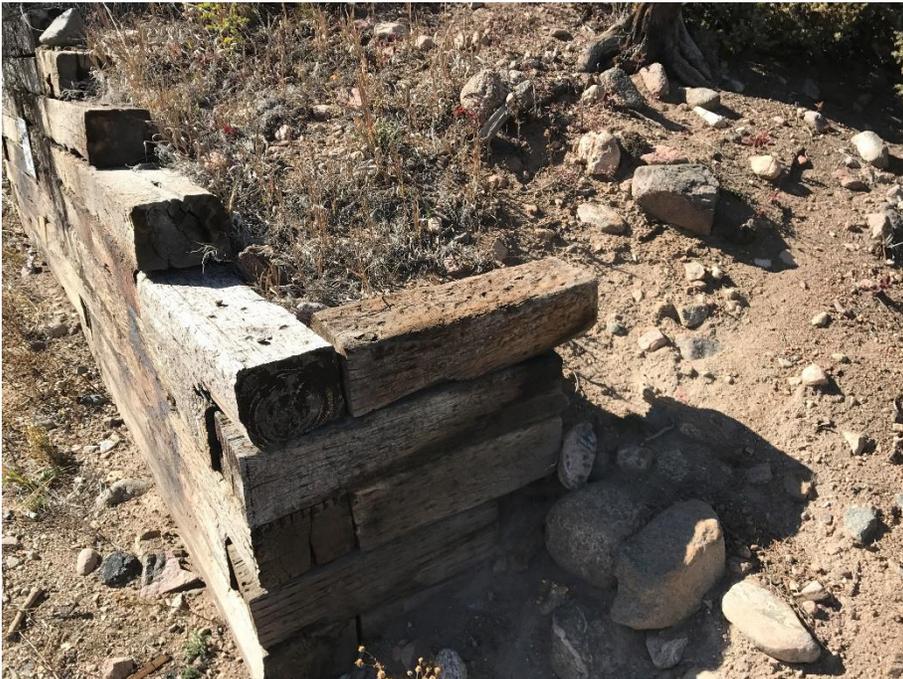
16

The buildings have partial gutters and downspouts designed to move water away from the foundations. No areas of surface standing water were observed although there were drainage issues present on the property. There were some areas of storm water erosion observed primarily at the railroad tie retaining walls.

Description: Erosion at East end of retaining wall behind Building F

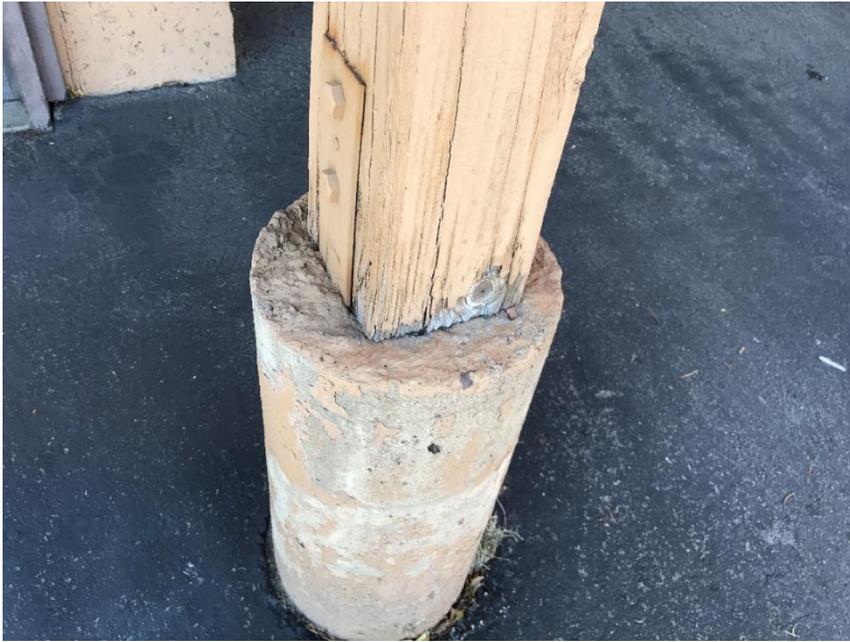
17

Description: Balcony support post deterioration Building E

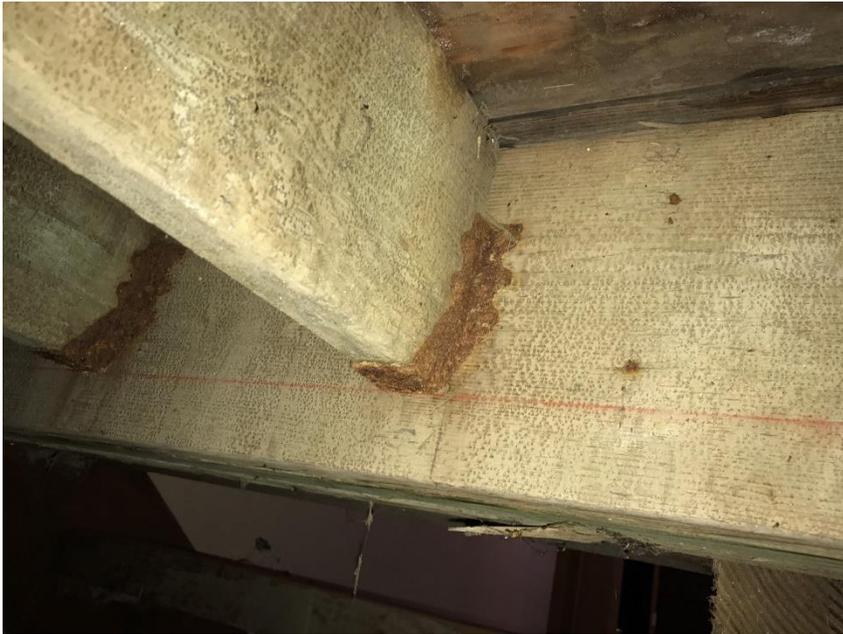
18

Description: Surface corrosion
stair joist hangers Building B

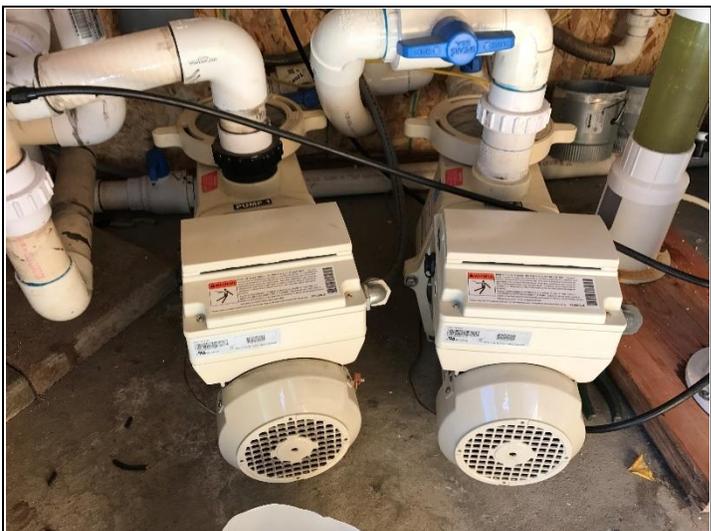
Photo 22: Spa pumps-tag not readable
