# **The Lodge at Riverbend Level 2 Reserve Management Plan As Of October 1, 2019**

**337 Streamside Lane, Frisco, Colorado 80443**

Re: 2018 Level 2 Reserve Management Plan

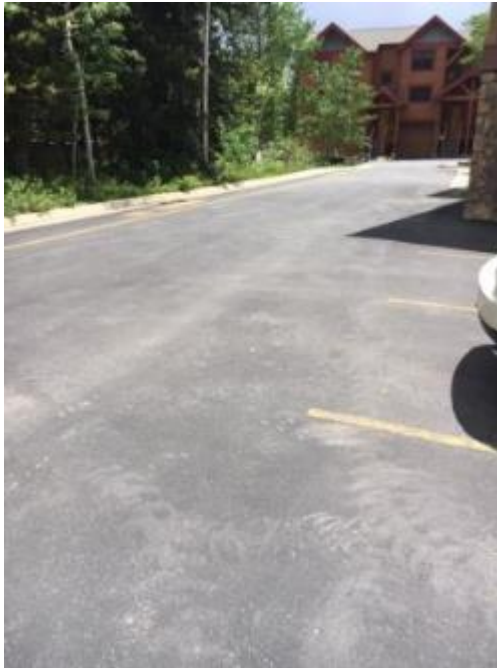
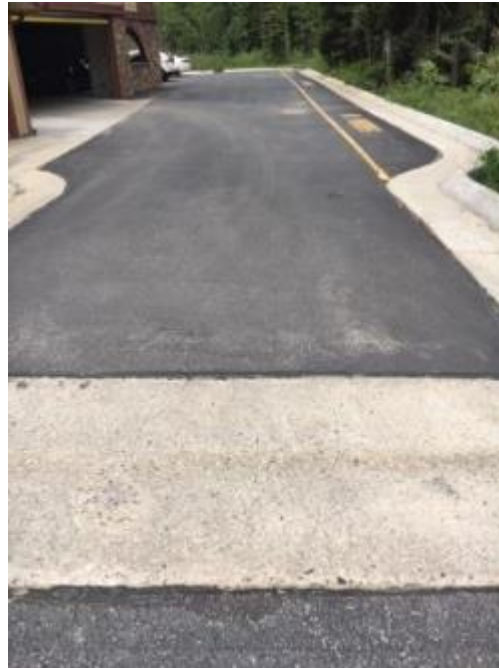
Location: The asphalt driveway in the development.

Comments: The asphalt driveway was installed in 2002 and has an estimated useful life of 22 years. The driveway was in excellent condition at the time of inspection. Care should be taken to provide proper maintenance, such as asphalt repair, crack filling and seal coating.

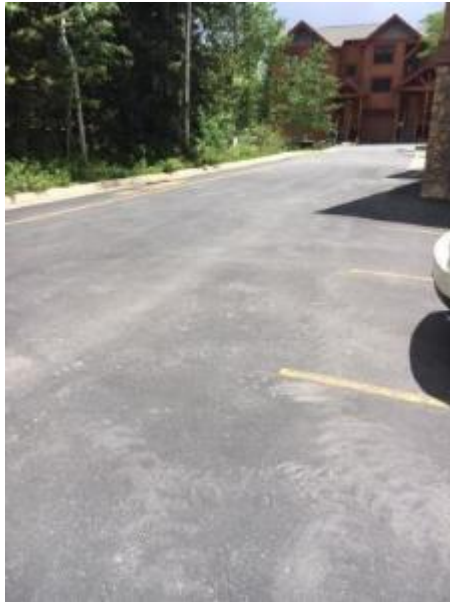
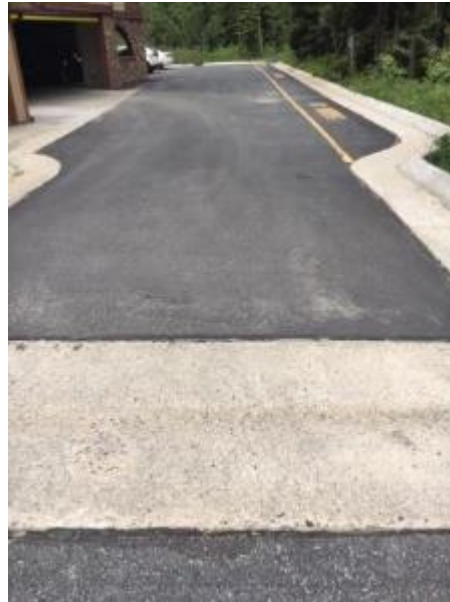
Location: Asphalt driveway in the Development.

Comments: The asphalt crack filling and seal coating was completed during the summer of 2018. Seal coating helps maintain the asphalt surfaces to prevent oxidation and excessive cracks. It is recommended that cracks be filled every fall prior to the winter season to prevent water from entering the cracks, freezing and expanding the crack and causing raveling (separation of aggregate particles in the pavement). Crack filling should be paid out of operating funds for the years between seal coating. Crack filling prior to seal coating is included in the basis cost. It is estimated the seal coating be completed every 3 or 4 years for proper protection and uniform appearance.

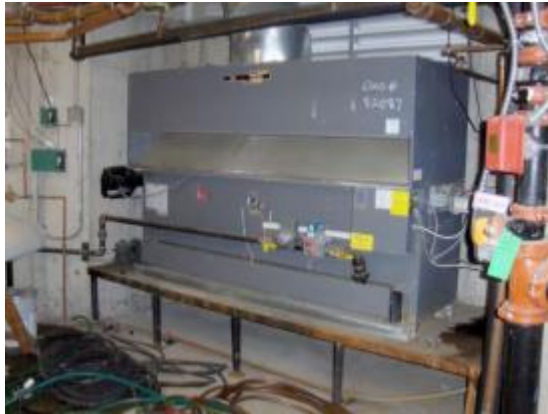
Location: In the mechanical room located in the garage level.

Comments: The Laars hot water gas boiler has a BTU output of 1,670,000. It was manufactured in 2003 with model number PH 1670 IN 09 K1 ACCM. It was stated by All Phases Plumbing in the 2012 Reserve Study, "...the current boiler loses considerable output efficiency, due to configuration, age and altitude (estimates current output about 800,000 BTU's. At the end of its life, it would likely be replaced with 2 smaller (about 400,000 BTU each) high efficiency boilers, such as made by prestige." The estimated useful life is 22 years with a remaining life of 5 years.

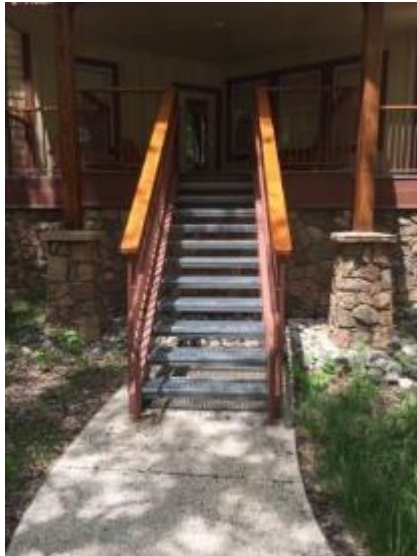
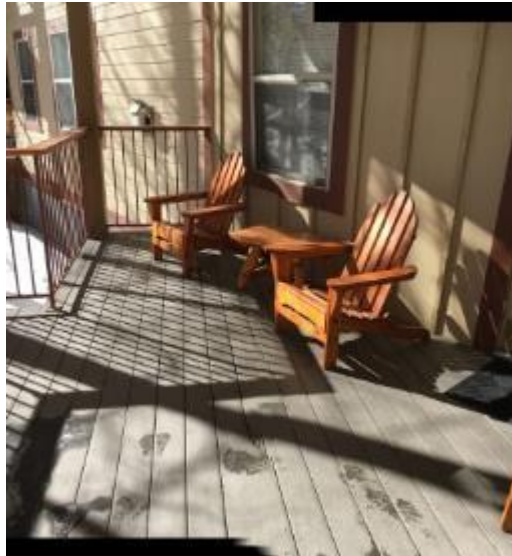
Location: At the front entrance.

Comments: The front entrance Trex decking is approximately 195 square feet and was in excellent condition at the time of inspection. The estimated useful life of the deck is 40 years with proper maintenance and board replacement, as needed. The current cost to replace the deck is \$4,144.

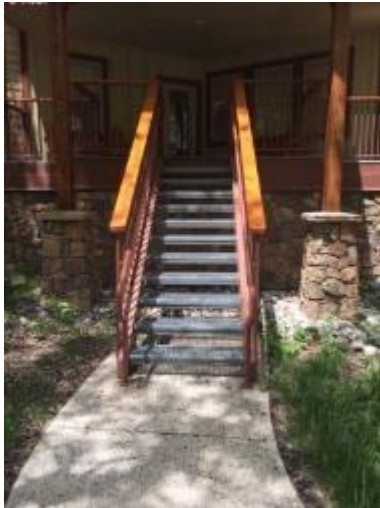
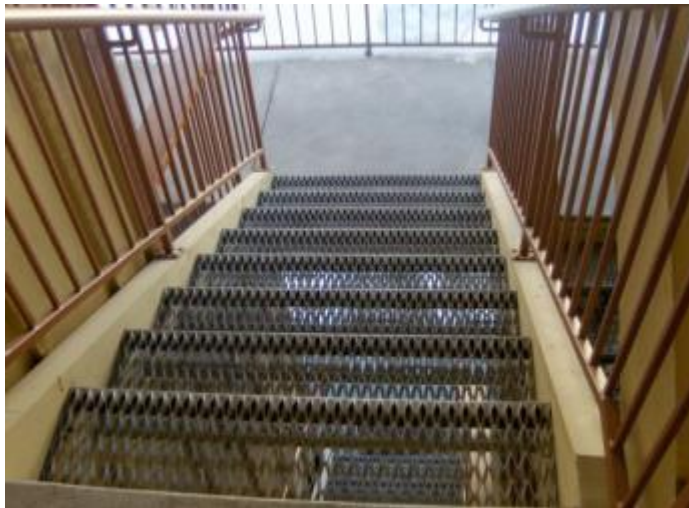
Location: The front and back entrance to the building.

Comments: The stair system was in very good to excellent condition at the time of inspection. The back entrance stairway has 8 galvanized steel treads (1 foot wide by 4 feet long) on each stair flight, for a total of 32 stair treads. There are 48 linear feet of stairs. The railings have 2 X 6 wood caps with iron balusters and are 4 1/2 feet high. There are also 112 linear feet of tubular hand rails.

Maintenance records for the stairs since the buildings were constructed are not available at the time of inspection. Due to the heavy duty construction of the stairs, the estimated useful life is 45 years with the remaining life of 27 years. Maintaining the railings, stairs and landings should be completed as needed and is included in the asset classification, "Building Siding, Decks & Trim - Painting and Staining". It is possible the iron balusters have a useful life beyond the scope of this Plan.

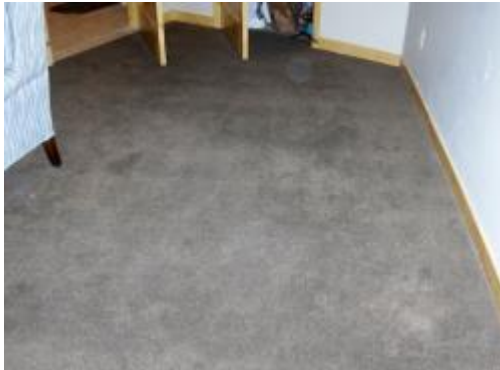
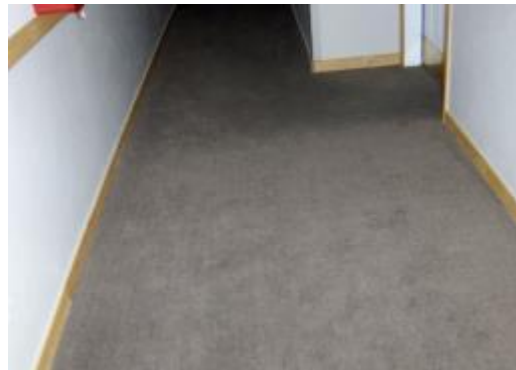
Location: The interior hallways, stairwell, community room and elevator.

Comments: The overall condition of the carpet at the time of inspection was excellent. The carpet was replaced in 2016 at a cost of \$30.08 per square yard. The useful life is 15 years with the remaining life of 12 years. The cost includes carpet removal and disposal and installation of medium to high quality interior commercial carpet. The current cost to replaced is adjusted for inflation since 2016.

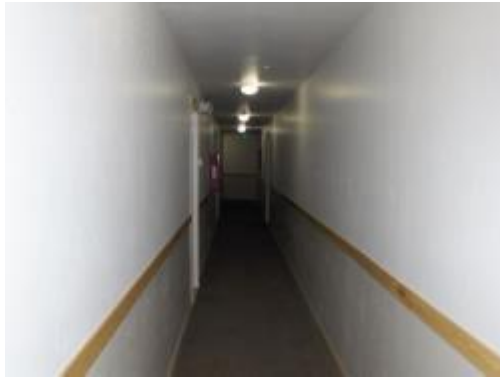
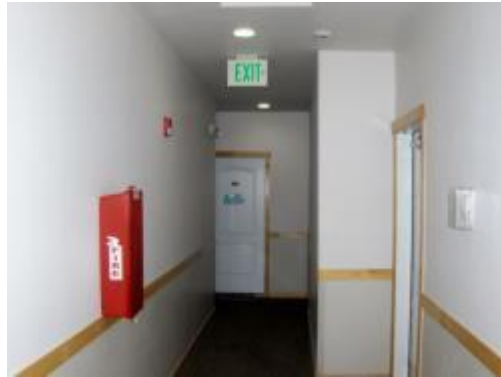
Location: All interior walls and ceilings in the building.

Comments: The overall condition of the walls and ceilings was excellent at the time of inspection. The total approximate drywall surface is 11,000 square feet. The interior walls were painted in 2016 at a cost of \$7,036, or \$.64 per square foot. The estimated useful life is 18 years with 15 years remaining life.

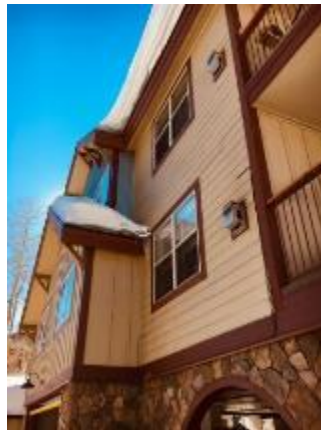
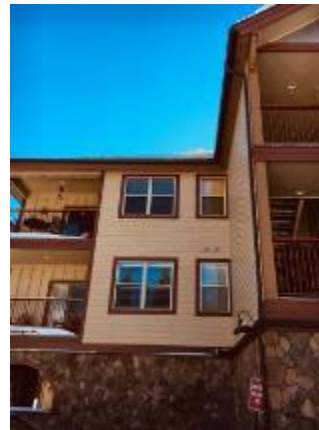
Location: The building exterior siding, decks, railings and trim.

Comments: This asset category includes 5,100 square feet of hard board lap siding, 7,200 square feet of board batten fiber cement siding, 3,800 square feet of deck and stairwell ceilings, and 4,500 linear feet of trim of varying widths. According to the previous Reserve Analysis dated October 1, 2012, "Management has advised that considerable painting was completed to the more exposed surfaces in July, 2012, by Peak Painting for about \$6,300." The Association wants to set a schedule of painting one side of the building each year. This schedule has been set up in this asset listing.

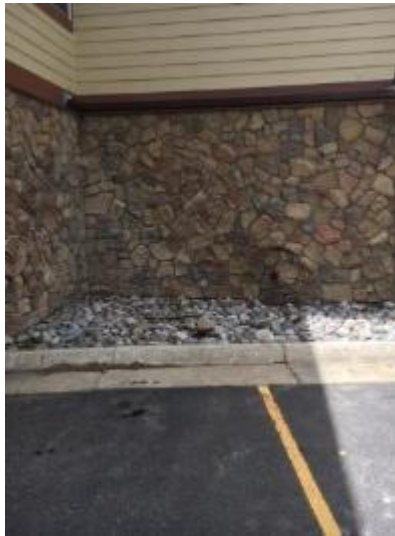
Location: On the exterior of the building.

Comments: The stone veneer covers approximately 10% of the building exterior walls and includes the stone bases for the entrance and deck support posts. During the inspection no loose or missing material was noted. This surface has an extended life and complete replacement is unlikely. Repairs such as tuck pointing or individual stone replacement may be needed, but this is very unpredictable as to when this may occur. Repairs and cleaning should be handled as a maintenance expense from operating funds as needed. If, in the future, it is determined that frequent repairs and improvements are needed, funding can be added in future Reserve Management Plans. The estimated useful life is beyond the scope of this Plan.

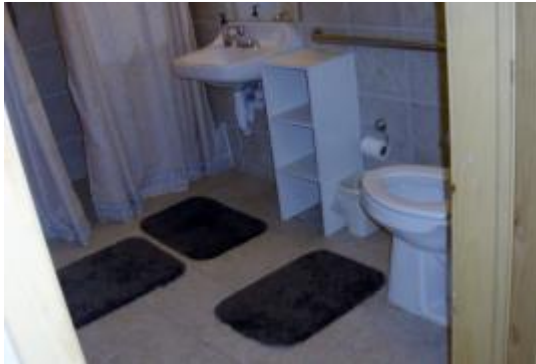
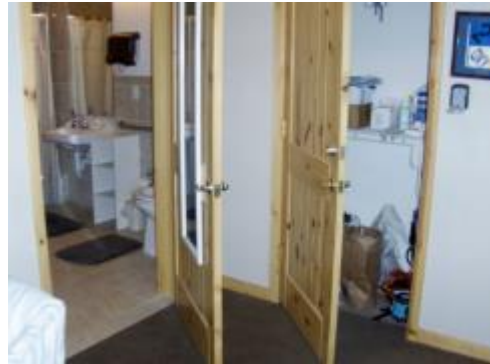
Location: In the bathroom at the community room.

Comments: The bathroom fixtures appear to be original and in good condition at the time of inspection. The estimated useful life is 28 years with 10 years remaining life.

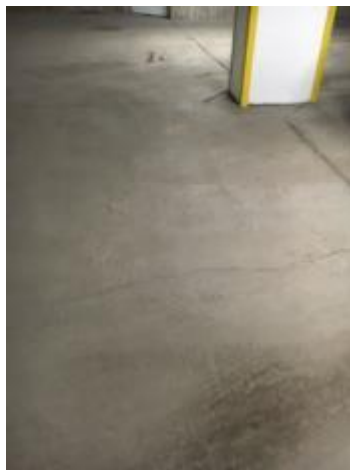
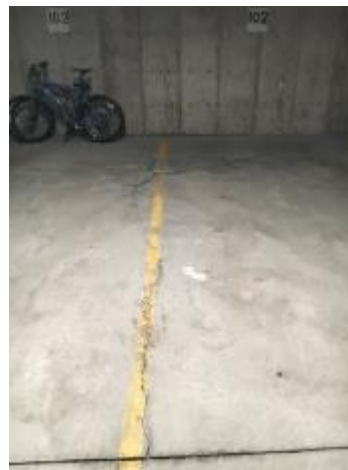
Location: The concrete floor in the parking garage.

Comments: The garage floor was in good condition at the time of inspection with some cracking noted. The estimated useful life of the concrete floor is 45 years. It is recommended to plan for some repairs and/or replacement of 10% (11,650 square feet X 10% = 1,165 square feet) of the garage floor area every 10 years starting in 2025. The frequency of these repairs/replacement can be adjusted in future Reserve Management Plans, if needed.

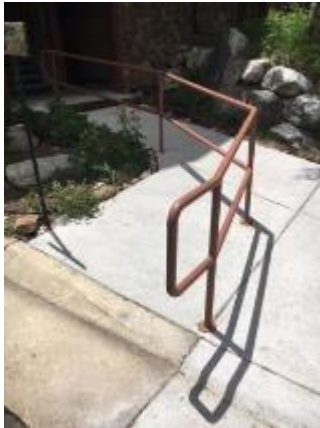
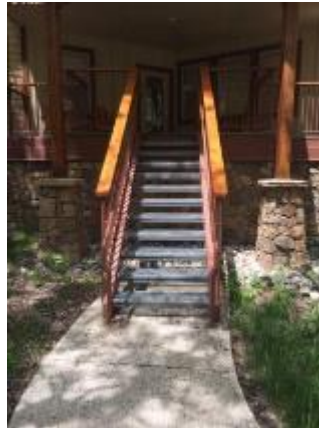
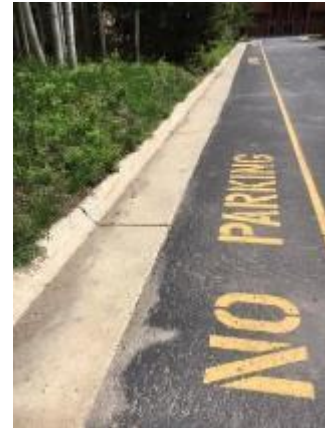
Location: Front and back sidewalks, front concrete stairs, curbs and gutters and dumpster base.

Comments: The back sidewalk was replaced in 2018 and is in excellent condition. The estimated useful life is 20 years with the projected replacement year of 2038. The front sidewalk is original (2002) and has some pitting and cracking. The front sidewalk, dumpster pad and the concrete area outside of the dumpster to the garage entrance have an estimated life of 27 years with a remaining life of 9 years. The estimated useful life of the curbs and gutters is 20 years with 3 years remaining life. The frequency of these replacements and the overall useful life can be altered in future Reserve Management Plans, if needed.

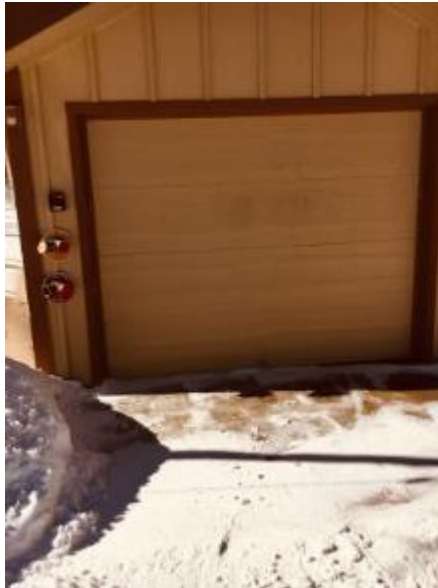
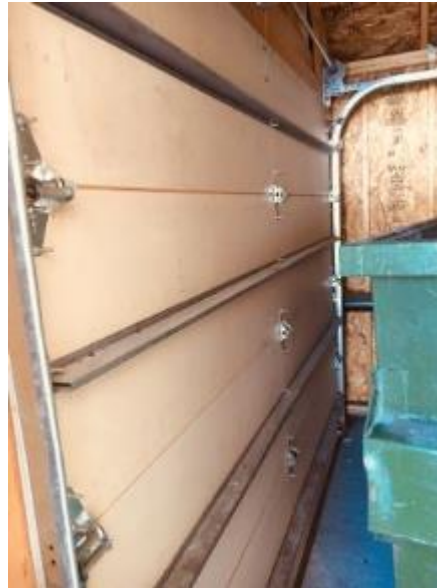
Location: Large garage style entrance door to the dumpster.

Comments: The door was in good condition at the time of inspection. The estimated useful life is 22 years with 4 years remaining life.

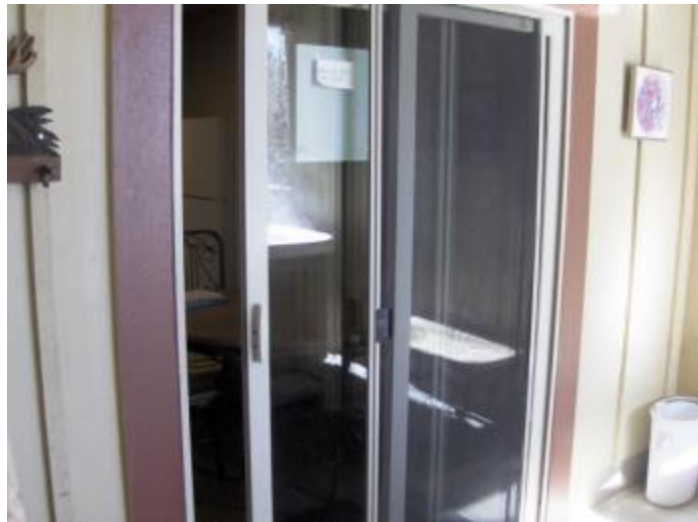
Location: Entrance to the hot tub area from the community room.

Comments: At the time of inspection the sliding glass door was in good condition. With a useful life of 25 years, the remaining life is 8 years. The current cost to install a new door is approximately, \$1,050.

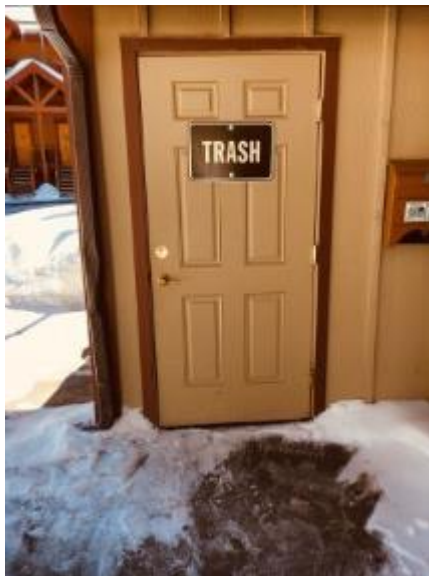
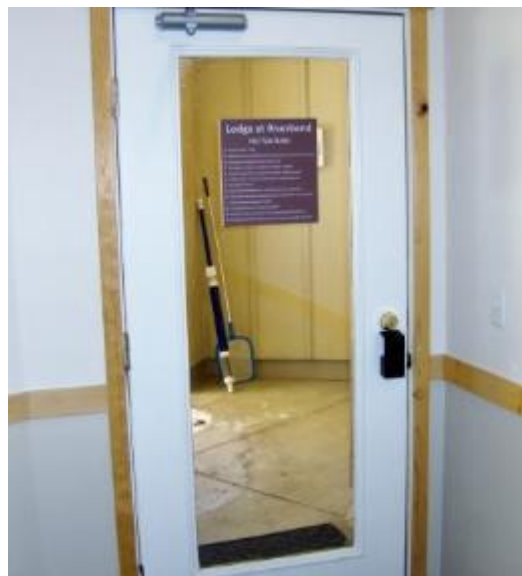
Location: Throughout the building.

Comments: The service door inventory includes all storage unit doors, back and front entrance doors, elevator mechanical room, entrance to residence area from garage, interior doors to the 2 floors, door to hot tub from the 2nd floor hallway, entrance door to the community room, 2 doors inside the community room to the bathroom and storage room, 1 door to the boiler room, and 1 trash enclosure person access door. All the 24 service doors were in good to excellent condition at the time of inspection. The estimated useful life for the doors ranges from 20 to 45 years, depending upon the quality and usage of the doors. It is recommended to plan to replace 5 doors

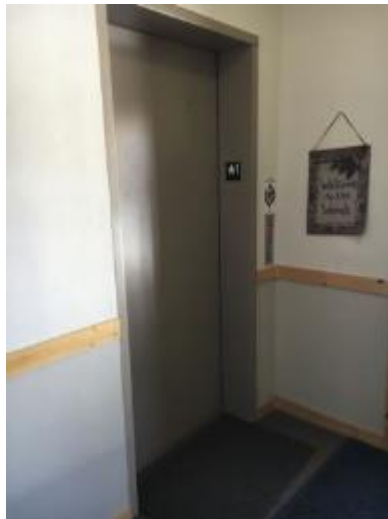
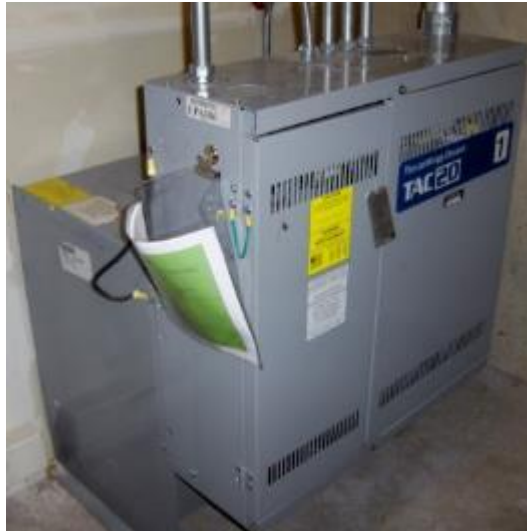
Location: The elevator mechanical room is located at the back entrance. The elevator services all 3 floors.

Comments: The elevator cab and other components were in proper working order at the time of inspection. The estimated useful life of hydraulic, multi-family residential elevators is generally 30 years, if proper repairs and overhauls are completed as needed. The elevator inspections have been completed annually to address any operation and safety concerns. The date of the last inspection was May 30, 2018 with the current inspection certificate expiring on June 30, 2019. The recommended correction action listed on the Annual Inspection Findings have been complied with.

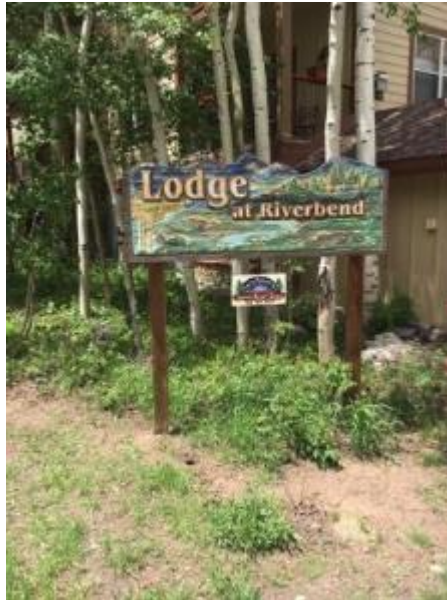
Location: At the front entrance to the development.

Comments: The entrance sign was in excellent condition at the time of inspection. The 6' by 3' sign generally has a useful life of 20 years, but based on the condition of the sign, a more realistic useful life is 25 years with a remaining life of 8 years.

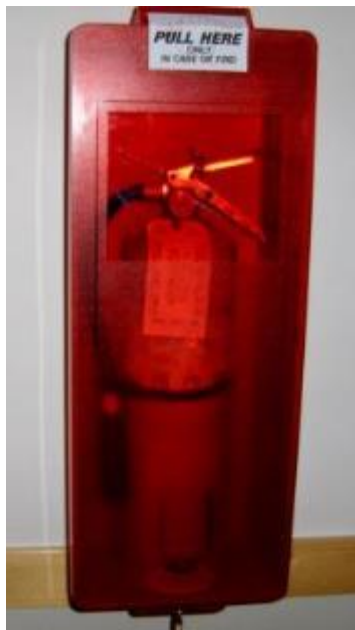
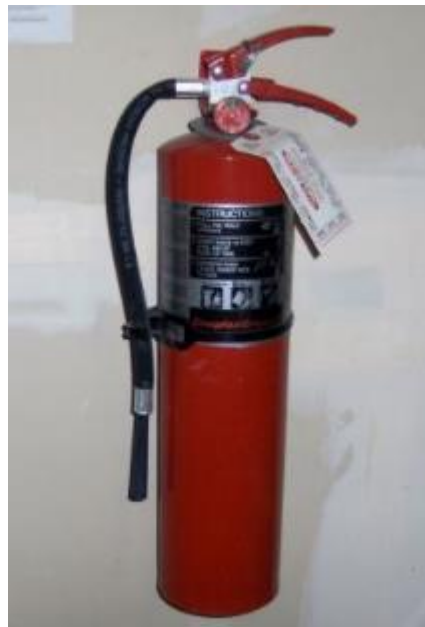
Location: Throughout the building - 3 per floor. 9 total.

Comments: The useful life of fire extinguishers is 15 years. The maintenance and servicing can be paid for out of operating funds. An excellent quality extinguisher can be purchased at Lowe's or Home Depot from \$80 to \$100.

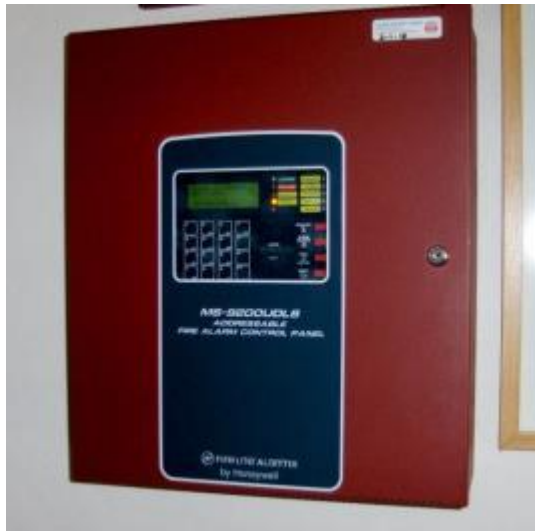
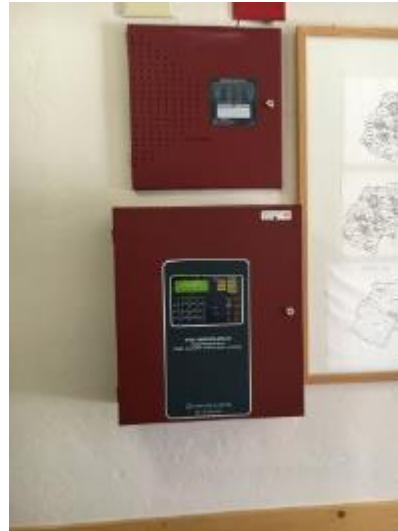
Location: Control panel located near the front entrance on the first floor.

Comments: There is 1 Honeywell Fire Lite Alarm Addressable Control Panel MS-9200UDLS for the building. This unit is a combination fire alarm control panel and digital alarm communicator/transmitter. It can monitor up to 198 devices and activate the notification circuits in under 10 seconds. This panel was installed in 2017 at a cost of \$3,844. The current cost to replace the panel is estimated at \$4,082, adjusted for inflation from 2017.

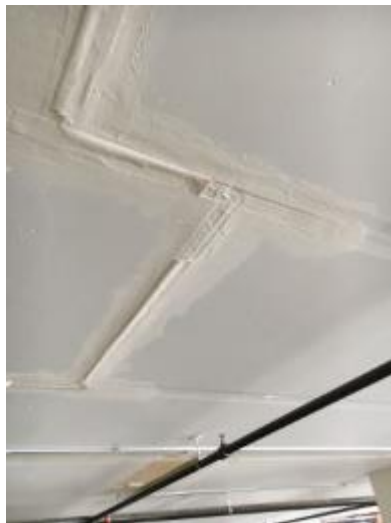
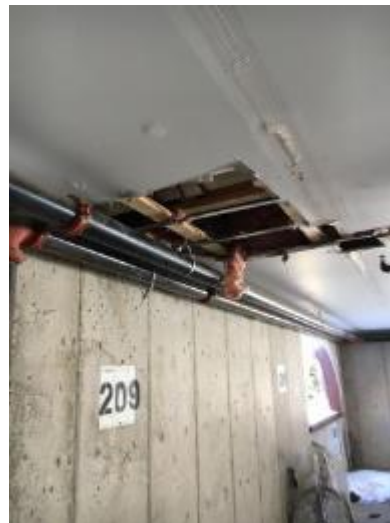
Location: The garage interior walls and ceiling.

Comments: At the time of inspection the walls and ceiling were in poor to good condition with some adhesion problems and drywall repairs needed on the ceiling. The walls have not been completely painted since the building was constructed in 2002, only painting and repairs where needed. The cost to prepare the surface for painting and applying quality paint through a combination of spraying and brushing is estimated at \$.82 per square foot. It

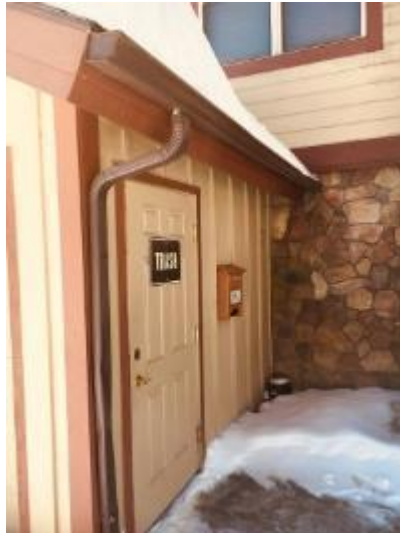
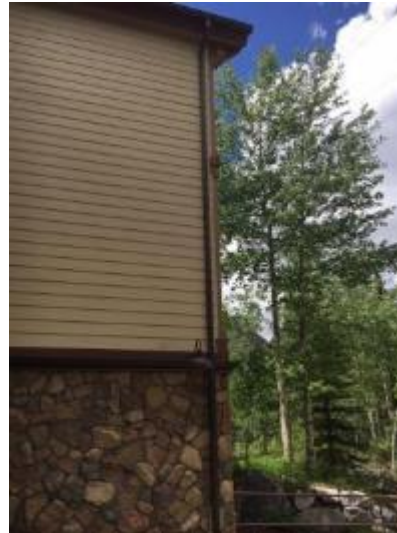
Location: On the building eaves over the parking lot and over the back entrance.

Comments: It is estimated there is 96 linear feet of gutters and 44 linear feet of downspouts on the building. If proper care and maintenance is taken, the estimated useful life is 30 years.

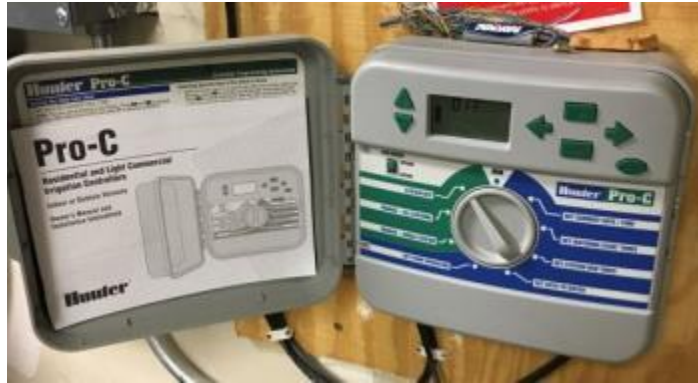
Location: Mounted on the wall in the boiler room.

Comments: There is 1 Hunter Pro-C irrigation controller for the landscaping. The estimated useful life is 12 years with 10 years remaining life. The controller uses separate modules to expand the zones. If the modules fail, they can be replaced without replacing the entire controller, which is much more expensive.

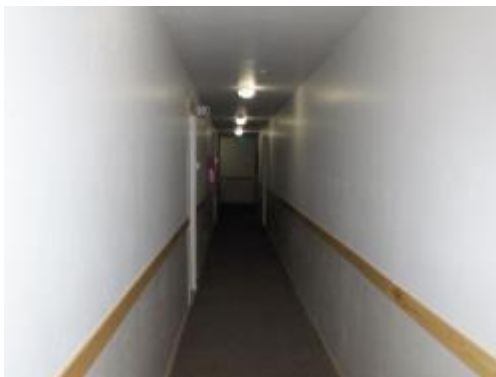
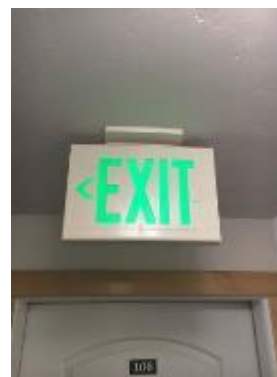
Location: Throughout the building.

Comments: The light fixtures include 14 by 4 foot fluorescent (4 bulb), Metalox fixtures in the garage area which were replaced in 2018 for \$185 per fixture, 15 dual security light fixtures (Sure-Lites), 14 lighted exit signs, 32 recessed hall lights, and 13 interior ceiling mounted globe lights. All light fixtures and exit lighting fixtures appeared to be in excellent condition at the time of inspection. The average cost for the fixtures including installation is \$195. The Association has established a 10 year replacement beginning in 2030 for all fixtures. This replacement schedule can be revised in future Reserve Management Plans if the estimated useful life is longer than projected.

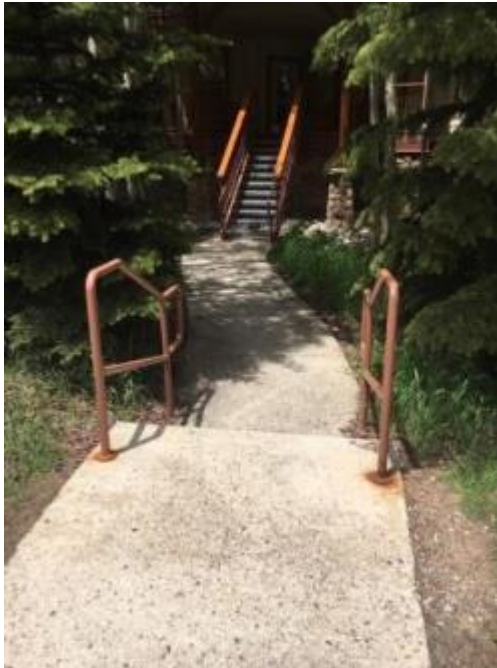
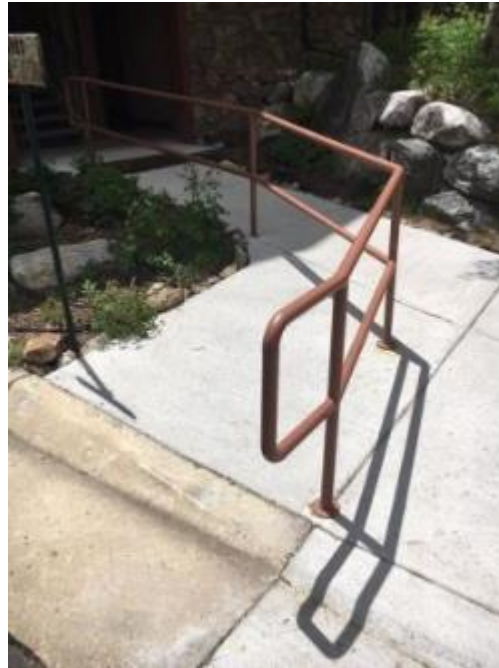
Location: Next to the sidewalk near the front entrance and next to the sidewalk at the back entrance.

Comments: The sidewalk railings were in very good condition at the time of inspection. The estimated useful life is 25 years with 8 years remaining life. There are a total of 36 linear feet of sidewalk railings. The estimated cost to replace the railings is \$45 per linear foot.

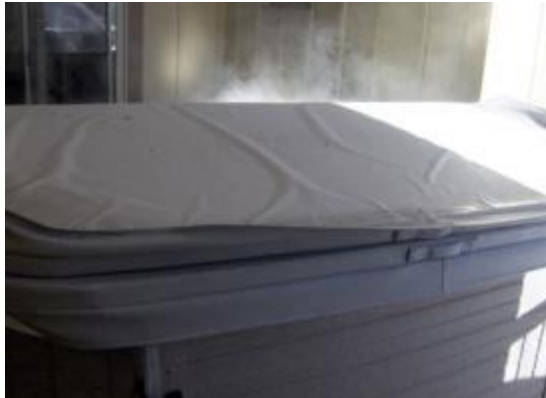
Location: On the spa next to the Clubhouse Room.

Comments: The spa cover was in good condition at the time of inspection. The estimated useful life is 6 years with normal use. The cover was last replaced in 2016, according to management. The current approximate replacement cost is \$445.

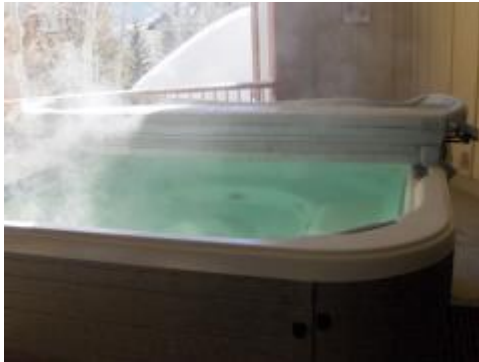
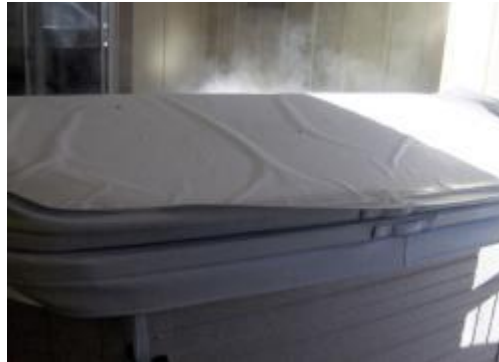
Location: On the deck off the Community Room.

Comments: It is assumed the spa is original. In the Reserve Analysis dated October 1, 2012, according to Ed Kaupas of Kaupas Water Labs, "...a replacement spa should be commercial in nature and have an ADA approved lift access, Such a brand of replacement tub might be Rio, Grecian or from Catalina." The current estimated replacement cost is \$20,000.

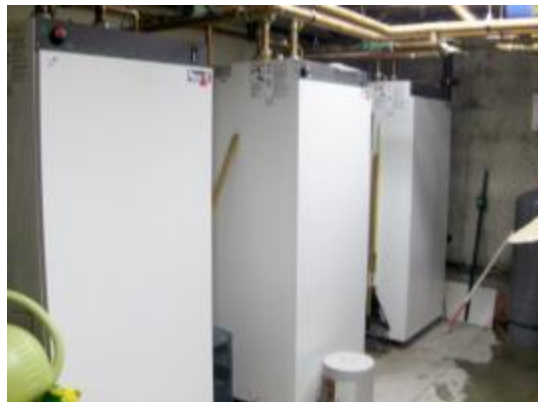
Location: In the mechanical room at the parking garage level.

Comments: There are 3 - 119 gallon indirect fired hot water tanks, Triangle Phase III Models #TR 120, with the water heated by the boiler. As the building is being heated, the domestic hot water is being heated at the same time, thereby, consuming less fuel and conserving energy. In the 2012 Reserve Analysis the All Phases Plumbing technician stated he was expecting one or more of the tanks to fail soon. It was recommended at that time to budget replacement of the units in 2013, 2014, and 2015. The replacements have not been completed. Association Management has recommended the 3 units be replaced by 2 more efficient units. Therefore, it is recommended to plan for one unit to be replaced in 2020 and the final tank in 2021.
