Lagoon TH Condominium Association, Inc.
700 Meadow Creek Drive
Frisco, CO 80443

Level 1, Platinum Reserve Analysis

Report Period – 07/01/15 – 06/30/16

Final Draft
Version

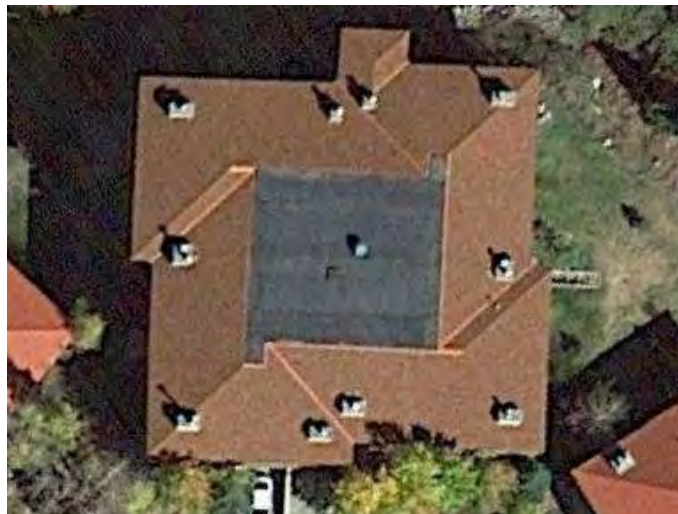
Comp #: 105 Asphalt Shingle/EPDM Roofs (2) - Replace

- This roof was replaced during the report period.
- It is assumed the roof was replaced with quality products and installed properly. If such is the case, the roofs (both flat and pitched) should last 20 years before replacement is necessary.
- It is recommended that this roof is inspected for proper installation during the next reserve study.

NOTE: Metal roofing system on pitched roofs was replaced with asphalt shingles in July 2015. Funding to replace with similar in the future.

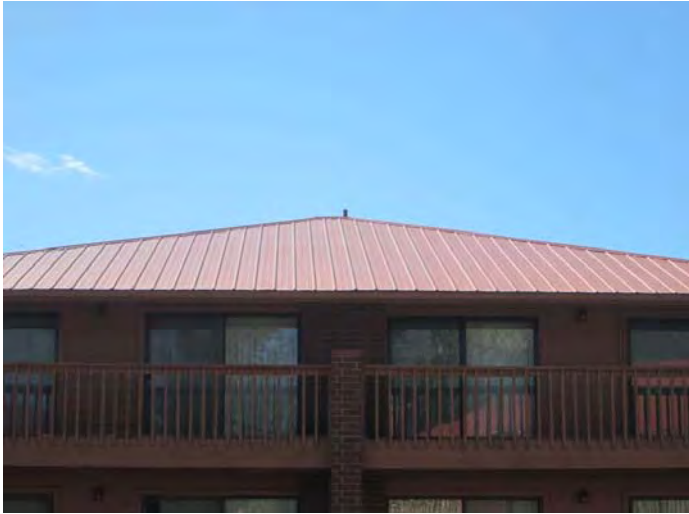
Comp #: 108 Metal Roofs (Phase 2) - Replace

- Outside of standard annual roof repairs associated with this type of roof, i.e. tightening of loose screws and caulking of exposed seals, these roofs appeared to be in good to fair condition at time of observation.
- As per the commissioned roof inspection, conducted by The Roofing Company, performed in 2013, it is recommended that all regular roof repairs are performed to ensure the longest possible roof life of these assets.
- As roof's age, it is recommended they are inspected on a regular basis to identify potential failures. The recommended repairs should be addressed with funding for this work coming from the operating account.

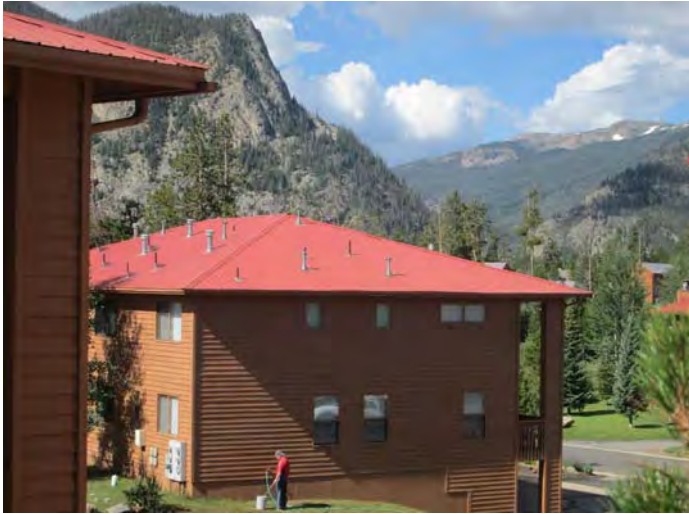
Comp #: 108 Metal Roofs (Phase 4) - Replace

- Outside of standard annual roof repairs associated with this type of roof, i.e. tightening of loose screws and caulking of exposed seals, these roofs appeared to be in good to fair condition at time of observation.
- As per the commissioned roof inspection, conducted by The Roofing Company, performed in 2013, it is recommended that all regular roof repairs are performed to ensure the longest possible roof life of these assets.
- As roof's age, it is recommended they are inspected on a regular basis to identify potential failures. The recommended repairs should be addressed with funding for this work coming from the operating account.

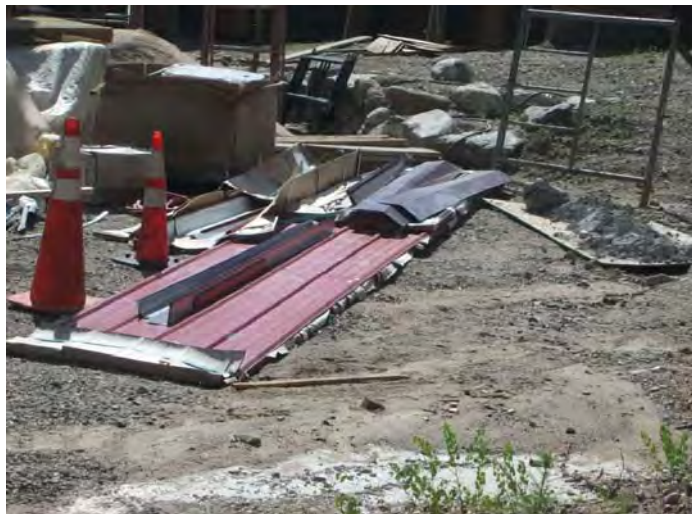
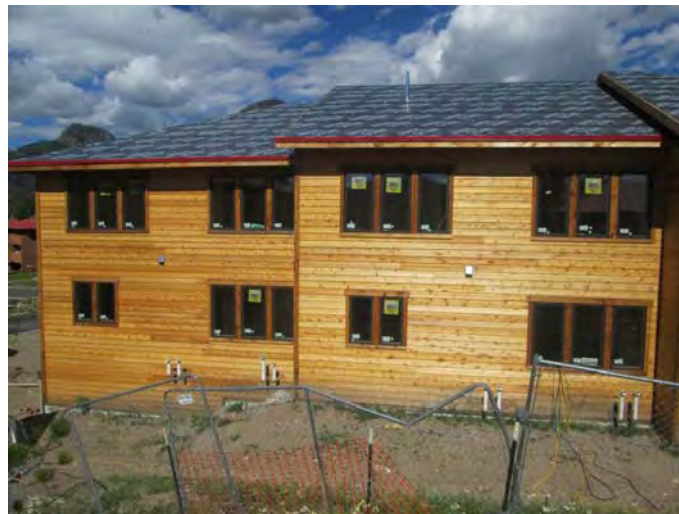
Comp #: 108 Metal Roofs (Phase 5) - Replace

- This roof was installed during the report period.
- It is assumed the roof was installed properly and with quality products per manufacturer's recommended installation. If such is the case, the roof should last 40 years before replacement is necessary.
- It is recommended that this roof is inspected for proper installation during the next reserve study. Furthermore, it's recommended that regular annual maintenance is performed to ensure the longest possible useful life of asset.

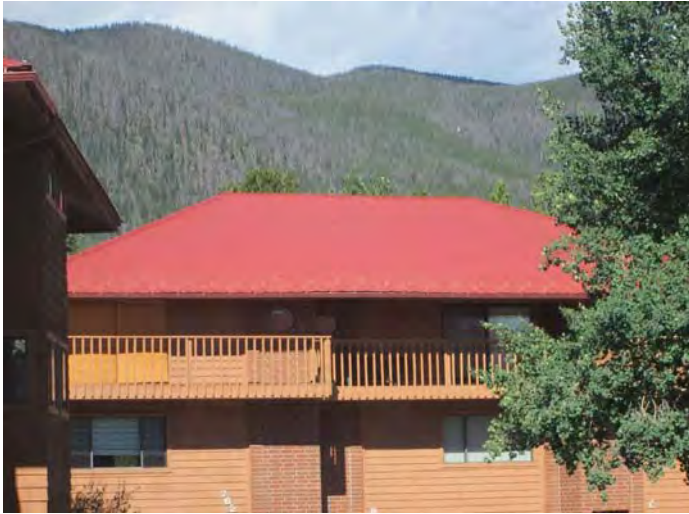
Comp #: 108 Metal Roofs (Phase 1) - Replace

- Outside of standard annual roof repairs associated with this type of roof, i.e. tightening of loose screws and caulking of exposed seals, these roofs appeared to be in good to fair condition at time of observation.
- As per the commissioned roof inspection, conducted by The Roofing Company, performed in 2013, it is recommended that all regular roof repairs are performed to ensure the longest possible roof life of these assets.
- As roof's age, it is recommended they are inspected on a regular basis to identify potential failures. The recommended repairs should be addressed with funding for this work coming from the operating account.

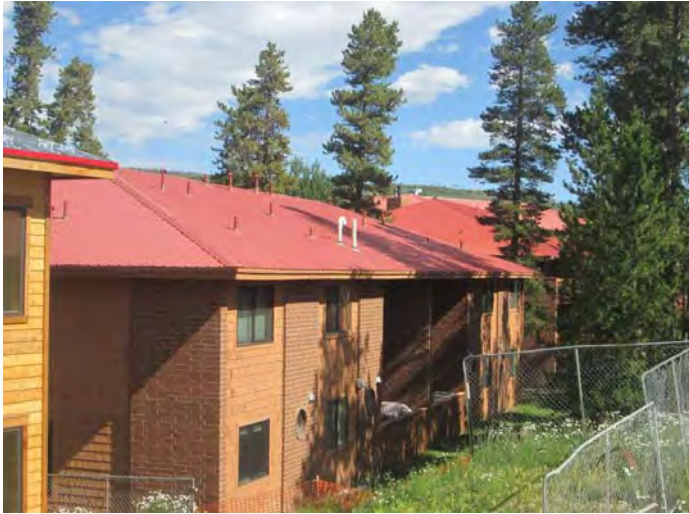
Comp #: 108 Metal Roofs (Phase 3) - Replace

- Outside of standard annual roof repairs associated with this type of roof, i.e. tightening of loose screws and caulking of exposed seals, these roofs appeared to be in good to fair condition at time of observation.
- As per the commissioned roof inspection, conducted by The Roofing Company, performed in 2013, it is recommended that all regular roof repairs are performed to ensure the longest possible roof life of these assets.
- As roof's age, it is recommended they are inspected on a regular basis to identify potential failures. The recommended repairs should be addressed with funding for this work coming from the operating account.

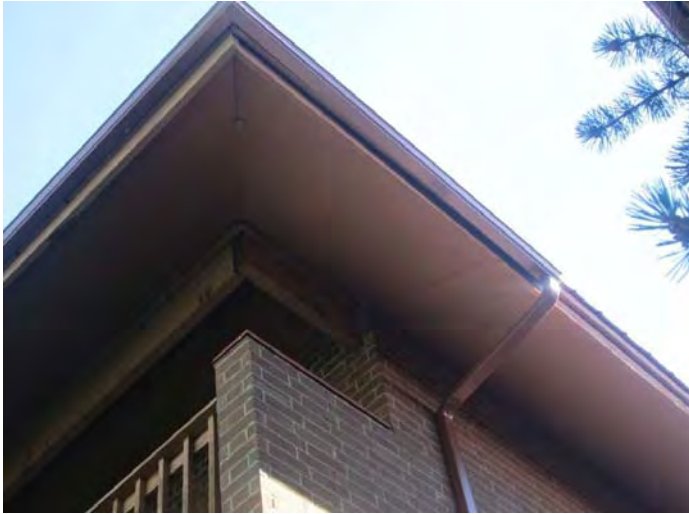
Comp #: 120 Gutters/Downspouts (Metal 2) - Replace

- It's recommended that all rain gutters and down-spouts are replaced when the roof is replaced.
- Gutters and downspouts should be inspected, with damaged sections being replaced, annually. Funding for this replacement, outside of the roof replacement, should be funded from the operating account.

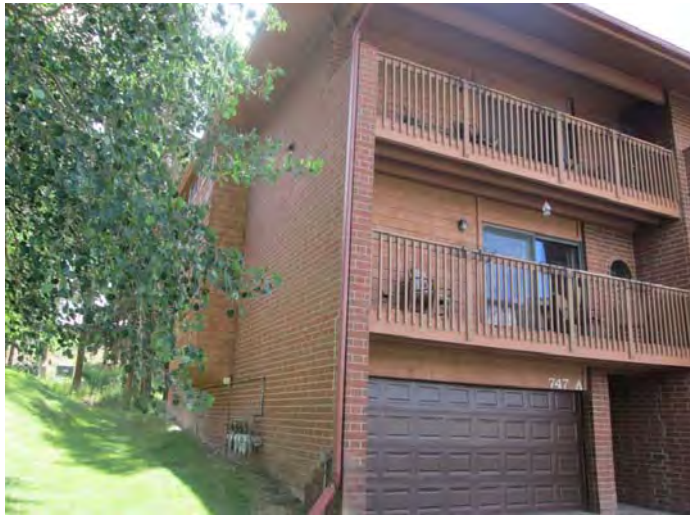
Comp #: 120 Gutters/Downspouts (Metal 1) - Replace

- It's recommended that all rain gutters and down-spouts are replaced when the roof is replaced.
- Gutters and downspouts should be inspected, with damaged sections being replaced, annually. Funding for this replacement, outside of the roof replacement, should be funded from the operating account.

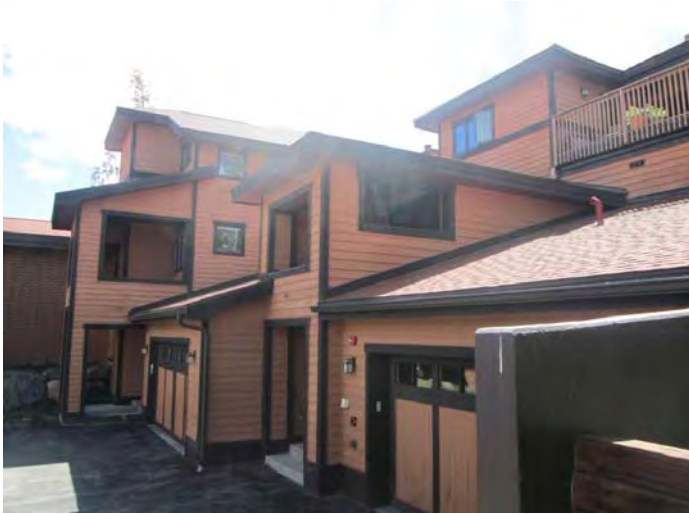
Comp #: 120 Gutters/Downspouts (Asphalt 1) - Replace

- It's recommended that all rain gutters and down-spouts are replaced when the roof is replaced.
- At the very least, it's recommended to budget for the work with the understanding that this work may not be needed.
- Gutters and downspouts should be inspected, with damaged sections being replaced, annually. Funding for this replacement, outside of the roof replacement, should be funded from the operating account.

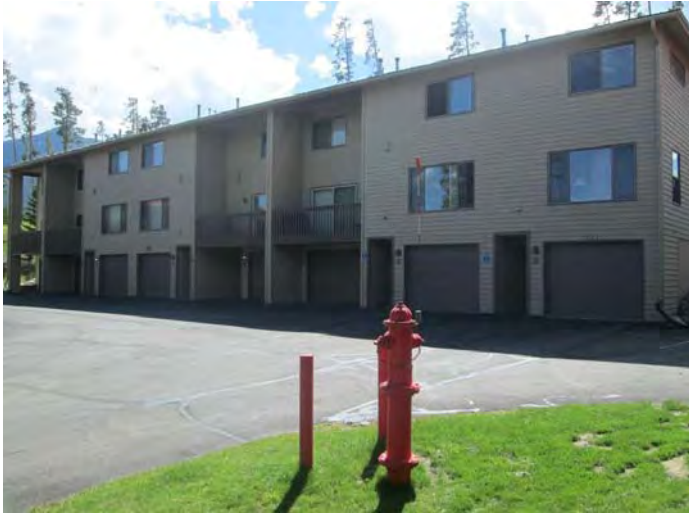
Comp #: 120 Gutters/Downspouts (Metal 3) - Replace

- It's recommended that all rain gutters and down-spouts are replaced when the roof is replaced.
- Gutters and downspouts should be inspected, with damaged sections being replaced, annually. Funding for this replacement, outside of the roof replacement, should be funded from the operating account.

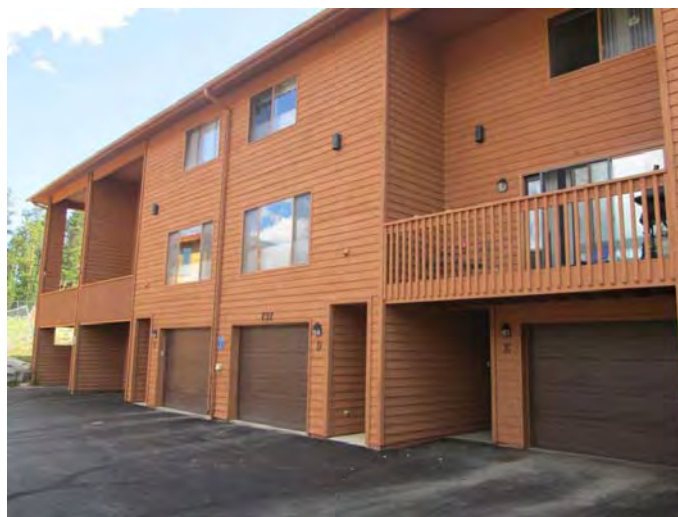
Comp #: 120 Gutters/Downspouts (Metal 4) - Replace

- It's recommended that all rain gutters and down-spouts are replaced when the roof is replaced.
- Gutters and downspouts should be inspected, with damaged sections being replaced, annually. Funding for this replacement, outside of the roof replacement, should be funded from the operating account.

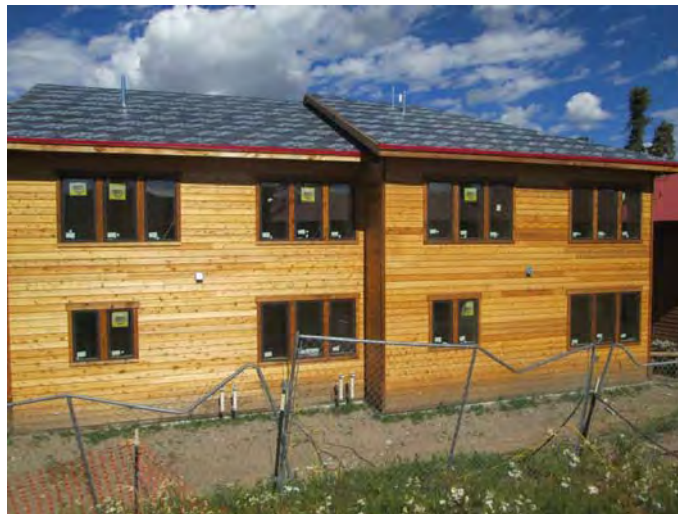
Comp #: 120 Gutters/Downspouts (Metal 5) - Replace

- It's recommended that all rain gutters and down-spouts are replaced when the roof is replaced.
- Gutters and downspouts should be inspected, with damaged sections being replaced, annually. Funding for this replacement, outside of the roof replacement, should be funded from the operating account.

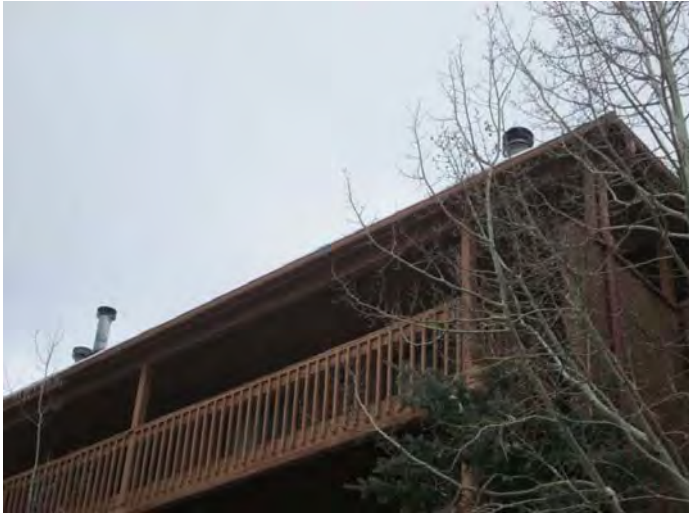
Comp #: 120 Gutters/Downspouts (Asphalt 2) - Replace

- It's recommended that all rain gutters and down-spouts are replaced when the roof is replaced.
- At the very least, it's recommended to budget for the work with the understanding that this work may not be needed.
- Gutters and downspouts should be inspected, with damaged sections being replaced, annually. Funding for this replacement, outside of the roof replacement, should be funded from the operating account.

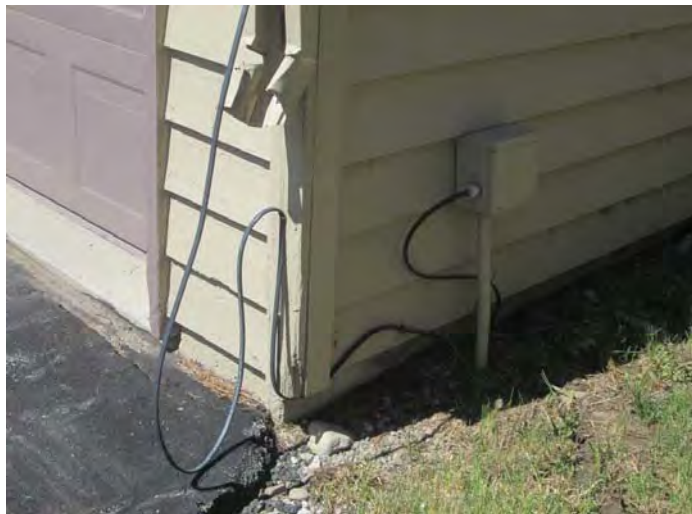
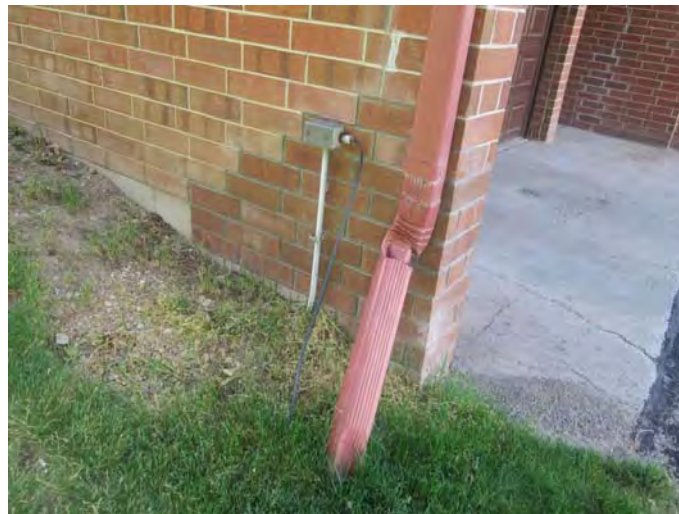
Comp #: 121 Heat Tape - Replace

- As most of the heat tape is protected, there was no way to observe all of the heat tape located on the property. The heat tape that was observed varied in condition from good to poor (faded & cracking sheathing).
- Deterioration will vary due to exposure and quantity of activation periods when tape is being heated.
- Due to the relatively high quantity of heat tape located throughout the property, it's recommended that an allowance be provided to replace damaged/failing sections of heat tape periodically.

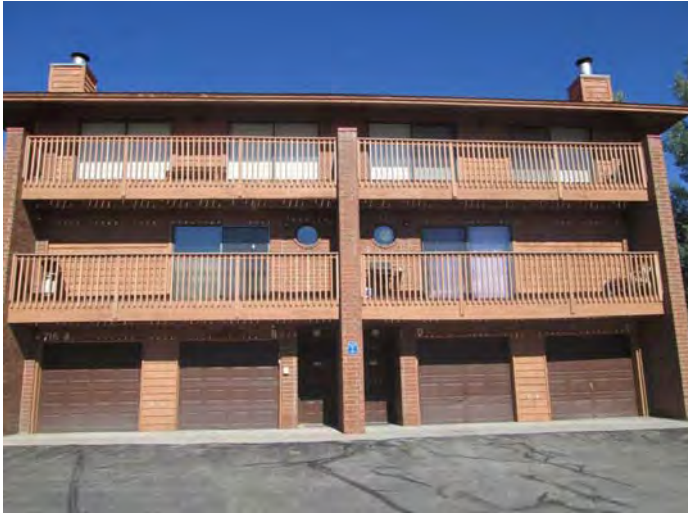
Comp #: 204 Building Exterior Surfaces (Phase 1) - Repaint

- The exteriors of these buildings, in general, were in fair to poor condition with higher exposures showing more deterioration due to constant freeze/thaw cycles during the winter months and constant UV degradation.
- Due to the accelerated deterioration associated with the aforementioned conditions, it's recommended the association paint these exteriors at a minimum of every 6 years.
- This includes all painted/stained surfaces on the exteriors of these buildings as well as regular prepping associated with paint projects, i.e. pressure washing, scraping/brushing, and applying primer & caulk.

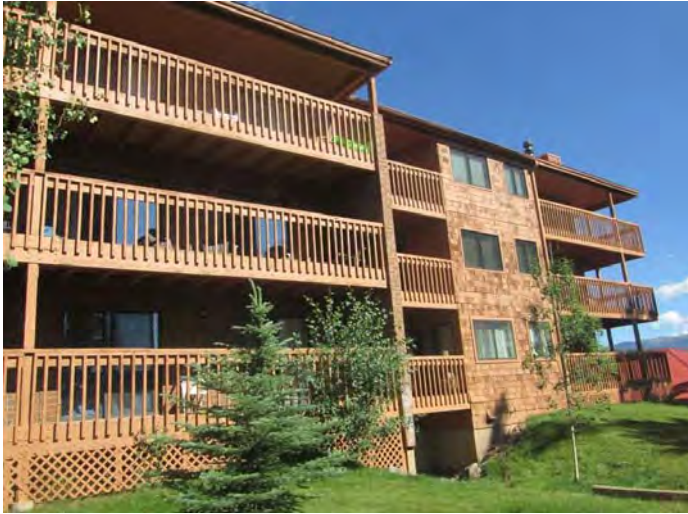
Comp #: 205 Building Exterior Surfaces (Phase 2) - Repaint

- The exteriors of these buildings, in general, were in good condition with higher exposures showing little fading on high exposures and no advanced deterioration (peeling or chipping paint, exposed wood surfaces, etc.)
- Due to the accelerated deterioration associated with the aforementioned conditions, it's recommended the association paint these exteriors at a minimum of every 6 years.
- This includes all painted/stained surfaces on the exteriors of these buildings as well as regular prepping associated with paint projects, i.e. pressure washing, scraping/brushing, and applying primer & caulk.

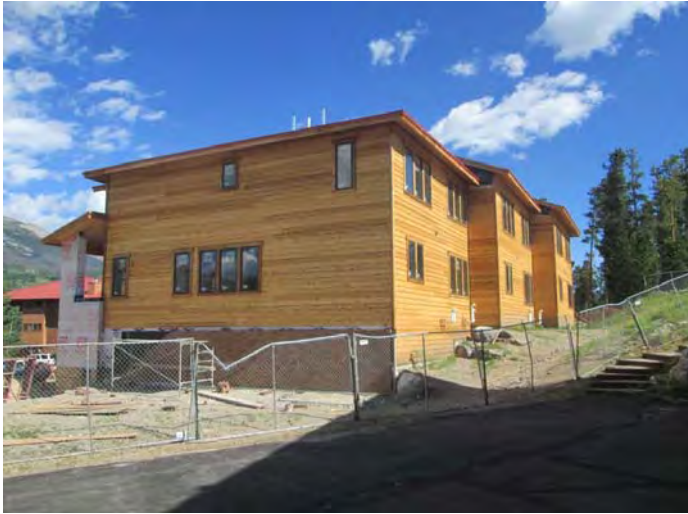
Comp #: 206 Building Exterior Surfaces (Phase 3) - Repaint

- These buildings, having been recently painted, appeared to be in good condition at time of observation.
- The painting schedule recommended is based on reports the association feels the current paint product will provide a longer than expected useful life and the reserve providers desire to align painting schedules and associated repairs with other work throughout the property.
- This includes all painted/stained surfaces on the exteriors of these buildings as well as regular prepping associated with paint projects, i.e. pressure washing, scraping/brushing, and applying primer & caulk.

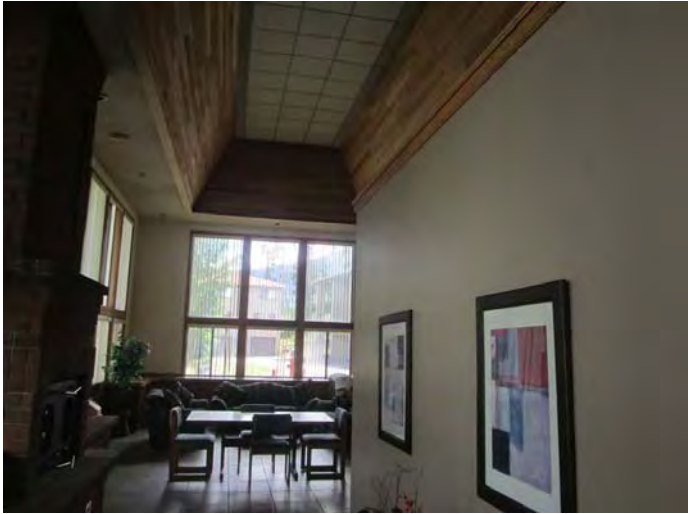
Comp #: 216 Clubhouse Interior Surfaces - Repaint

- Numerous scuffs and repaired surfaces were visible during time of observation.
- To provide a uniform appearance, and to allow colors to align with current design trends, it's recommended funding be provided to repaint all regularly used interior surfaces on a regular basis.
- This work has been aligned with other trades to ensure interior renovations are aligned for the best cost estimates.

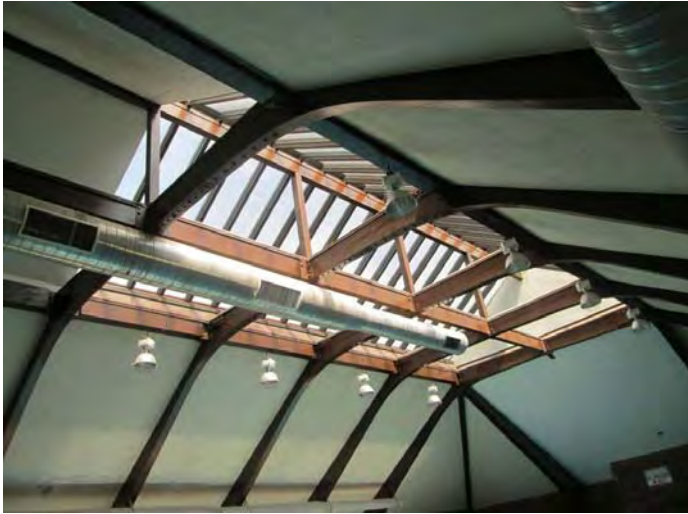
Comp #: 216 Poolhouse Interior Surfaces - Repaint

- The interior surfaces appeared to be in good condition, during observation, considering the environment in the building.
- It's recommended that all interior surfaces are painted on a regular basis to prevent deterioration from the high humidity levels in this building throughout the year.
- All damaged/deteriorating surfaces should be replaced prior to painting.

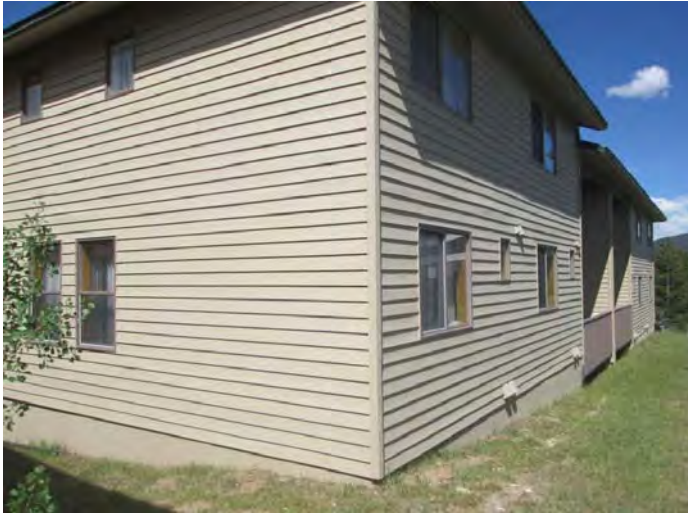
Comp #: 303 Cedar/Wood Siding (Phase 3) - Repair

- The building exteriors were, as a whole, good during observation with high exposure areas (southern exposures and areas near drip lines) beginning to show some advanced deterioration (cracking/peeling of paint).
- It's recommended funding be provided to replace a portion of the siding every other paint cycle to replace boards experiencing advanced deterioration.
- Outside of this replacement scheduled, repairs to extremely deteriorated boards should be handled with operating funds as needed. Otherwise, the prepping typically associated with painting will allow for replacement of a few boards during the regularly scheduled painting cycles.

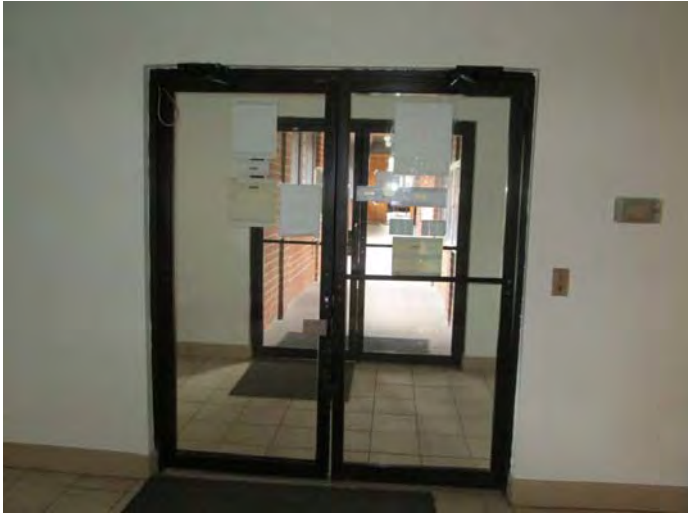
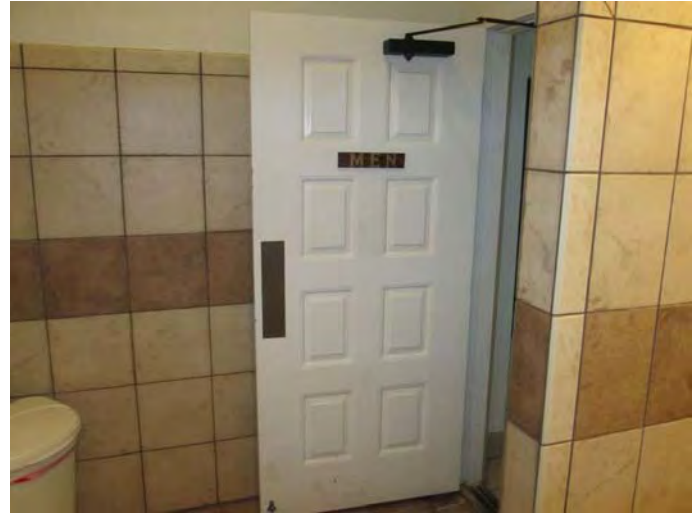
Comp #: 503 Utility doors (Dept A) - Replace

- Overall, the condition of the doors were in good to fair condition with no serious issues noted in their operation.
- Due to the varying construction and use of the doors, it's recommended funding be provided to replace 1/3 of the every 10 years. This allow for complete replacement of all doors every 30 years.
- Doors needing replacement, due to unanticipated damage, should be replaced with operating funds, unless the association's capital/reserve spending threshold is reached.

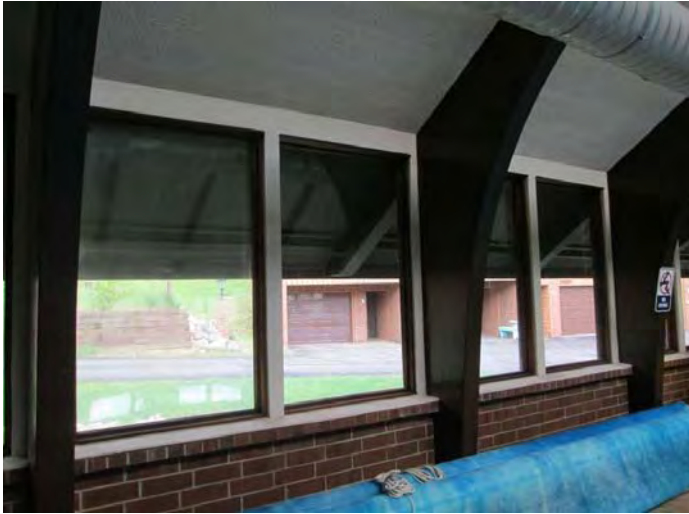
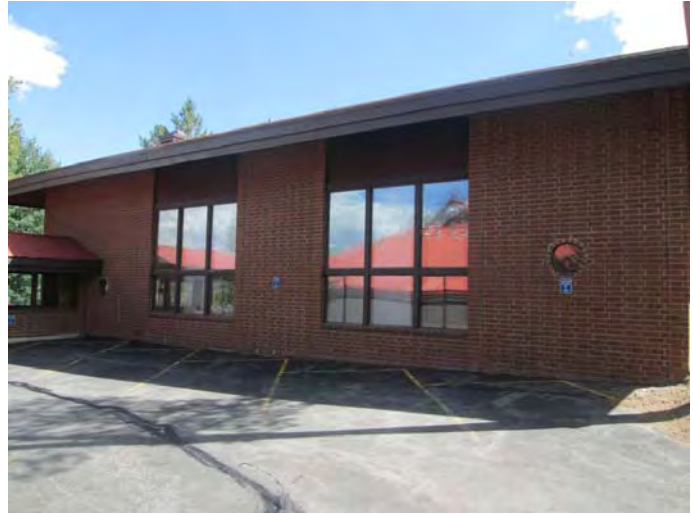
Comp #: 506 Windows (Dept A) - Replace

- It was reported the windows are in great shape and that complete replacement of the windows isn't anticipated.
- If these commercial grade windows begin to show signs of widespread deterioration, funding for their replacement will be required. If windows are included in future reserves, anticipated cost is between \$93,500 - \$104,500.
- Broken windows should be replaced with operating funds unless the association's capital/reserve threshold is reached in the replacement of a window.

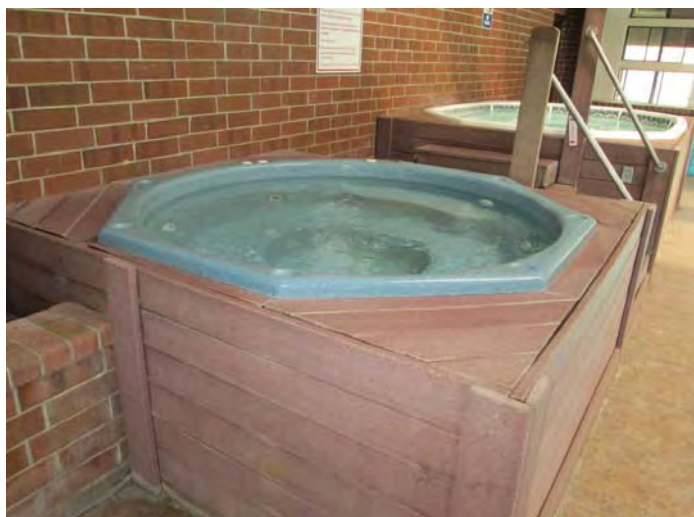
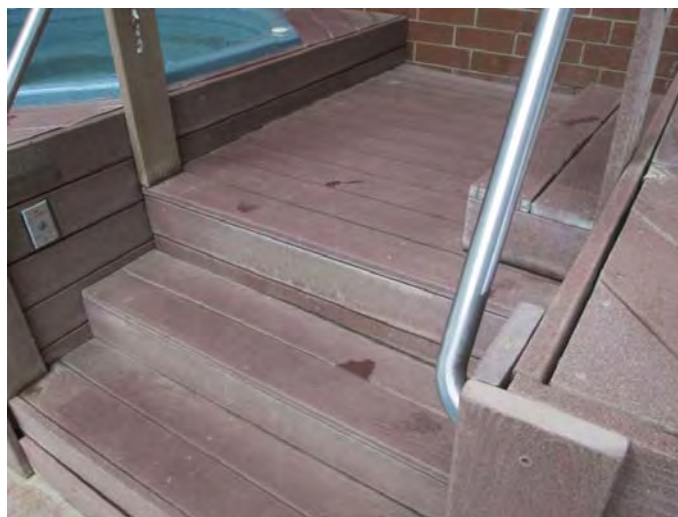
Comp #: 609 Composite Decking - Replace

- The composite decking appeared to be in fair condition with no advanced deterioration noted during observation (advanced fading, wearing in traffic areas, splintering, peeling, exposed fibers, etc.).
- Due to the construction of these decks, and concerns regarding code compliance, it's recommended funding be provided for replacement of half of the decking every 10 years (aligned with tub replacements).
- Replacement of damaged boards should be handled with operating funds on an as needed basis.

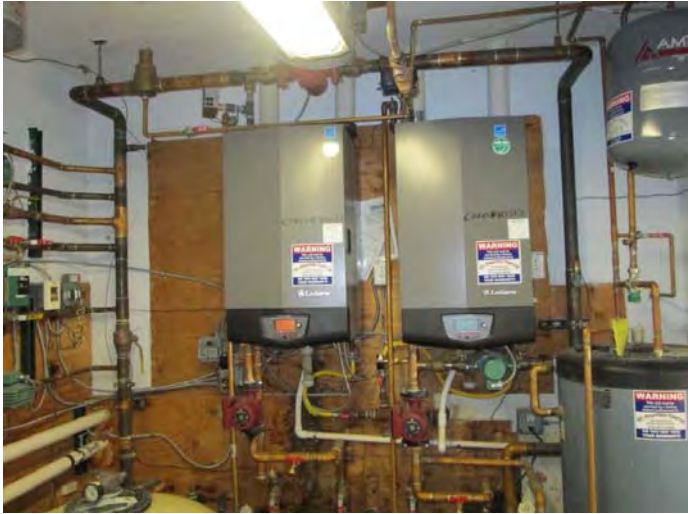
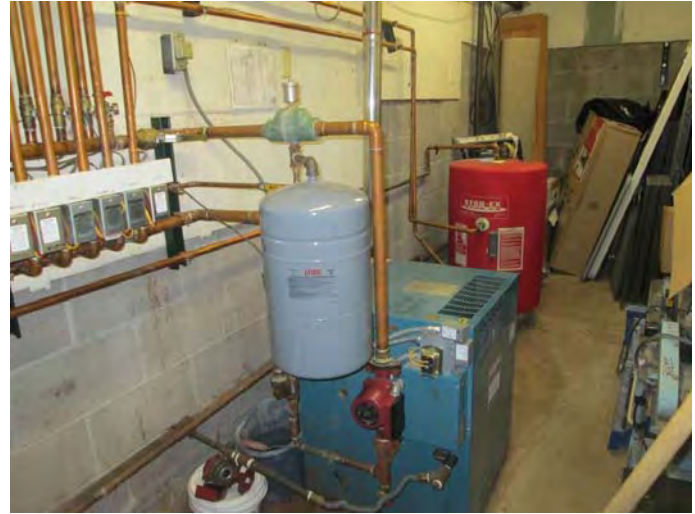
Comp #: 701 Heating Boilers (Dept A) - Major Repairs

- The recently installed high efficiency boilers appeared to be in good condition with no issues noted, or reported, during observations. The aging Burnham boiler showed signs of previous leaking with most components having already been replaced. However, there were no current issues reported.
- High efficiency boilers need regularly scheduled maintenance to ensure they're operating at peak efficiencies and to repair failing components (to take advantage of energy savings). The Clubhouse boiler is included in this as it was reported the boiler would be replaced with a high efficiency system...which will need regular repairs.
- Funding is provided to ensure proper glycol levels and to replace failing components.

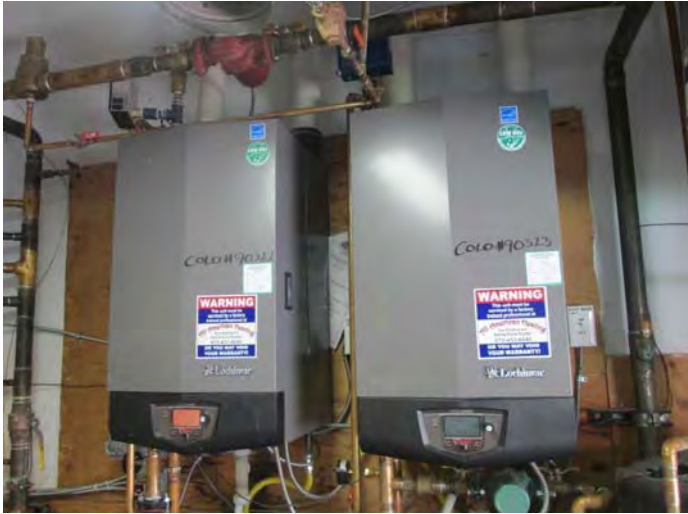
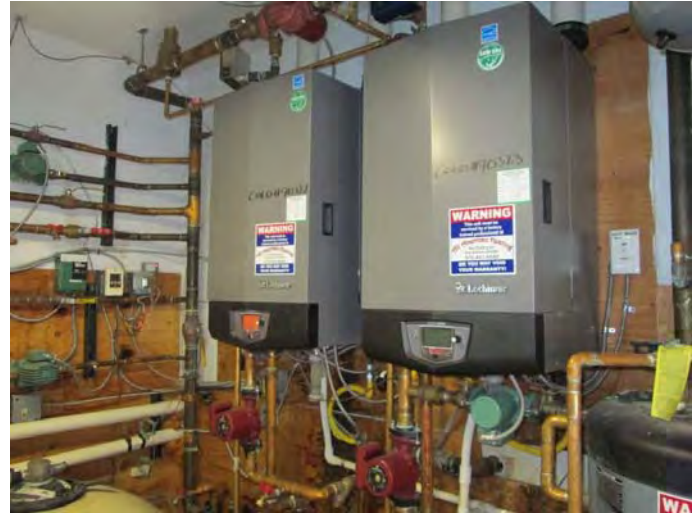
Comp #: 702 Poolhouse Heating Boilers - Replace

- The recently installed high efficiency boilers appeared to be in good condition at time of observation with no issues reported.
- These boilers, with regularly scheduled maintenance, currently have an anticipated useful life of 20 years before irreparable damage occurs.
- Replacement of these boilers is relatively cost effective after energy savings are taken into account.

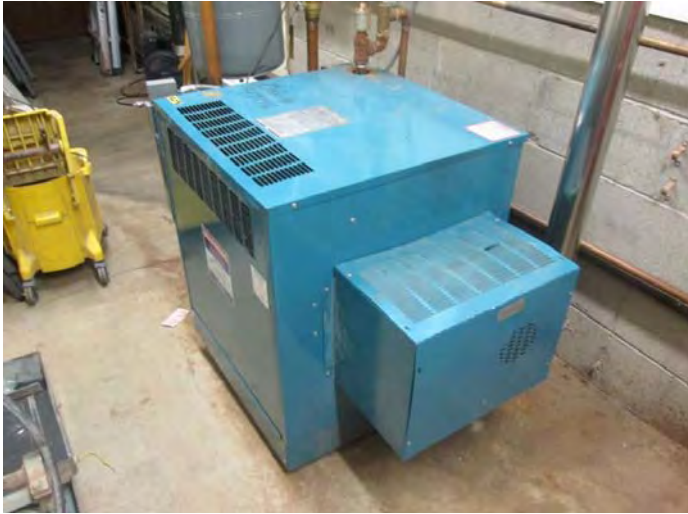
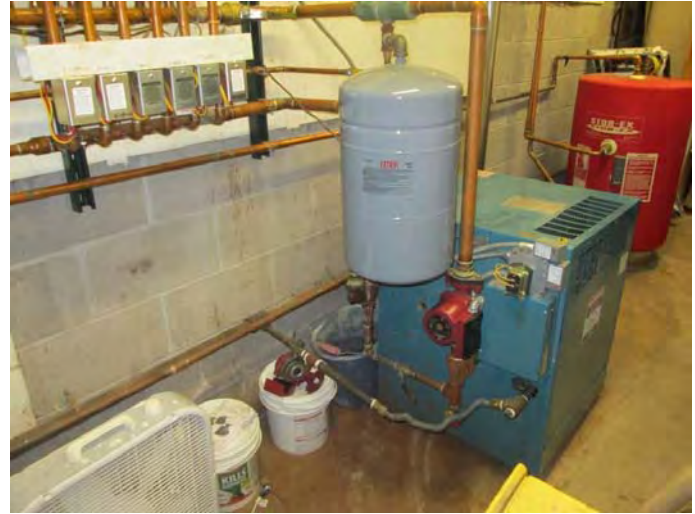
Comp #: 702 Clubhouse Heating Boiler - Replace

- Though the boiler didn't have any reported issues, and most of the components have been replaced, previous signs of leaking and research with the association's plumber, prompted the recommendation to replace this boiler.
- Boilers of this design typically have a useful life of 30 years before needing replacement. As such, funding is recommended to replace the boiler in the very near future.
- If this boiler is replaced with a high efficiency system, it's expected to cost in the \$22,000 - \$25,000 range.

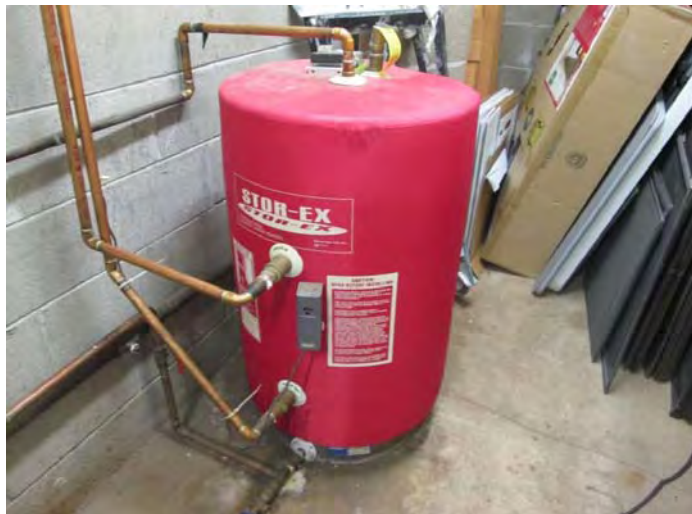
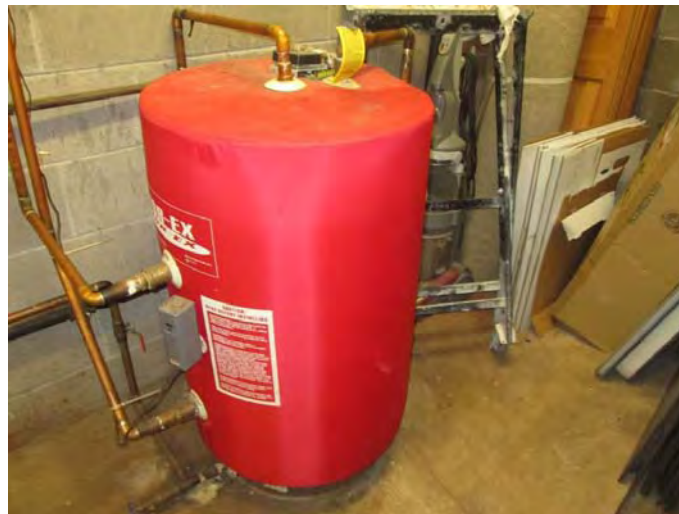
Comp #: 703 Clubhouse Water Heater - Replace

- The water heater, though aged and encapsulated, appeared to be in good condition with no active leaks visible during observation.
- Indirect fired water heater typically have an expected useful life of approximately 10 - 15 years before failure. As the heater was manufactured in 2001, it's recommended funding be provided to replace the unit prior to failure.
- Installation of high efficiency boilers may cause the removal of this component from future studies.

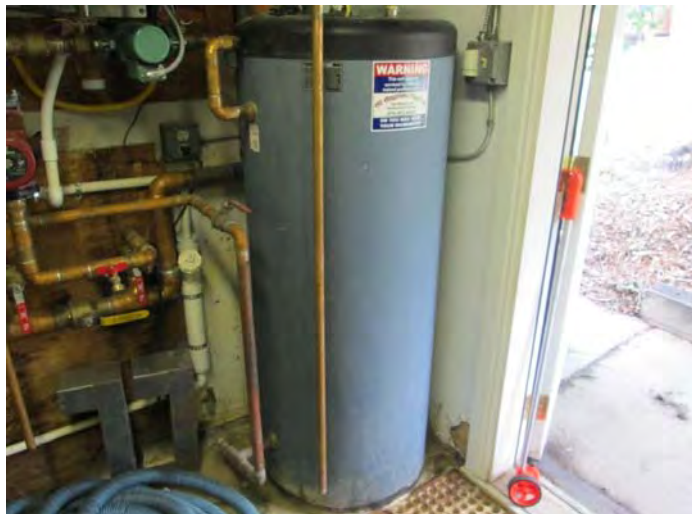
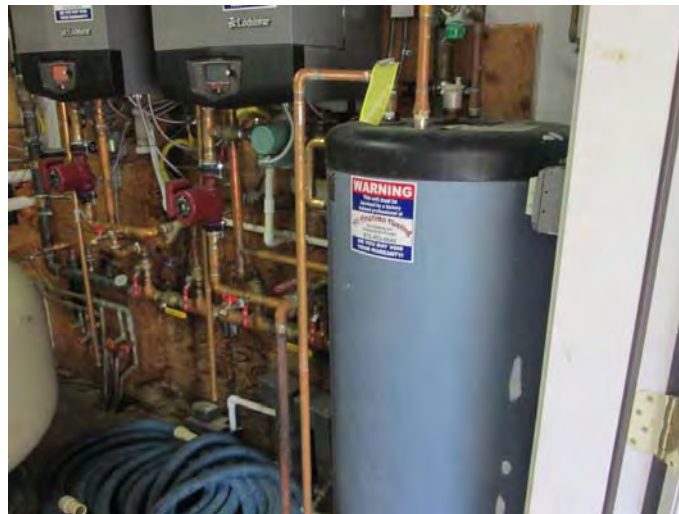
Comp #: 703 Poolhouse Water Heater - Replace

- The water heater appeared to be in good condition at time of observation with no leaking noted or issues reported.
- Indirect fired water heaters typically have a useful life of 10 - 15 years before failure.
- Funding for replacement of this heater, prior to failure is recommended.

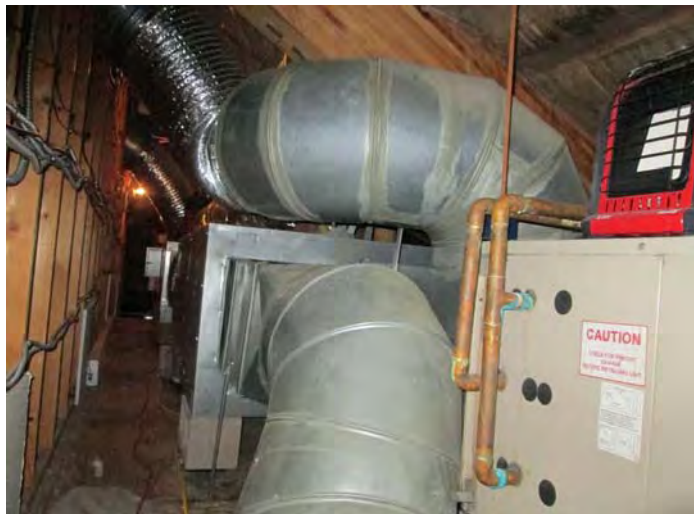
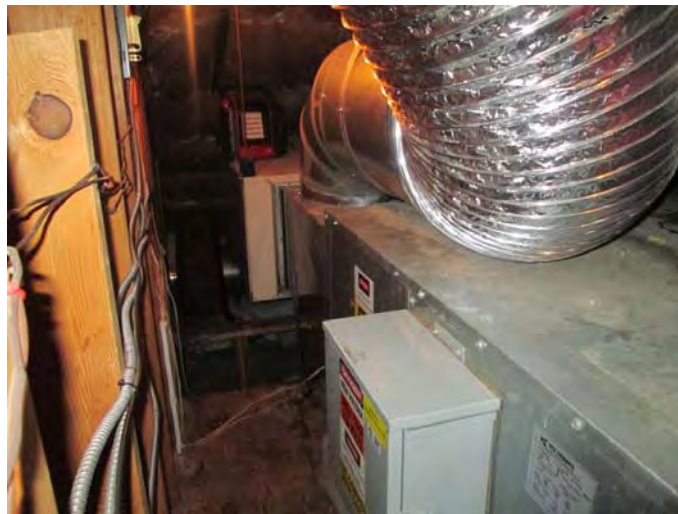
Comp #: 720 Air Handler Units - Replace

- The air handler units appeared to be in good condition during observation with both units observed in operation during observations.
- Discussions with the association's HVAC contractor has led to the recommendation of replacement in 12 years. This is due to previous history associated with these specific units and the anticipated useful life of 25 years.
- The relatively high cost for replacement is associated with the costs associated with installation in the roof cavity.

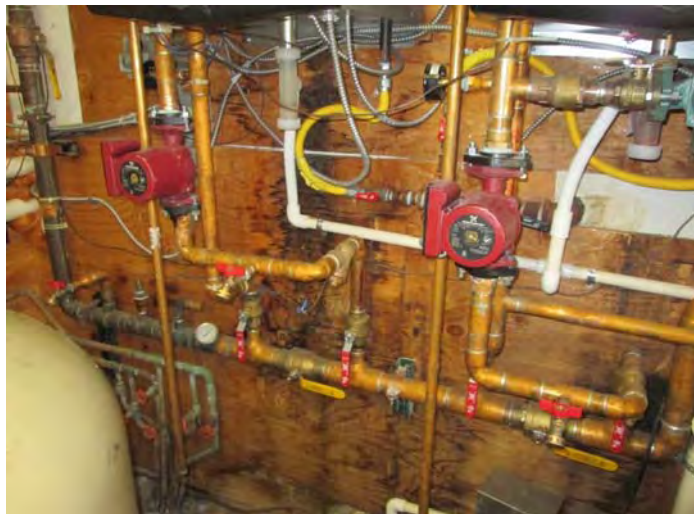
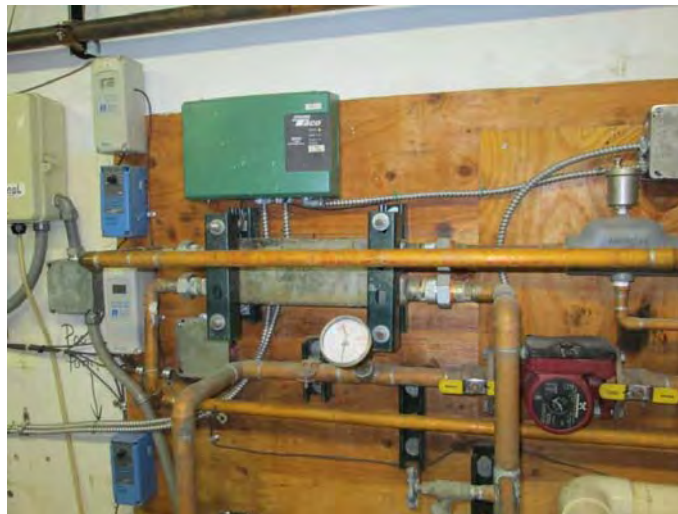
Comp #: 725 Misc Mech Equipment (Dept A) - Replace

- The conditions of the mechanical equipment used to heat the buildings and the water features varied from new to poor.
- The high quantity of equipment allows the association to provide for the capital replacement of equipment on a regular basis. Specifically for the replacement of the relatively high cost items detailed above.
- This funding is in addition to the operational funding allocated for regular annual maintenance of these items.

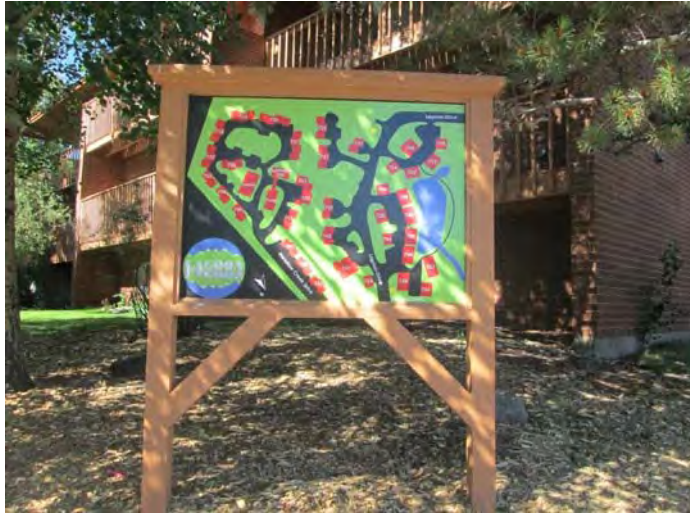
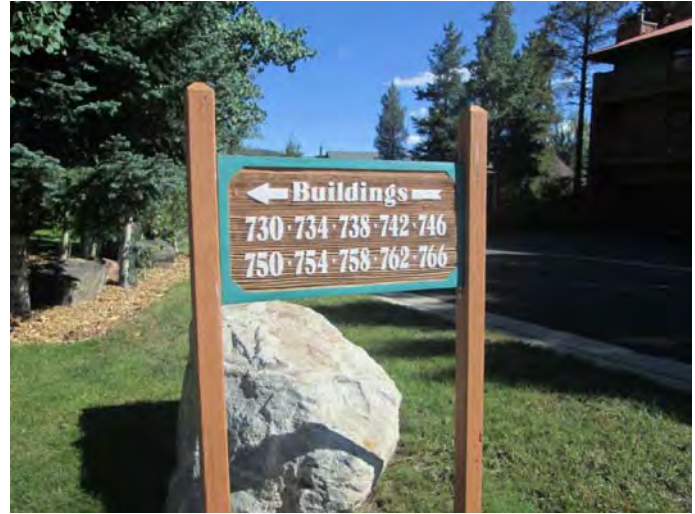
Comp #: 809 Address Signs - Replace

- The signs throughout the property, in general, were in good condition at time of observation.
- Due to the varying size, design, and replacement cost of all signs, it's recommended funding be provided to replace all of the signs, throughout the property, to ensure a uniform appearance.
- Signs should be inspected annually with higher exposure, and damaged, signs being touched up on an as needed basis with operating funds.

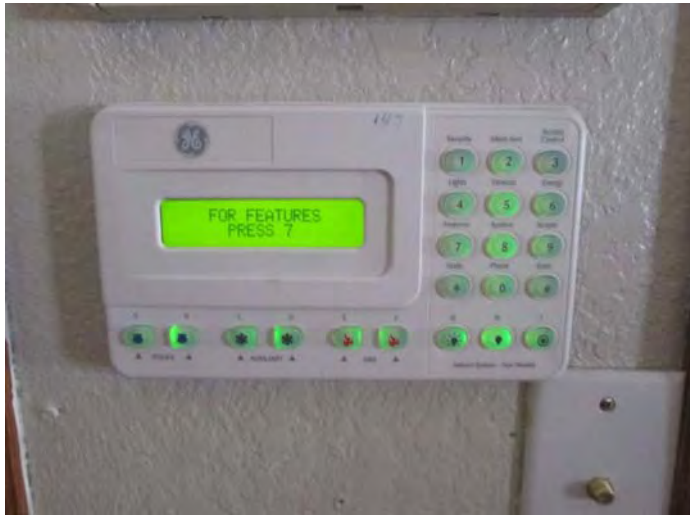
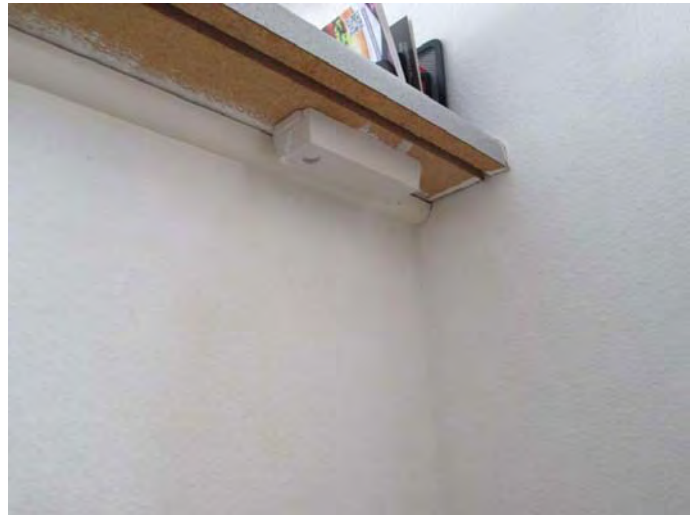
Comp #: 902 Freeze Alarm System - Replace

- The freeze alarms appeared to be in working condition, i.e. sensors reporting low temperatures, with the only problem reported due to flash memory error on the two control panels.
- The association's monitoring company, Allied Security, reported that the current issue is irreparable and that the controllers need to be replaced to alleviate the constant monitoring reports associated with current issues.
- Based on reported issues, it's recommended that the controllers are replaced approximately every 15 years.

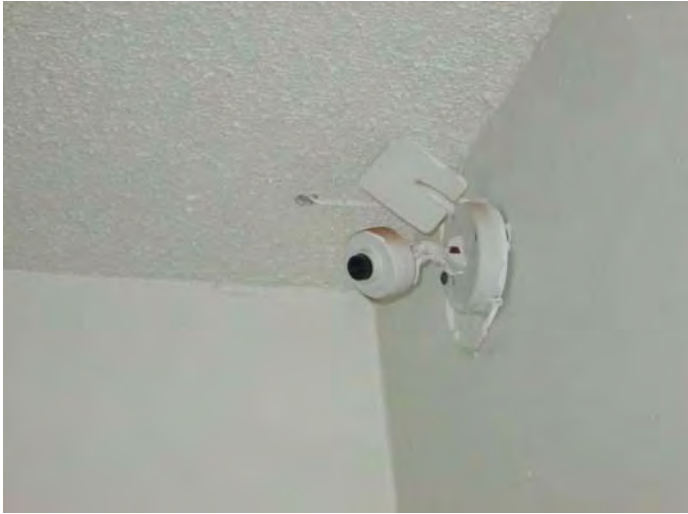
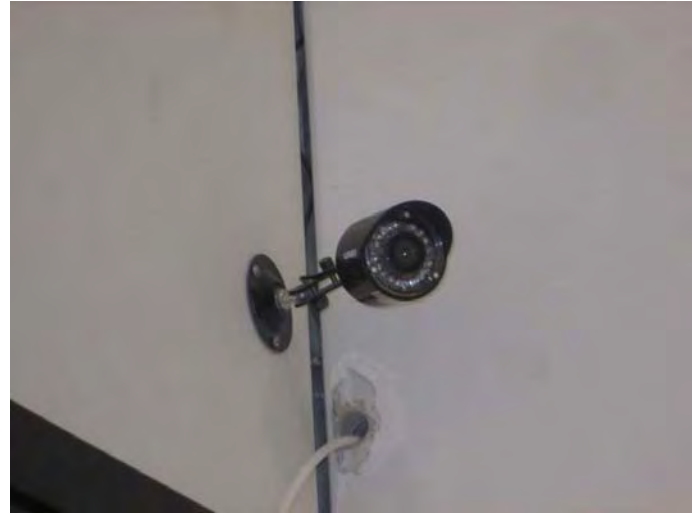
Comp #: 903 TV Security System - Replace

- The security system was functioning during observations.
- It's recommended funding be provided to replace CCTV security systems on a regular basis to take advantage of new technology and increase the functionality, and effectiveness, of the system.
- Cost variance will allow for replacement, or upgrade, of similar quantity and quality of cameras and DVR. Significant increases in quality, quantity, or both, could result in higher costs than anticipated.

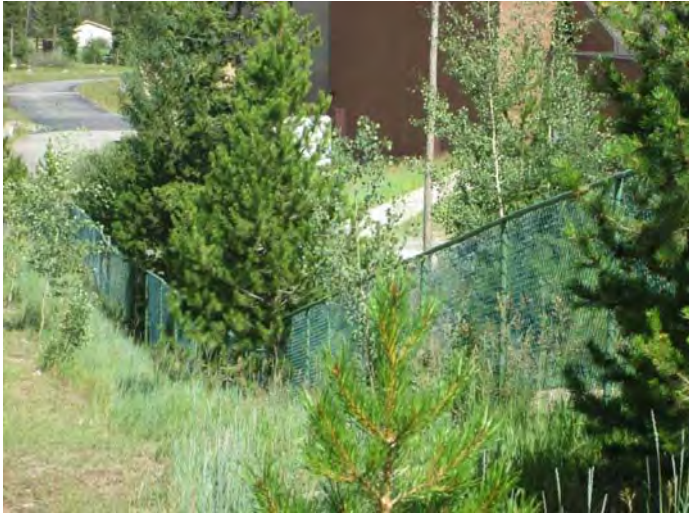
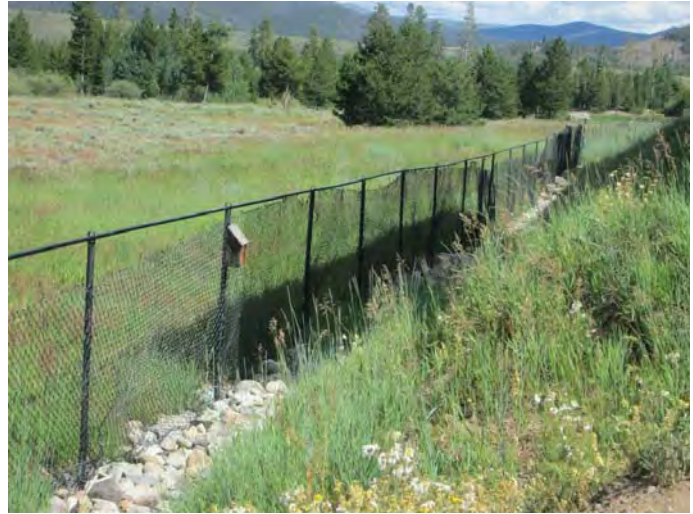
Comp #: 1003 Chain Link Fencing - Replace

- The fencing throughout the property varied with the newly installed green fencing located on the southern property line being in good condition and the black fencing located on the eastern and southern lines in fair to poor condition. Tennis court fencing appeared to be in good to fair condition.
- As the fencing condition varied, and due to conversations with Strategic Fence, it's recommended funding be provided to replace the fencing only, with damaged supports, every ten years.
