Lagoon TH Condominium Association, Inc.
700 Meadow Creek Drive
Frisco, CO 80443

Level 1, Platinum Reserve Analysis

Report Period – 07/01/15 – 06/30/16

Final Draft
Version

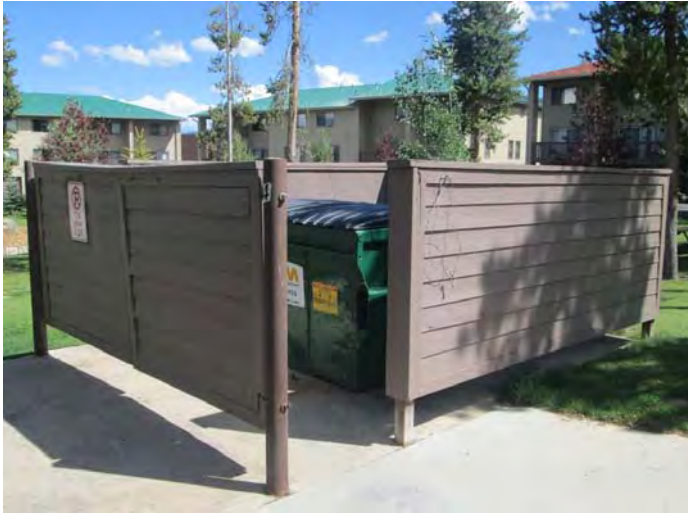
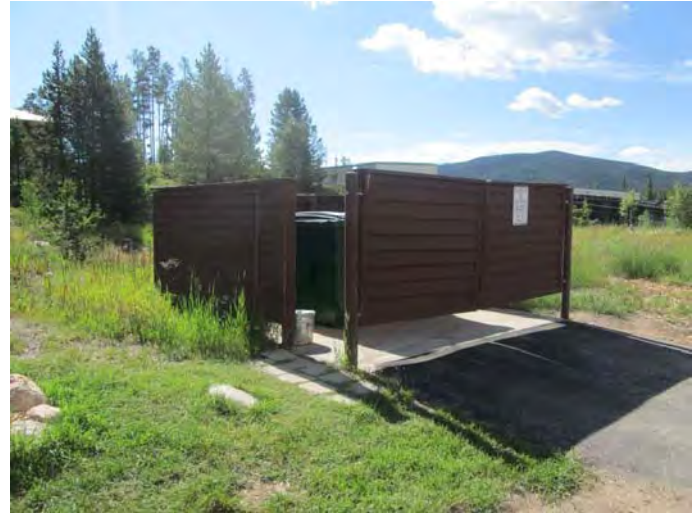
Comp #: 1010 Trash Enclosures - Replace

- The enclosures, in general, appeared to be in good to fair condition with no significant signs of damage noted.
- Due to the construction of these enclosures, and the current conditions, it's recommended an allowance be provided to replace one enclosure every cycle. This allows for replacement of all enclosures every 20 years.
- If it's determined the enclosures are lasting longer than expected, and unanticipated damages don't occur, it's possible the useful life of these could be extended or an enclosure north of 730 could be included.

Allowance to replace one enclosure/cycle

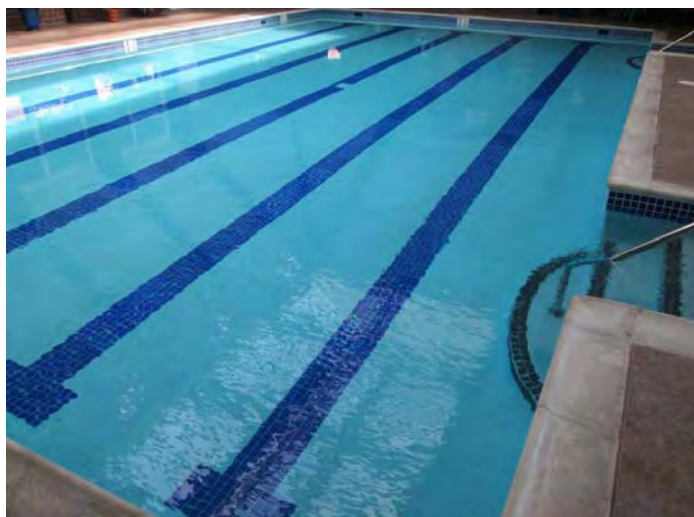
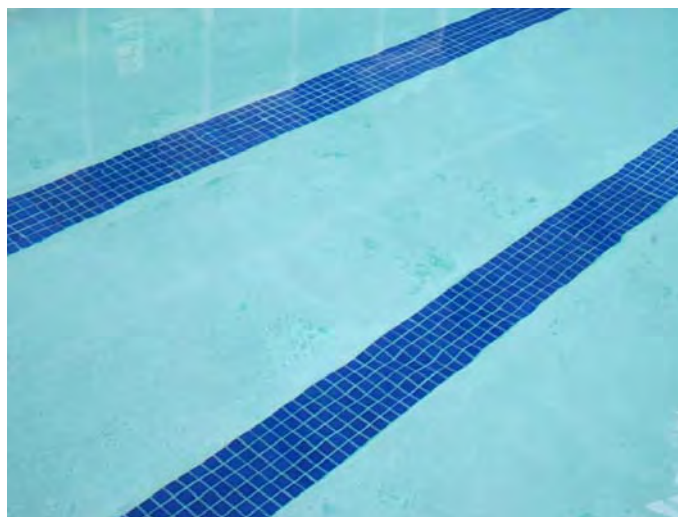
Comp #: 1101 Pool - Resurface

- The pool surfaces appeared to be in good condition at time of observation with few rough surfaces noted during observation and conversations with a few owners using the pool confirming this fact.
- After years of continued use, causing etching of the tile surfaces, and deterioration of the plaster due to regular water chemistry and acid cleaning, pool surfaces need to be replaced.
- Funding is for replastering of all pool surfaces.

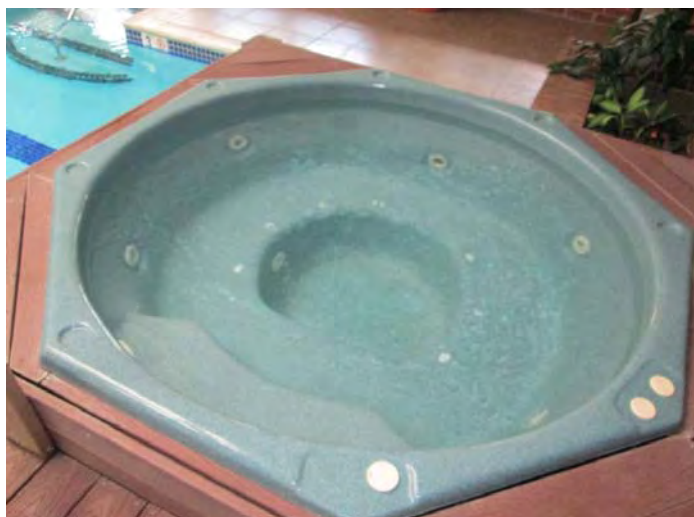
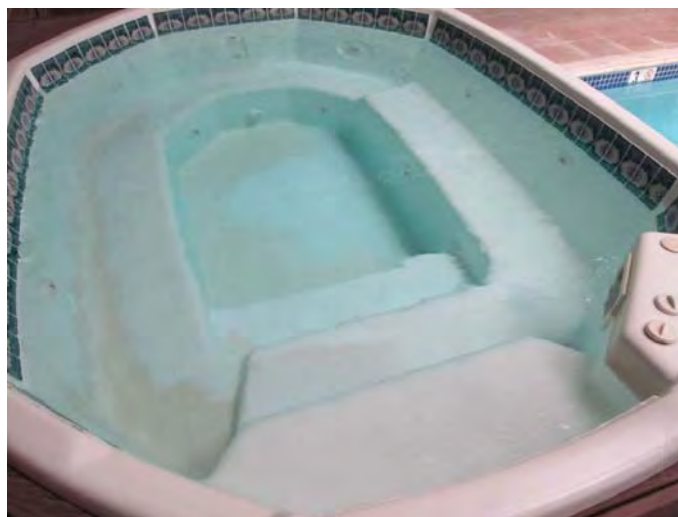
Comp #: 1102 Spas - Replace

- The spas varied in condition from good to fair with the older tub showing signs of deterioration with the gel coating starting to become opaque.
- As these assets age, the gel coating will deteriorate causing rough surfaces to present throughout. Jets will also start to leak increasing annual maintenance costs.
- Funding for replacement of one tub every 10 years is recommended to ensure an enjoyable experience.

Estimate to replace one tub every cycle

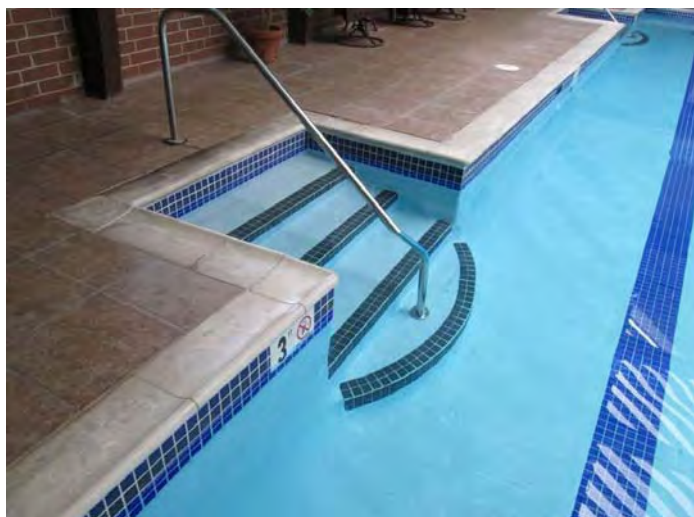
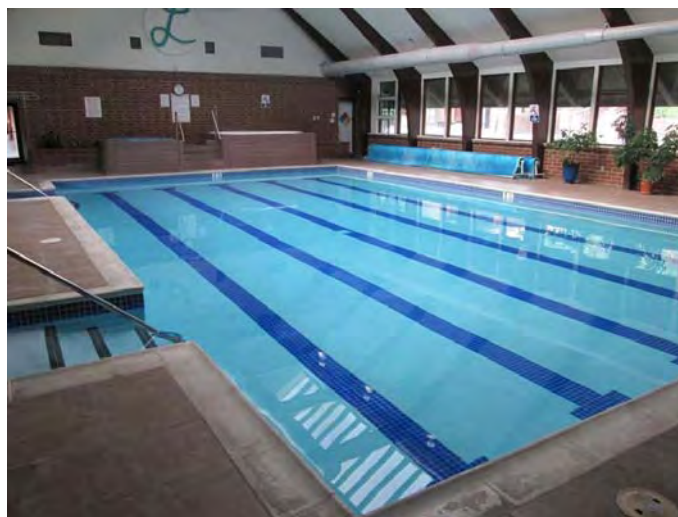
Comp #: 1104 Pool Coping Stone & Tile - Replace

- The coping and tile appeared to be in good to fair condition at time of observation with etching starting to show on the tile. The coping stones were starting to show deterioration with the minimal surface spalling beginning to show.
- Over time, the water line tile will become etched and the coping stones will spall with rough surfaces becoming prevalent around the entire pool.
- Funding for replacement is recommended when the pool is replastered. These components have been aligned.

\$50/LF; Estimate to replace tile and coping stones

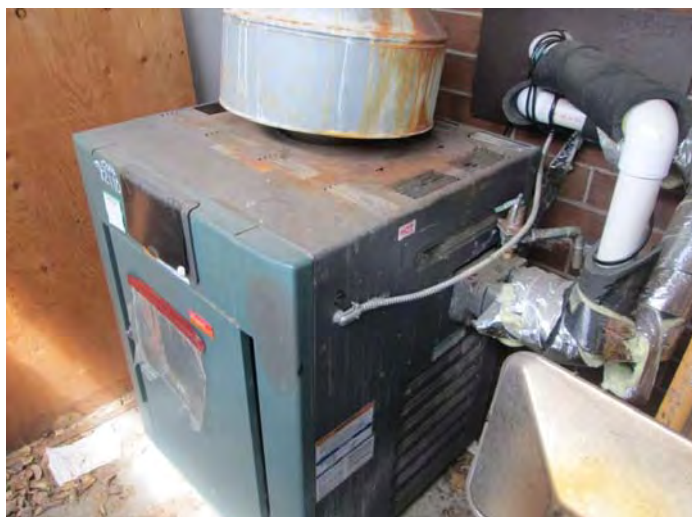
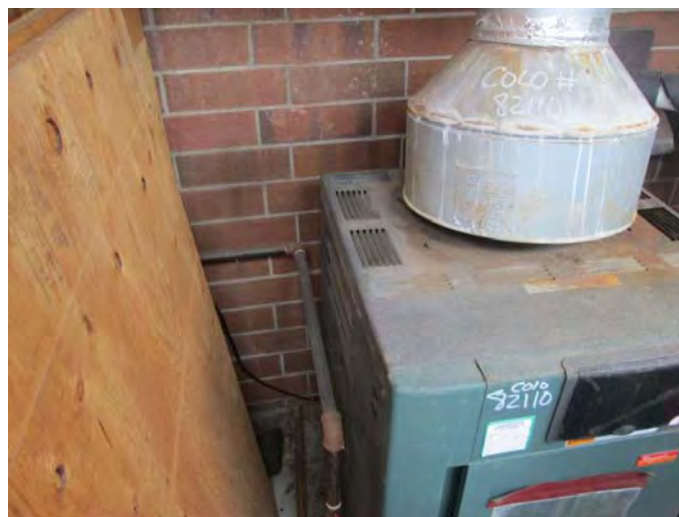
Comp #: 1105 Pool Heater - Replace

- The pool heater appeared to be in fair to poor condition at time of observation with signs of previous leaking noted. It was reported that this heater needs repairs on a regular basis to ensure proper operation.
- As these heaters age, the pool water, and natural gas, slowly cause the heat exchanger to deteriorate. The heat exchangers typically last an average of 15 years before failure necessitates replacement of the unit.
- It's recommending funding be provided to replace the heater prior to failure for best replacement cost estimates.

Estimate to replace with similar type heater

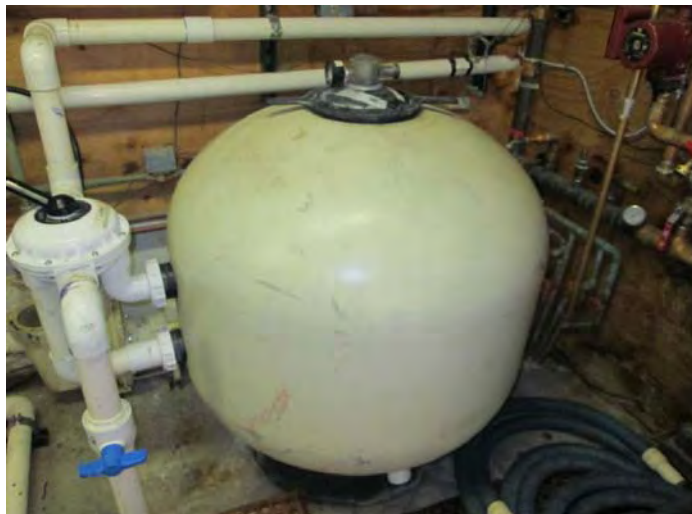
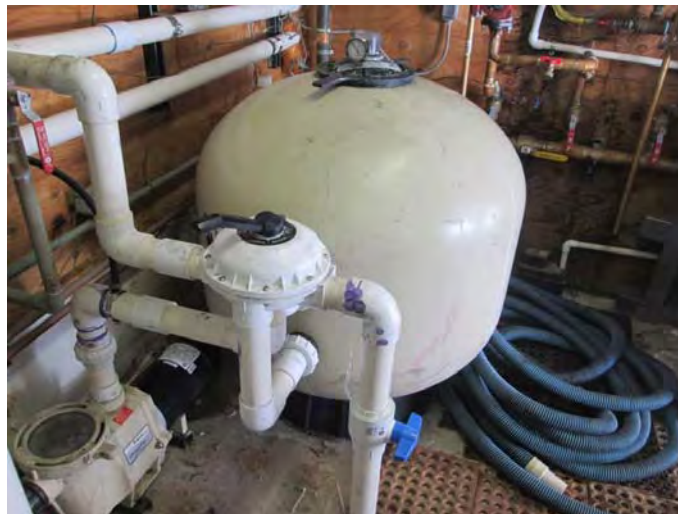
Comp #: 1108 Pool Filter - Replace

- The pool filter appeared to be in fair condition at time of observation.
- Funding for replacement of sand filters is recommended every 15 years to ensure proper filtration and to reduce annual maintenance costs associated with aging equipment. The Manufacturer recommends replacement of this pressure vessel as the shell will become weaker over time.
- Replacement of the filter body includes replacement of the filter media.

Estimate to replace with similar size

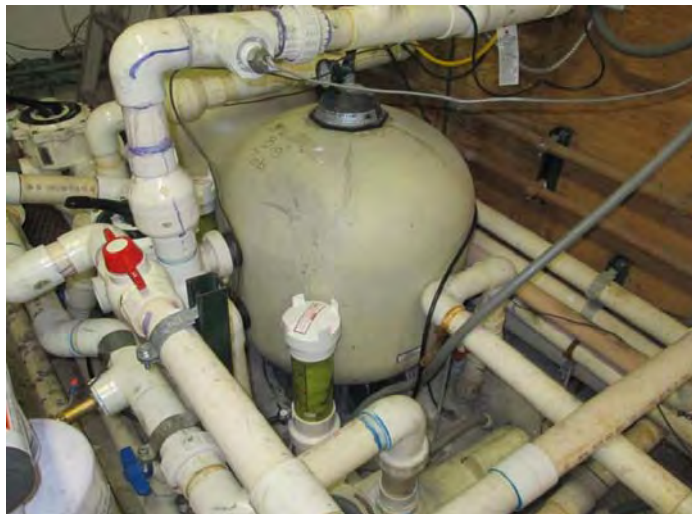
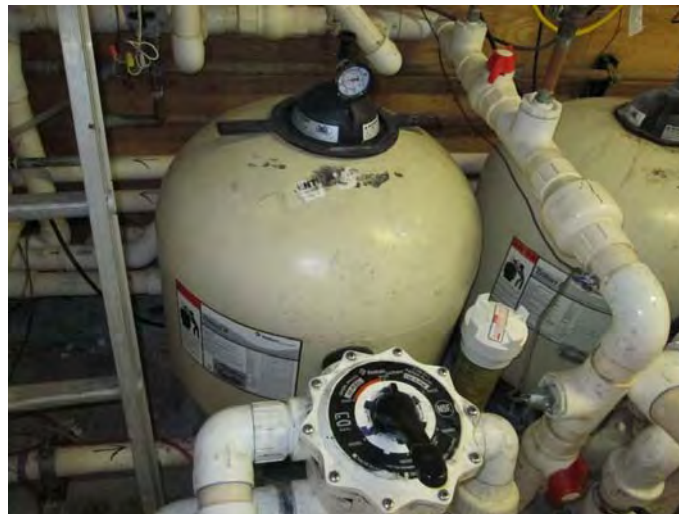
Comp #: 1109 Spa Filters - Replace

- Similar to the pool filter, the spa filters appeared to be in fair condition during observation.
- Replacement of the filters every 15 years is recommended by the manufacturer as changes in pressures during regular operation, and deterioration of the internal components will cause the vessel to operate inefficiently. Furthermore, failure of these vessels can cause significant damage to surrounding equipment.
- Replacement of filter body includes replacement of filter media.

\$2,500/filter; Estimate to replace filters

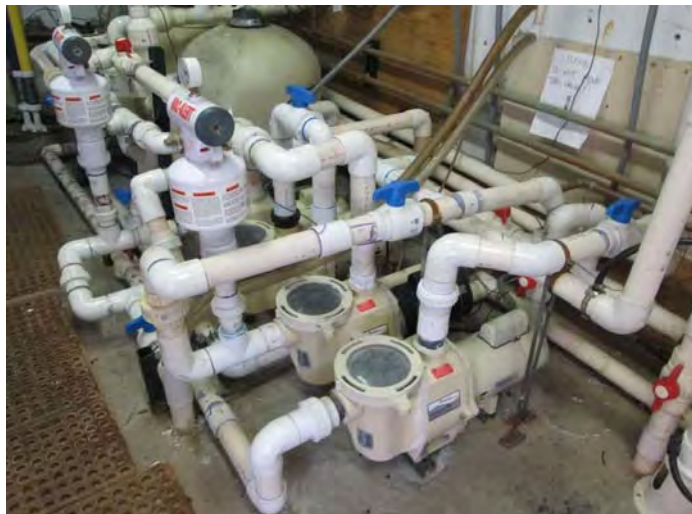
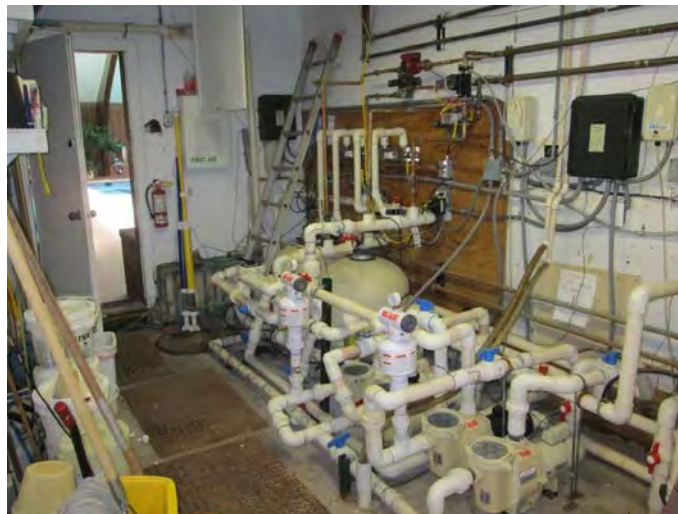
Comp #: 1111 Miscellaneous Pool/Spa Equipment - Replace

- The pool/spa equipment varied in condition from new to poor during observations.
- Funding for replacement of the various equipment used for pool/spa operations is recommended on a periodic basis.

Allowance to replace failing equipment

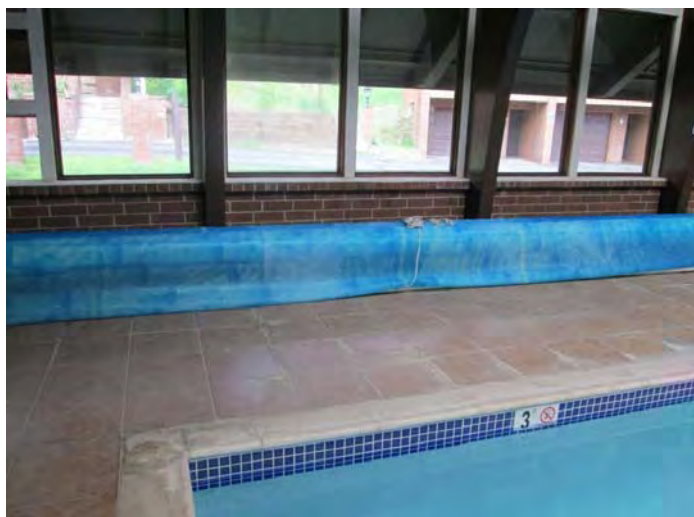
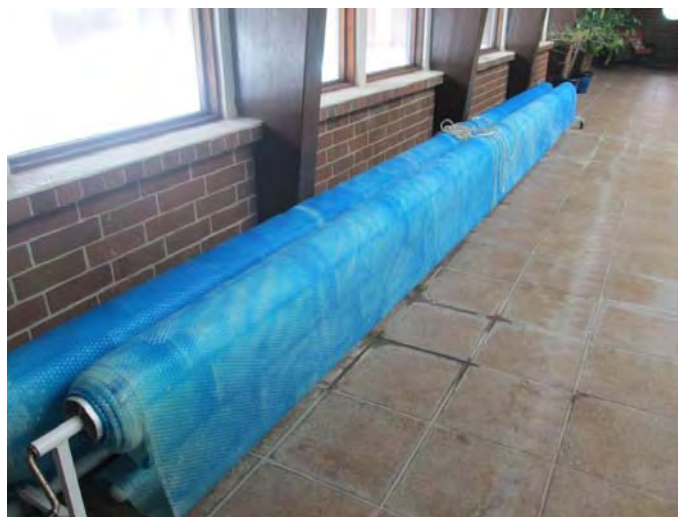
Comp #: 1113 Pool Cover - Replace

- Funding not recommended as \$1,000 cost threshold will not be met. Replace, as needed, with operating funds.
- Additionally, with an indoor pool, there is little need to spend money on the covers and the labor associated with covering and uncovering the pool.
- Deterioration of decking surfaces is also accelerated due to the constant moisture on the deck during storage.

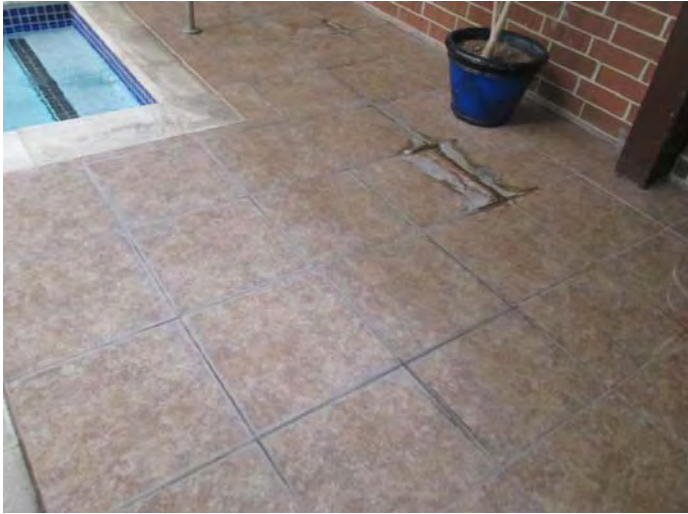
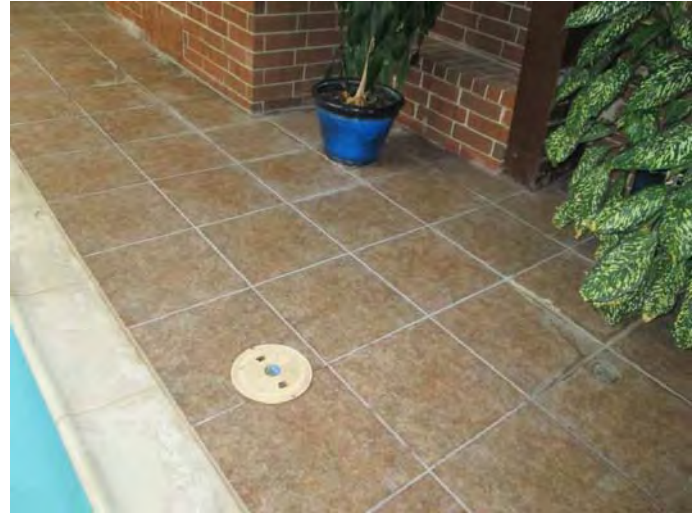
Comp #: 1117 Pool Deck Tile - Replace

- The decking surfaces appeared to be in good condition with no advanced deterioration noted during observations.
- The newly installed porcelain decking has an extended useful life with funding recommended to align with current design trends.
- Regular annual maintenance should be performed with regular cleaning and replacement of damaged or missing grout handled on an as needed basis with operating funds.

\$10/GSF; Estimate to replace with similar

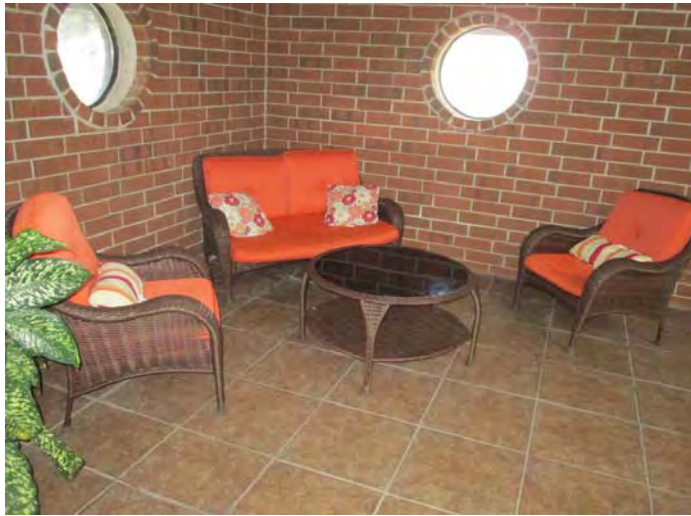
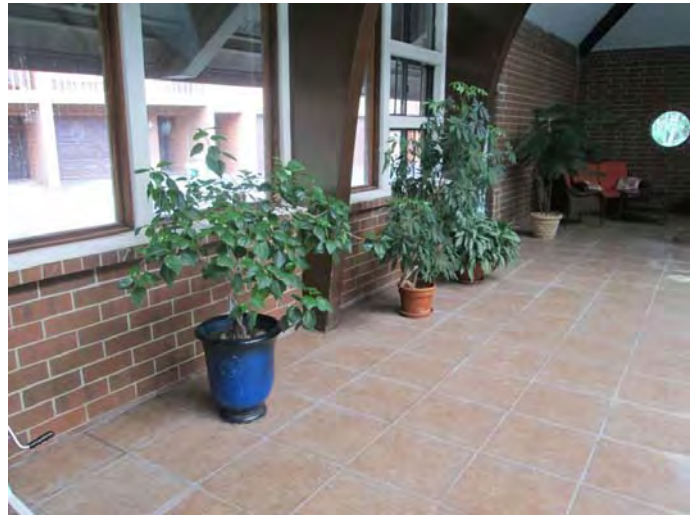
Comp #: 1121 Pool Furniture - Replace

- During observations, the pool furniture, though dated, appeared to be in good condition. The plants throughout appeared healthy with no issues noted on the planters.
- Funding for replacement of the furniture and for additional plants is recommended to allow the association to conform with current design trends.
- Replacement of damaged pieces should be handled with operating funds outside of this replacement schedule.

Estimate to replace with similar

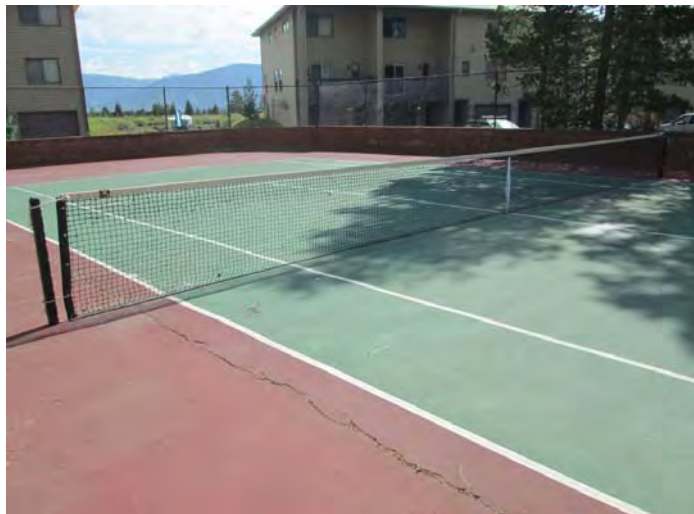
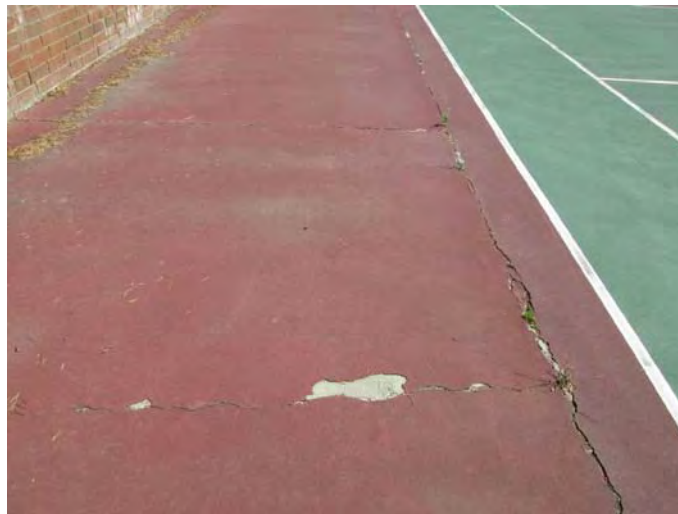
Comp #: 1201 Tennis Court - Replace

- Outside of the large cracks surrounding the playing area, the court appeared to be in fair condition. However, the cracks can be a detriment to play and increase trip hazards.
- A properly installed tennis court, with regularly scheduled maintenance, will last 20 - 30 years in this environment before complete removal and replacement of the play surface is required.

Estimate to replace playing surface

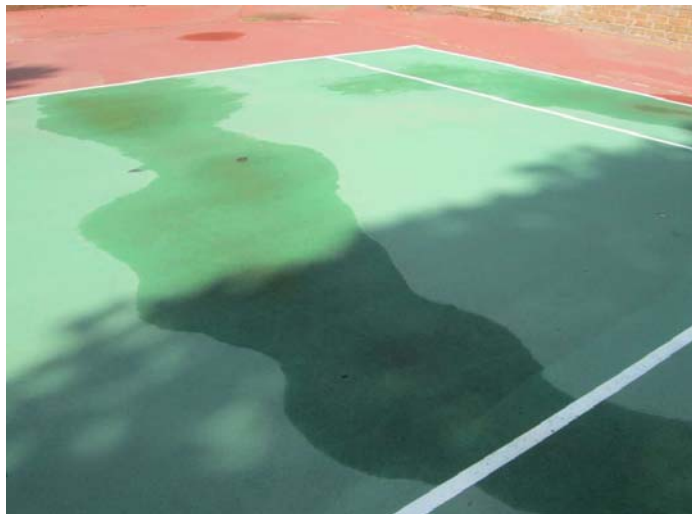
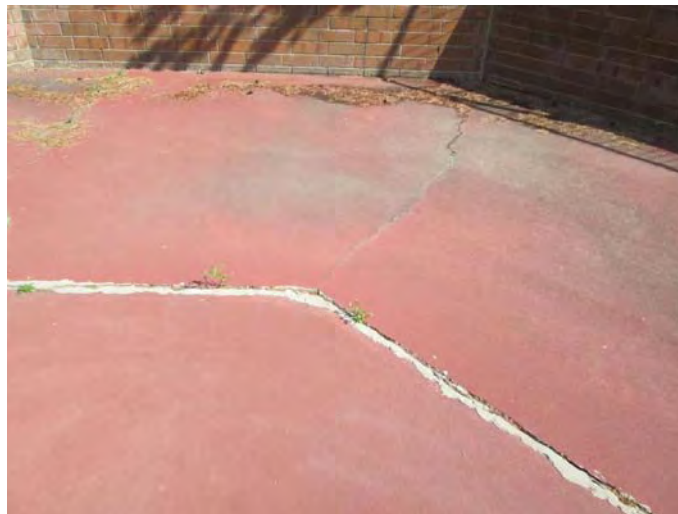
Comp #: 1202 Tennis Court - Resurfacing

- The play surface appeared to be in good to fair condition during observation. However, the cracks in the apron surrounding the court are not conducive to play and can cause tripping hazards.
- Resurfacing of the court is recommended on a regular basis to seal any cracks, preventing water intrusion and degradation of the substrate. A new surface also improves play and increases use of this asset.
- Outside of regular resurfacing, cracks should be sealed on an annual basis to extend the useful life of the surface.

Estimate to repair cracks and resurface

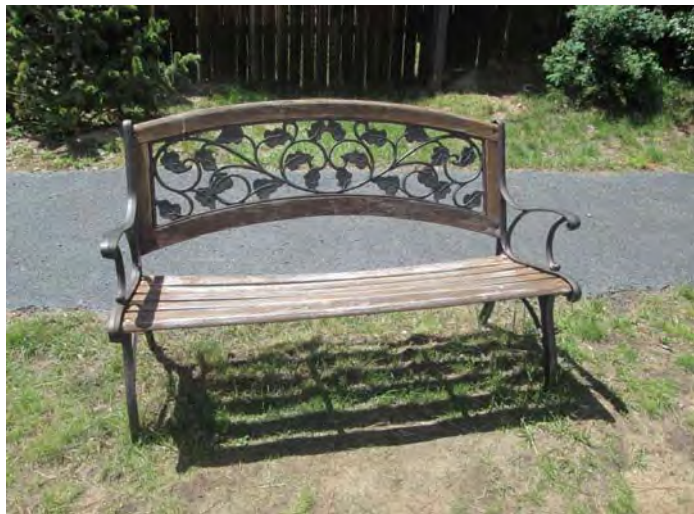
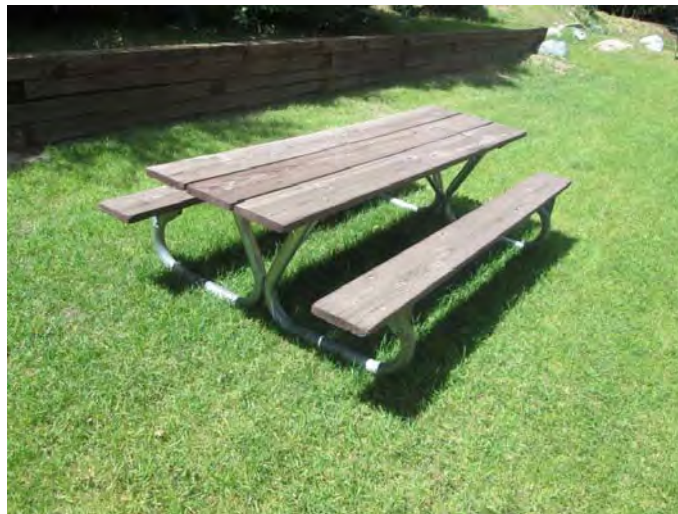
Comp #: 1306 Misc Recreation Equipment - Replace

- The recreation equipment throughout the property varied in condition from good to poor with some items needing replacement in the near future and others needing minor maintenance to extend their useful life.
- An allowance for replacement of these assets is recommend to ensure the membership has equipment that will be utilize for the enjoyment of the property.
- Regular annual maintenance, including painting/staining, should be performed to ensure a long useful life.

Allowance to replace damaged equipment

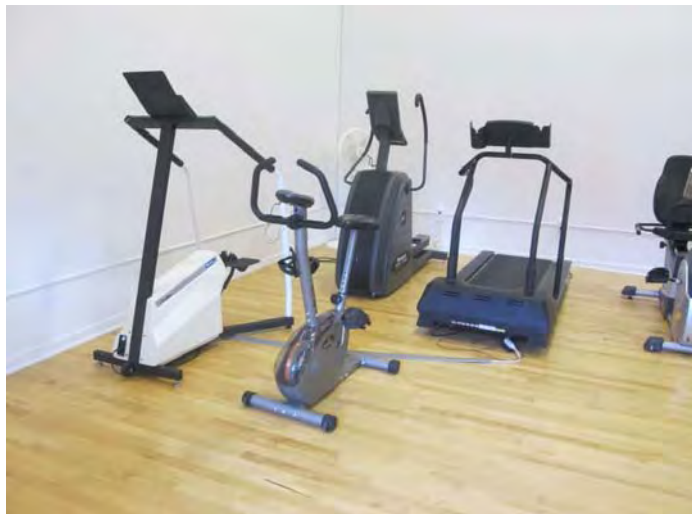
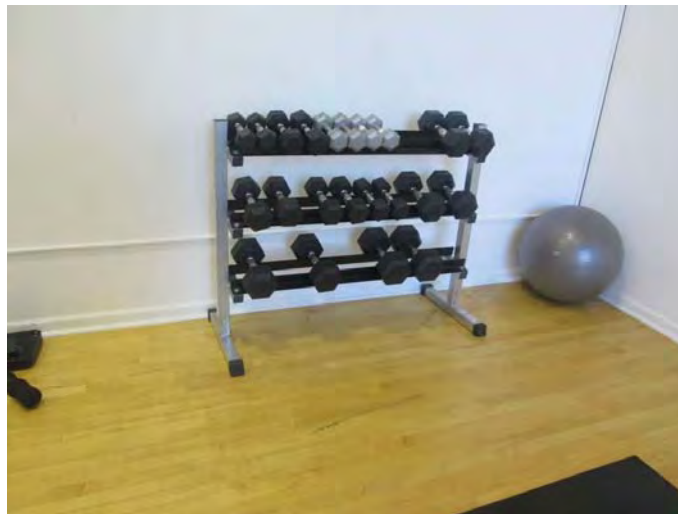
Comp #: 1406 Fitness Equipment - Replace

- All of the equipment in the fitness room was mismatched and old. However, all equipment was in working order and conversations with the membership didn't reveal any issues with the equipment.
- Funding for replacement of half of this equipment is recommended every five years to take advantage of new technology and training methods. This provides for complete replacement of all equipment every 10 years.
- Regular annual maintenance of this equipment will ensure the longest possible useful life.

Estimate to replace 50% of equipment

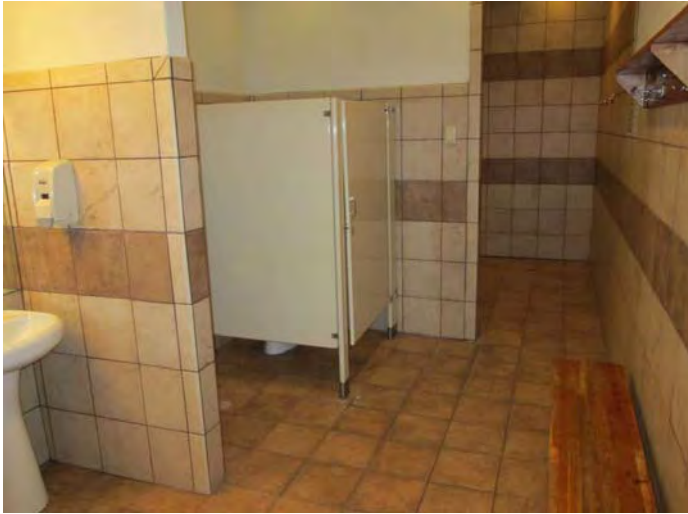
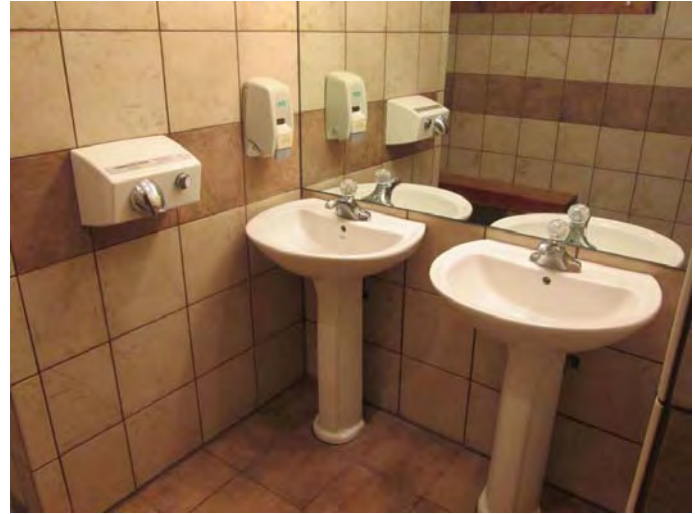
Comp #: 1413 Poolhouse Restrooms - Remodel

- During observation, The restrooms appeared to be in good condition with no issues noted.
- Funding for the remodeling of the restrooms is recommended on a periodic basis. This allows the association to replace dated fixtures and tile and to conform with current design trends.
- Damaged fixtures and tile should be replaced on an as needed basis with operating funds unless the association's capital/reserve spending threshold is reached.

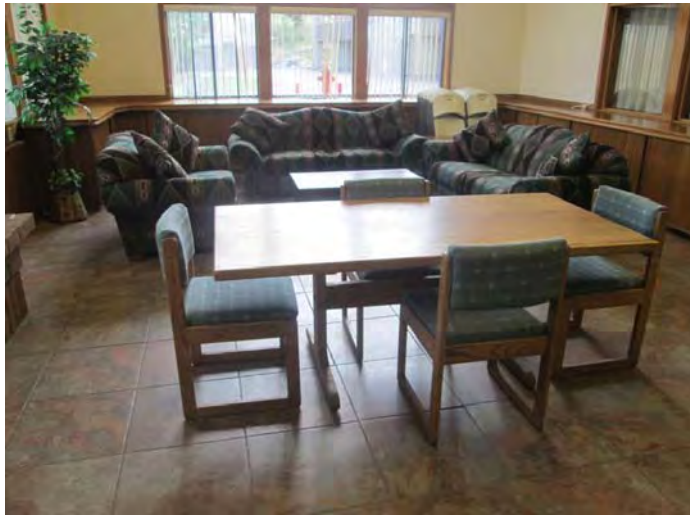
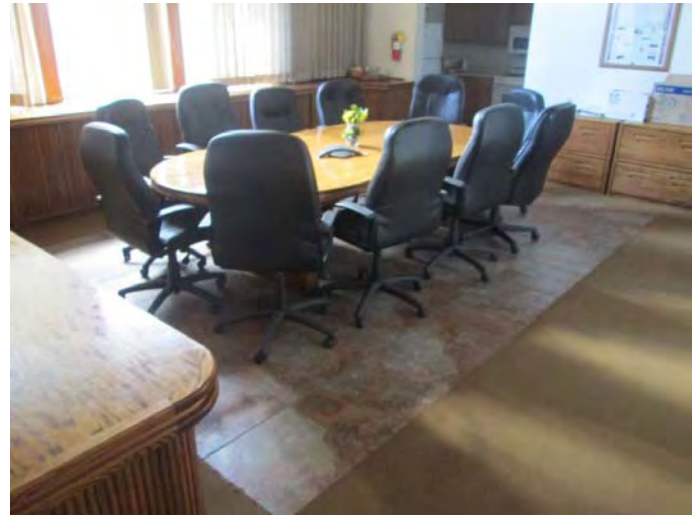
Comp #: 1414 Clubhouse - Remodel

- Though dated, the clubhouse interior appeared to be in good to fair condition with no significantly damaged furniture, fixtures or equipment noted during observation.
- As with all other interior Common Elements, it's recommended funding be provided to remodel these areas to conform with current design trends. This typically results in increased use of these valuable assets/amenities.

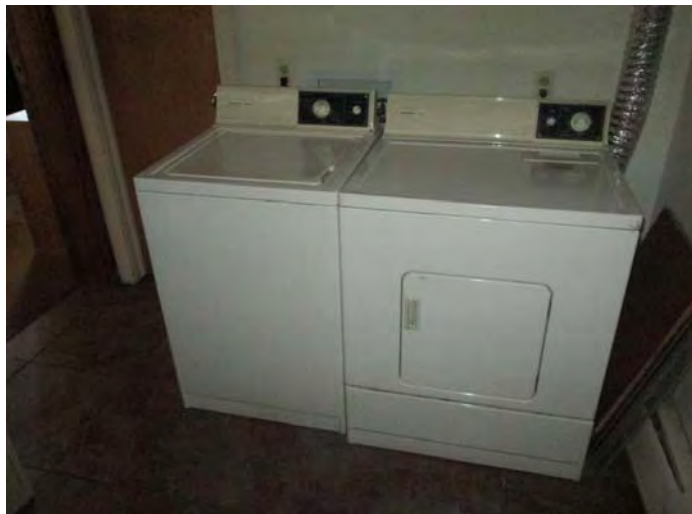
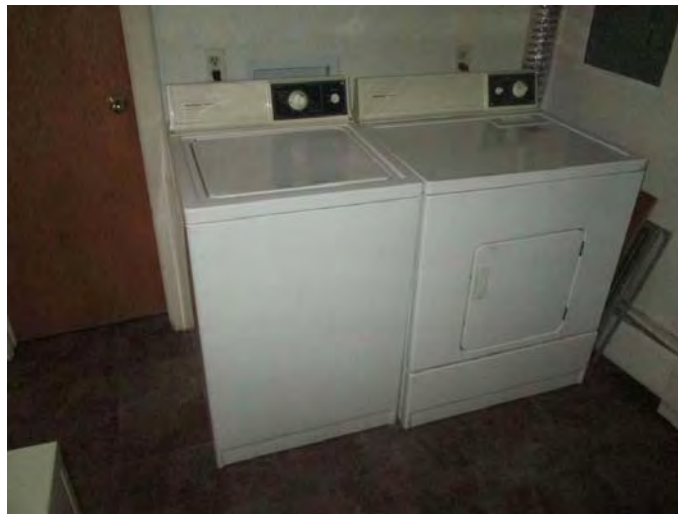
Comp #: 1427 Washer & Dryer - Replace

- Funding for replacement of these assets isn't recommended as it was reported they are seldom used.
- If these are replaced, it is recommended that operating funds are used as similar models will not reach a spending threshold of \$1,000.

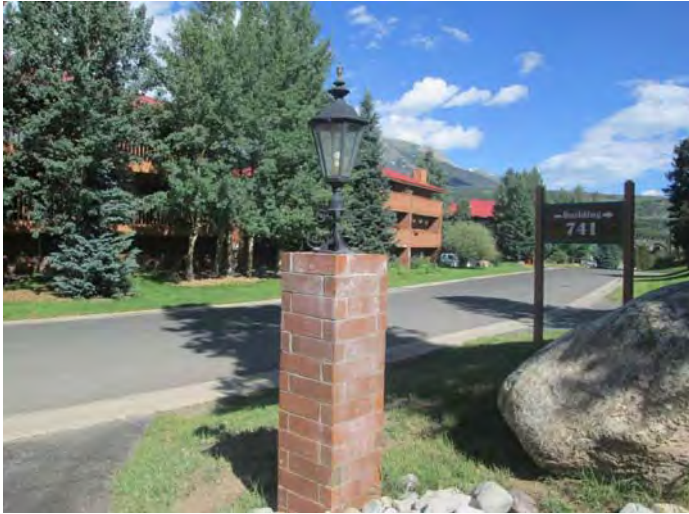
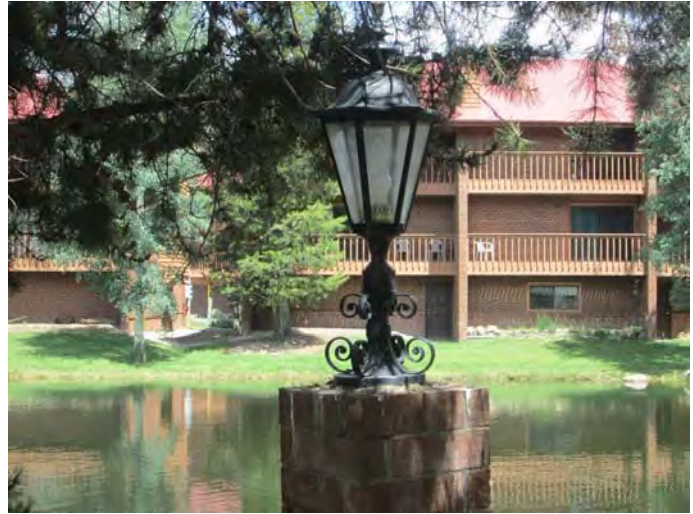
Comp #: 1602 Exterior Deco Light Fixtures - Replace

- The fixtures all appeared to be in good to fair condition during observation with reports that all lights were operating as expected.
- Funding for complete replacement of these fixtures is recommended to ensure conformity throughout the property and to align with current design trends and code regarding Dark Sky Lighting.
- Damaged fixtures should be replaced, as needed, with operating funds.

\$500/fixture; estimate to replace with similar

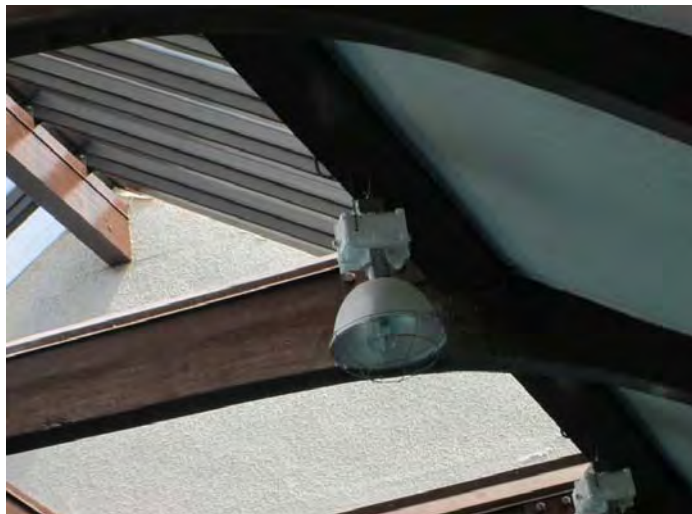
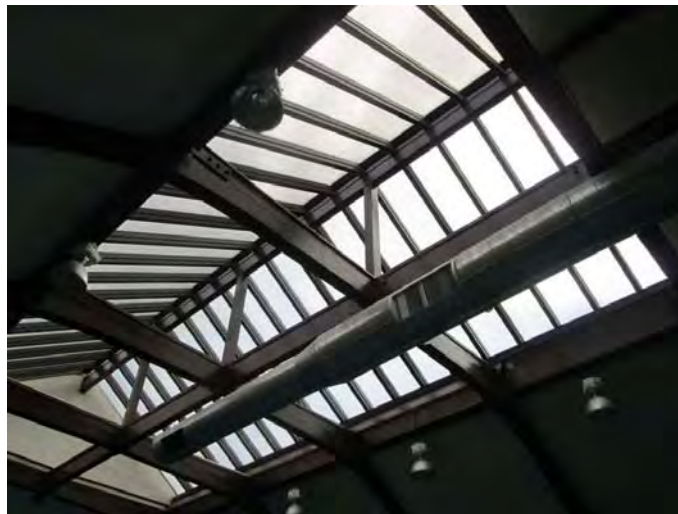
Comp #: 1606 Pool Lights - Replace

- It was reported that all light fixtures worked as expected.
- funding for replacement of these fixtures, or retrofitting to take advantage of new technology, is recommended on a periodic basis.
- The spend associated with replacement/retrofitting can usually be offset with rebates from the energy company. Energy savings, over the life of the fixture, will offset the initial, and ongoing, costs associated with the fixtures.

Estimate to replace with new technology

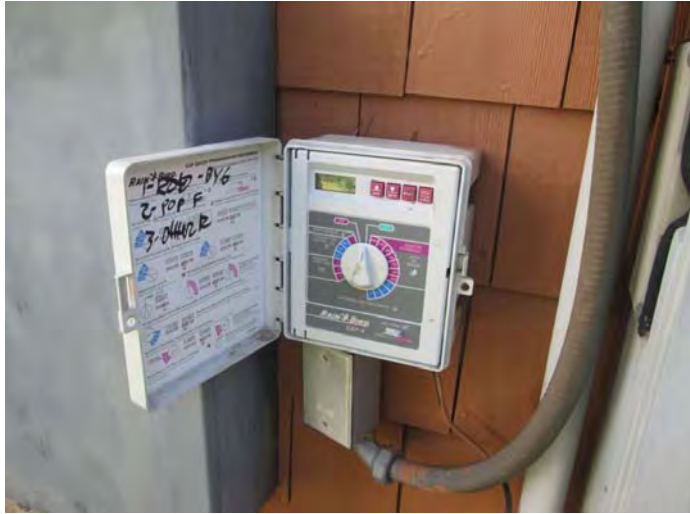
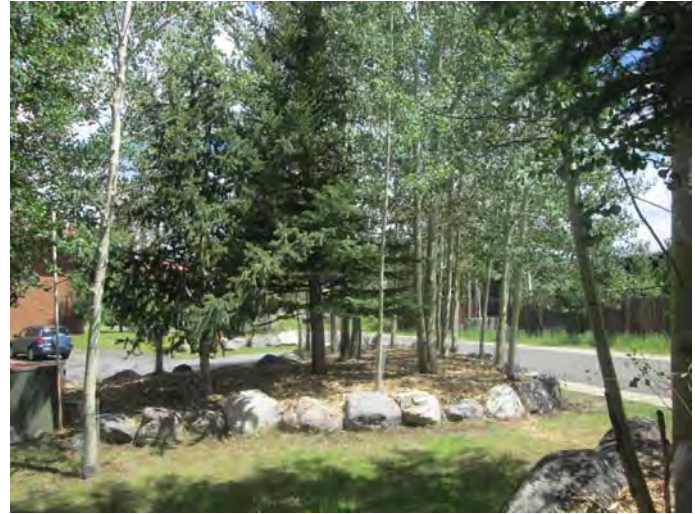
Comp #: 1701 Irrigation System - Major Repairs

- The irrigation system appeared to be in good to fair condition with zones observed in operation working as expected. It was reported that the aging system is starting to show signs of failure.
- As systems age, and mature growth starts to impede operation, it's recommended funding be provided to perform major repairs above any beyond the operational funding provided to maintain the system.
- Replacement of controllers with ET controllers will help save money on water as time passes.

Allowance to perform major repairs

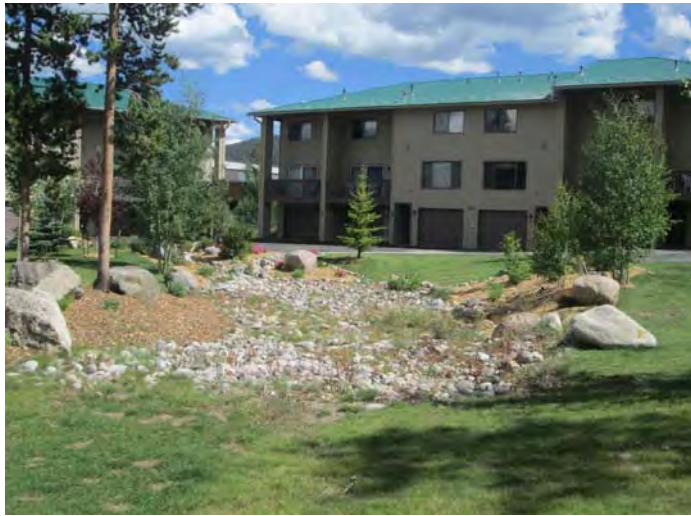
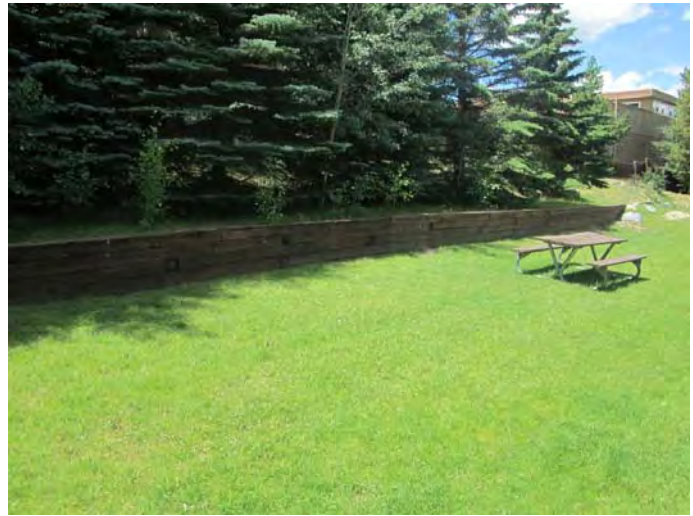
Comp #: 1801 Landscaping - Replenish

- The landscaping, in general, appeared to be in good condition during observation with only a few areas noted as needing attention.
- Funding for replenishment of landscaping is recommended to ensure aging areas are updated to allow for continued growth and to ensure a pleasing appearance throughout the property.
- This funding is for improvements to all landscaping above and beyond regular annual maintenance.

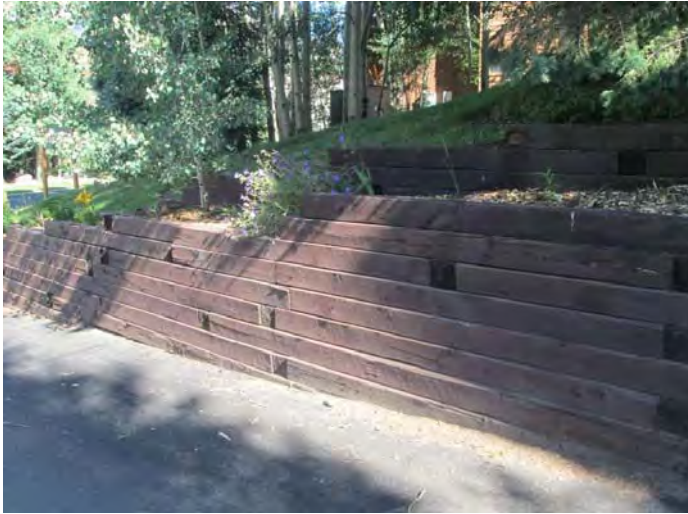
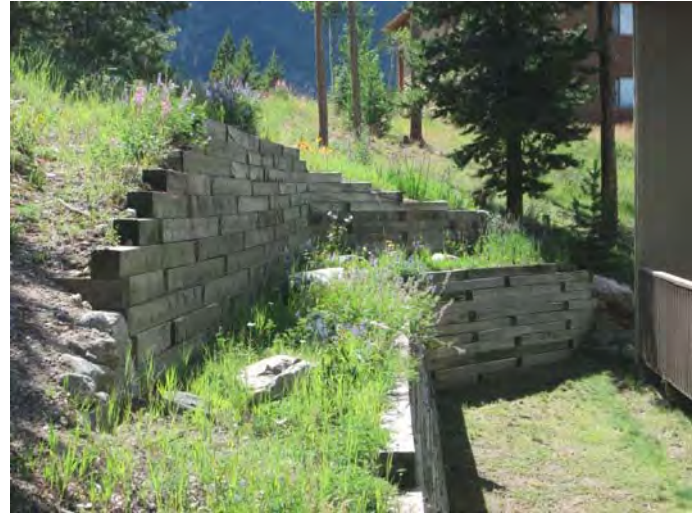
Comp #: 1805 Landscape Timbers - Replace

- In general, the landscape timbers used throughout the property as retaining walls appeared to be installed properly with few signs of advanced deterioration, or leaning, noted during observations.
- It's recommended funding for replacement of 10% of the walls is provided to repair damaged areas on a periodic basis. This provides for complete replacement of all timber walls every 80 years.
- Minor repairs can be handled on an as needed basis with operating funds, outside of this repair schedule.

Allowance to repair 10% of timbers every 10 years

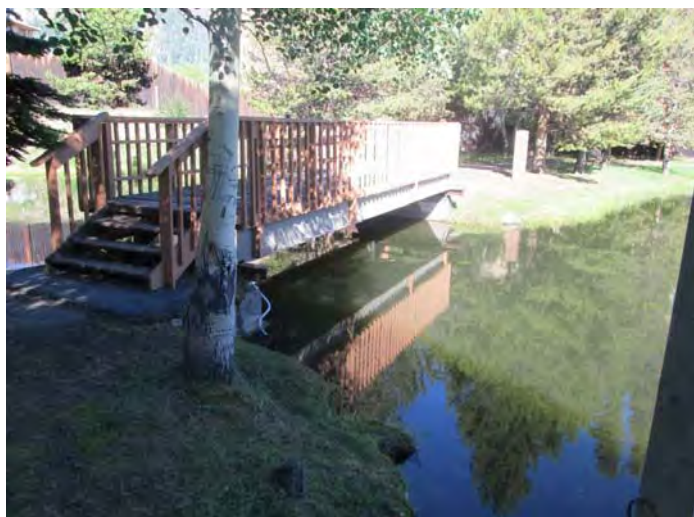
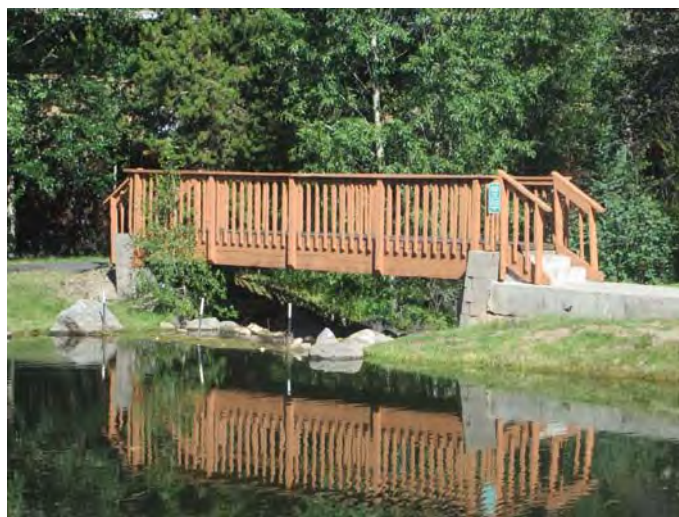
Comp #: 1806 Bridges - Major Repairs

- There were no significant issues noted, or reported, with the bridge structures. However, damage to the stairs and pavement leading up to them was noted during observation.
- Funding for major repairs to these bridges is recommended to ensure the longest possible useful life.
- Without regular, major, repairs to these assets, it's possible that complete replacement will be required. As the cost for complete replacement will likely exceed \$100,000, it's recommended this work is completed.

Allowance for major repairs

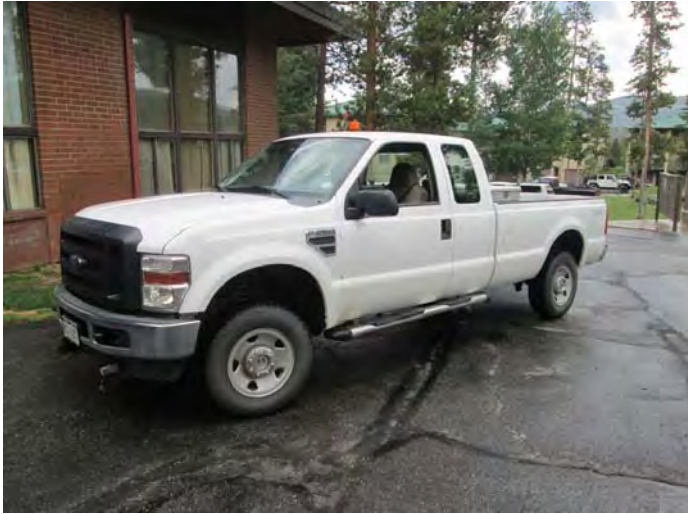
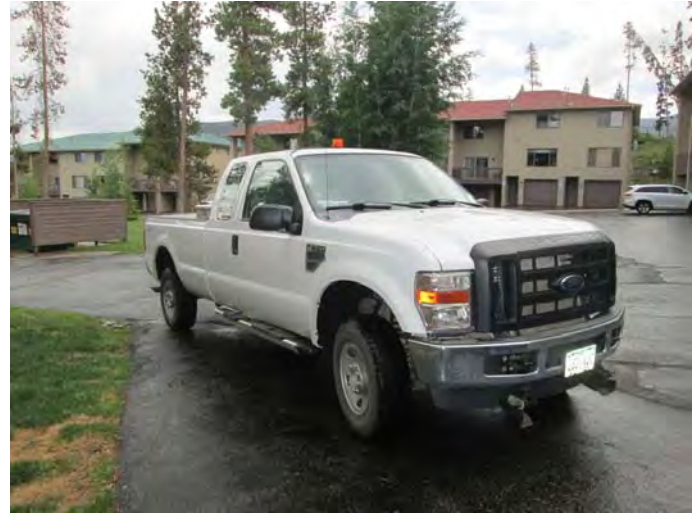
Comp #: 1901 Work Truck - Replace

- The plow truck appeared to be in good to fair condition with no significant body, or interior, damage noted during observation. It was reported that regular maintenance has been performed with no major issues.
- As the suspension and drive train of trucks used for plowing deteriorate at an accelerated rate, replacement of the truck, and accompanying plow equipment, is recommended before major repairs are needed to ensure proper operations. This typically occurs every 12 years or at 75,000 - 80,000 miles.

Estimate to replace with similar and attachments

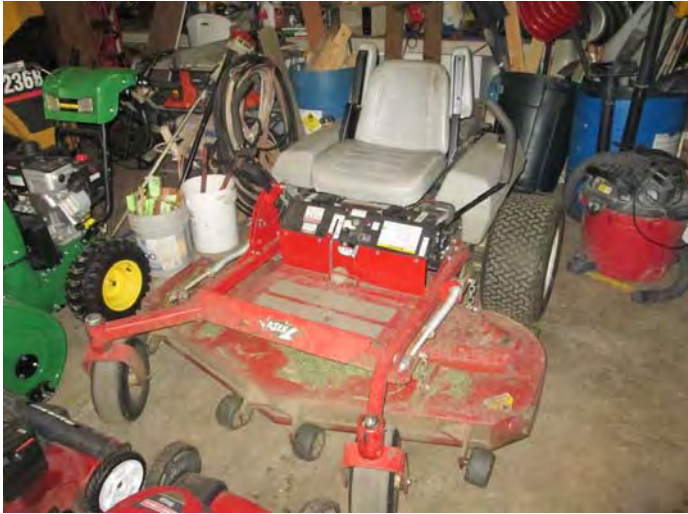
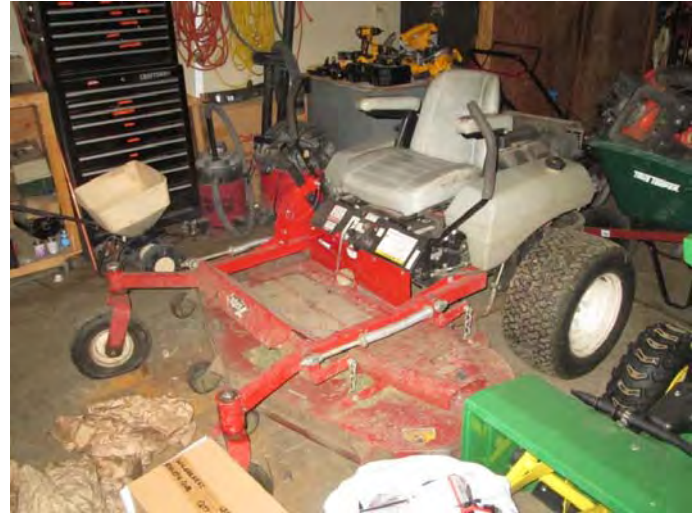
Comp #: 1902 Riding Mower - Replace

- The riding mower appeared to be in good condition with all systems operating as expected. No major issues were reported and the machine operated as expected when observed.
- Replacement of this type of mower is recommended on a periodic basis as the machine ages and regular repairs become more costly.
- Funding for replacement may not be needed if the association outsources mowing operations in the future.

Estimate to replace with similar

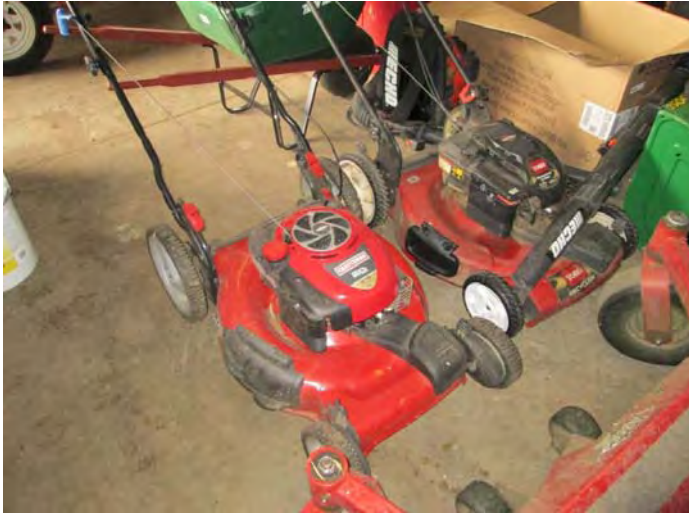
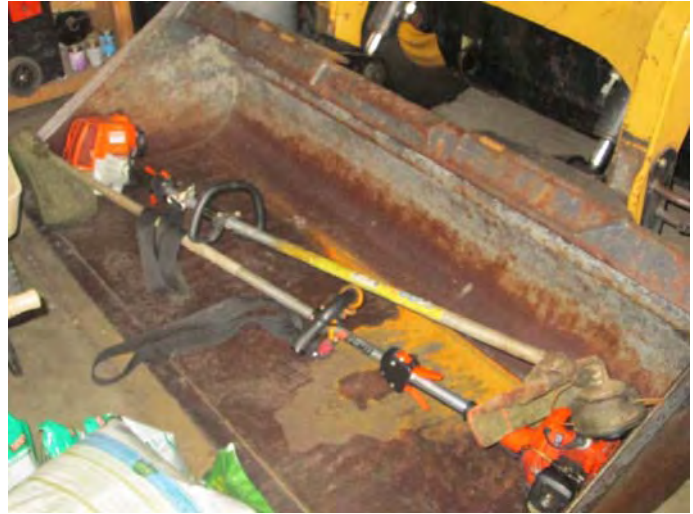
Comp #: 1903 Maintenance Equipment - Replace

- The conditions of the various pieces of handheld equipment varied from good to poor during observation. It was reported that the older equipment is being used to make repairs to the newer equipment.
- An allowance for replacement of failing items is recommended to ensure the equipment needed to maintain the property is on hand and operating properly.
- funding for replacement of these items may not be needed if this work is outsourced in the future.

Allowance to replace failing equipment
