Lagoon TH Condominium Association, Inc.
700 Meadow Creek Drive
Frisco, CO 80443

Level 1, Platinum Reserve Analysis

Report Period – 07/01/15 – 06/30/16

Final Draft
Version

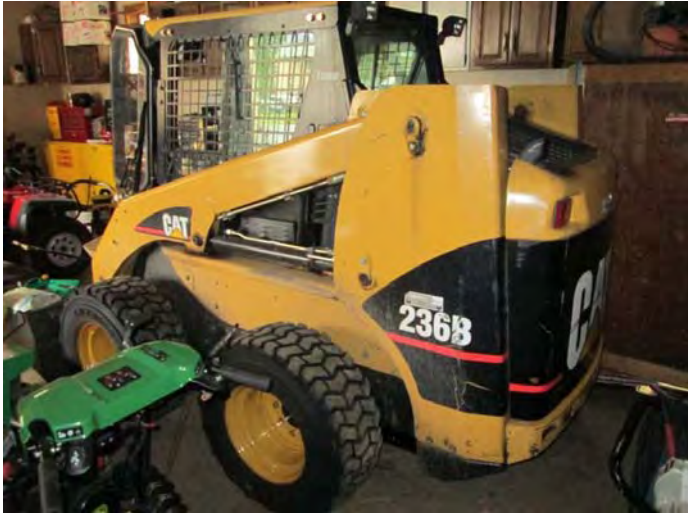
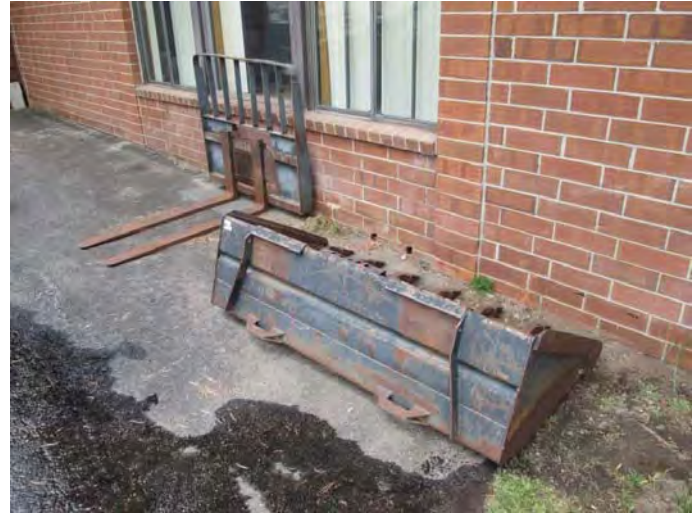
Comp #: 1904 Skid Steer Loader - Replace

- the skid steer appeared to be in good condition at time of observation with no issues reported.
- Replacement of this machine, with all associated attachments, is recommended on a periodic basis as increasing regular annual maintenance costs begin to outweigh the replacement value of the asset.
- As with most other pieces of equipment owned by the association, it was reported that this machine may not be replaced with the outsourcing of plowing, and landscape, operations.

Estimate to replace with similar equipment

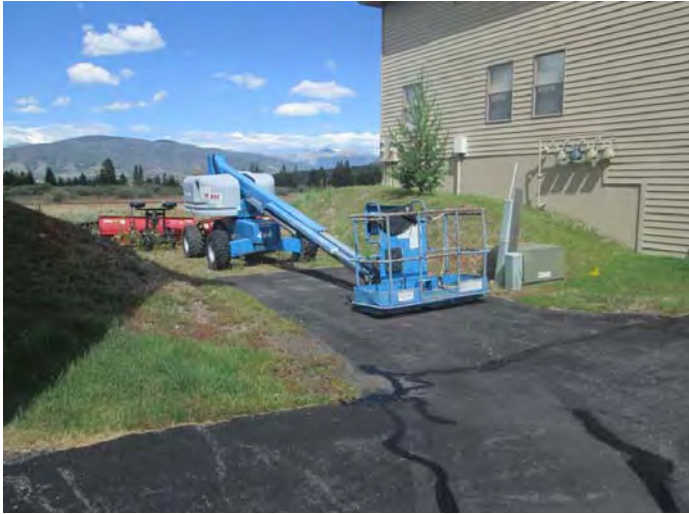
Comp #: 1905 Man Lift - Replace

- No funding, it has been reported that the association is selling this asset.

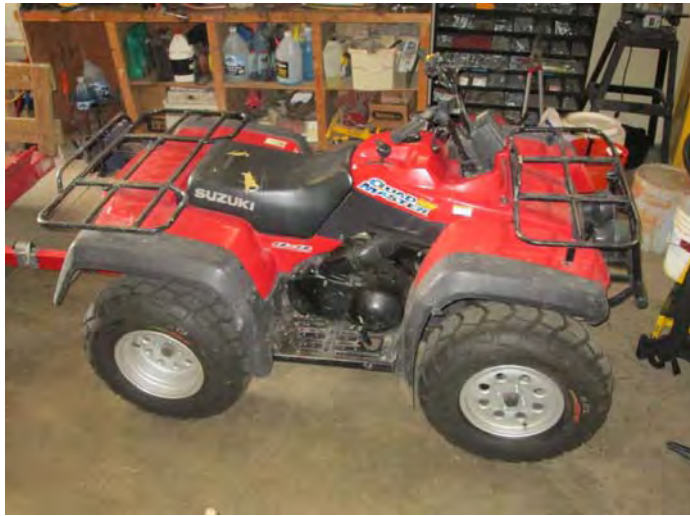
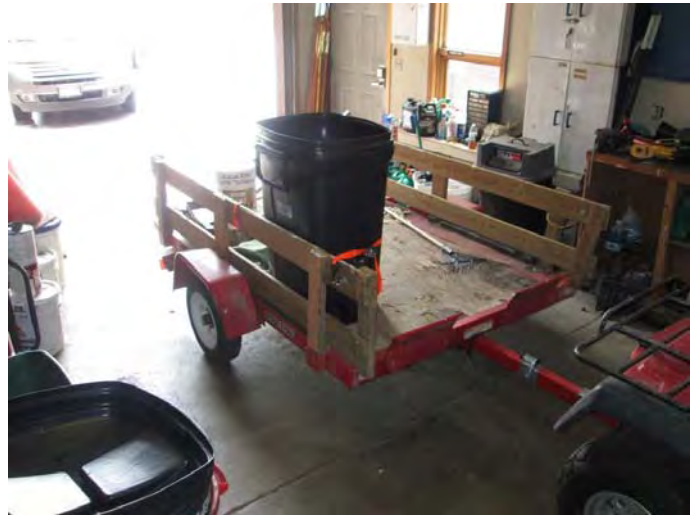
Comp #: 1905 Quadrunner - Replace

- No funding, it's been reported that the HOA will be selling the current asset as it isn't utilized effectively.

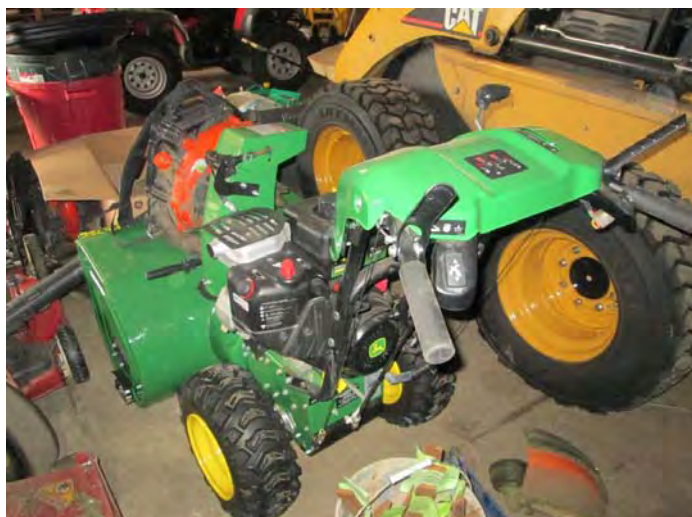
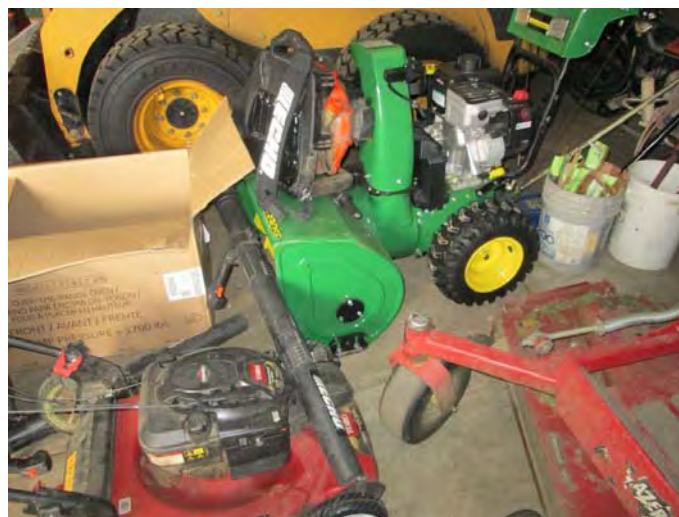
Comp #: 1906 Snow Blower - Replace

- Though not observed in use, it was reported that the snow blower is operating as expected with regular annual maintenance taking place to ensure the longest possible useful life of this asset.
- Funding for replacement of this asset is recommended to ensure the association has the ability to clean-up after the plow company and between storms when plowing isn't triggered, but wind-blown drifts need to be removed.
- As with all other association owned equipment, funding may net be needed with outsourced contracting.

Estimate to replace with similar

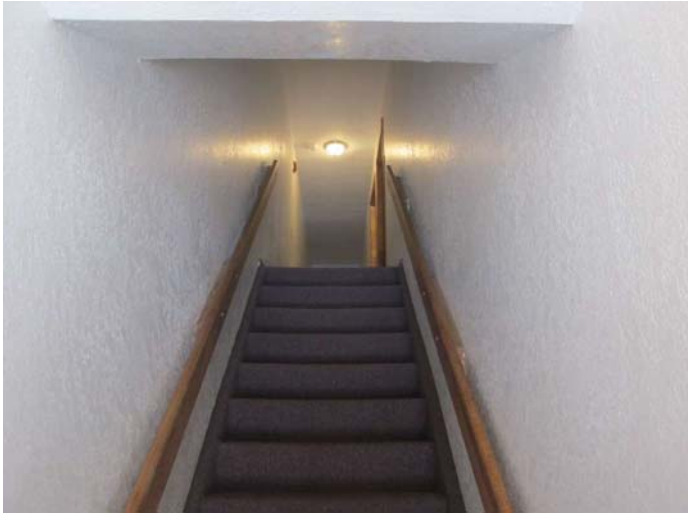
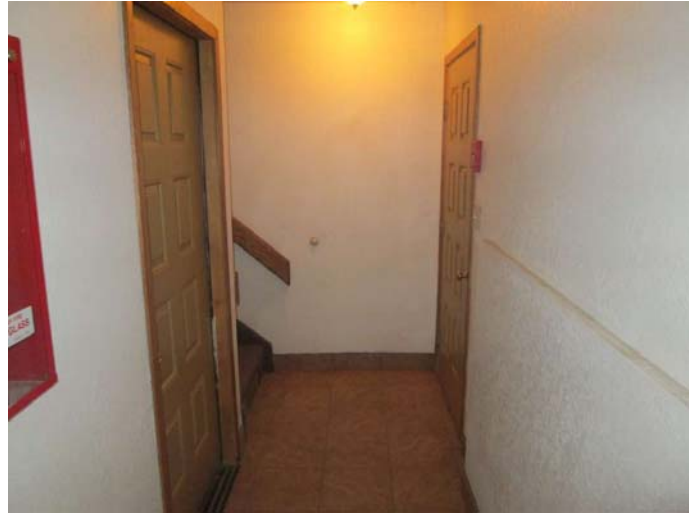
Comp #: 216 Interior Surfaces (Dept B) - Repaint

- Overall, the common area hallways appeared to be in fair to poor condition during observations. Touch-ups were noted throughout and it appears as though repairs are taking place.
- It is recommended that repairs to these halls continue to occur, as needed, with operating funds.
- It is recommended that funding to paint these hallways, with minor repairs to the surfaces, is provide periodically. As time passes, even with regular annual repairs, the hallways will begin to show their age and need to be painted.

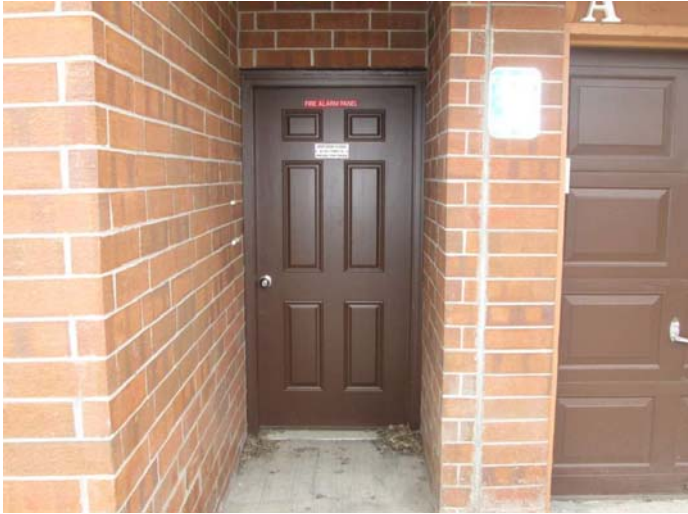
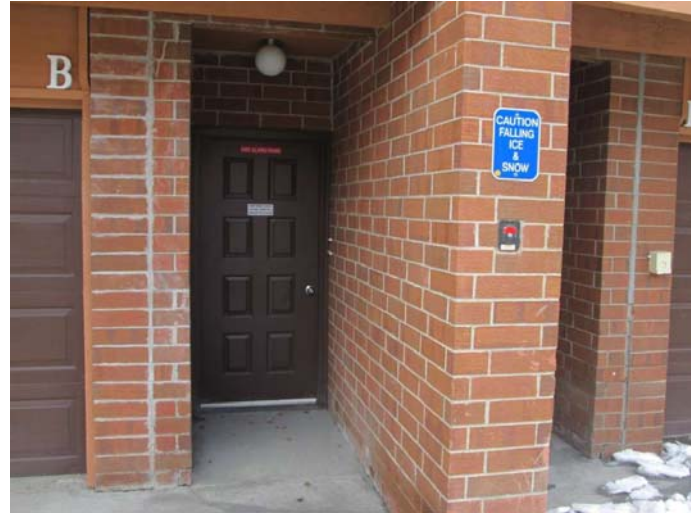
Comp #: 503 Utility doors (Dept B) - Replace

- During observations, the conditions of the doors varied from good to poor. This can be contributed to varying exposure, use and some doors having already been replaced.
- As the expected lives of these doors will vary, it is recommended that funding be provided to replace approx. 25% of the doors every 8 years. This will allow for complete replacement of all doors every 24 years.
- Regular repairs to the closers, hinges, doors and frames should be completed, as needed, with operating funds.

\$850/door; Estimate to replace 10 doors

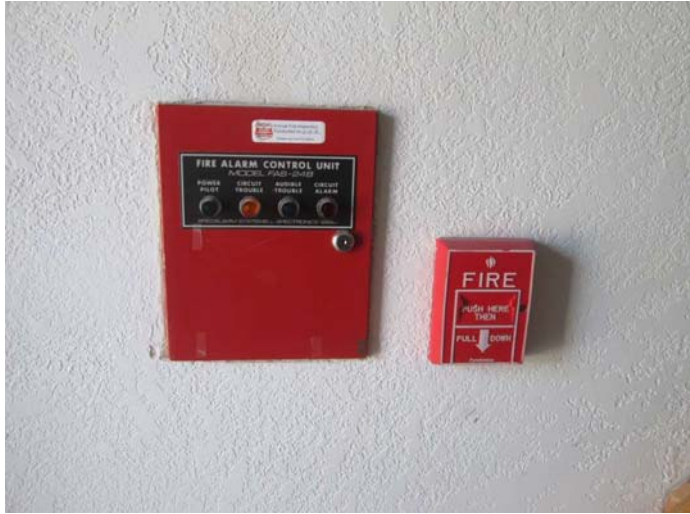
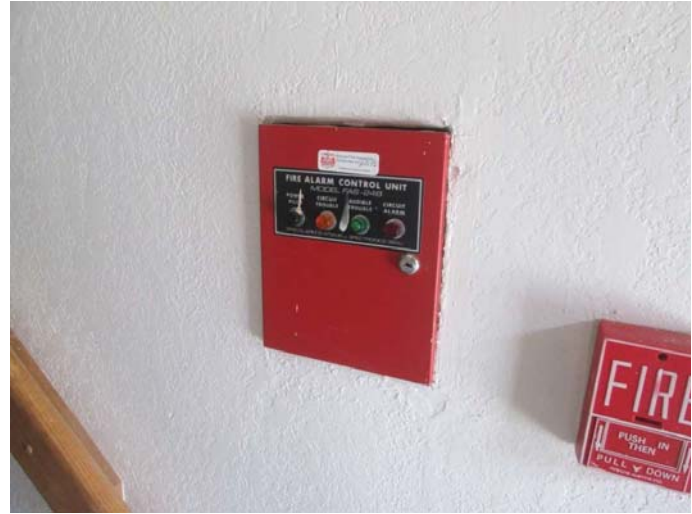
Comp #: 901 Fire Protection System (Dept B) - Replace

- The panels appeared to be operational and it was reported that the current fire panels are functioning as expected.
- These panels typically have an extended useful life. However, new technology and the absence of replacement parts require replacement of the panels and associated hardware. It should be noted that the current panels are obsolete and will need to be replaced at failure.
- It is recommended that funds be provided to replace all of the panels at the same time to best cost estimates.

Estimate to replace fire panels

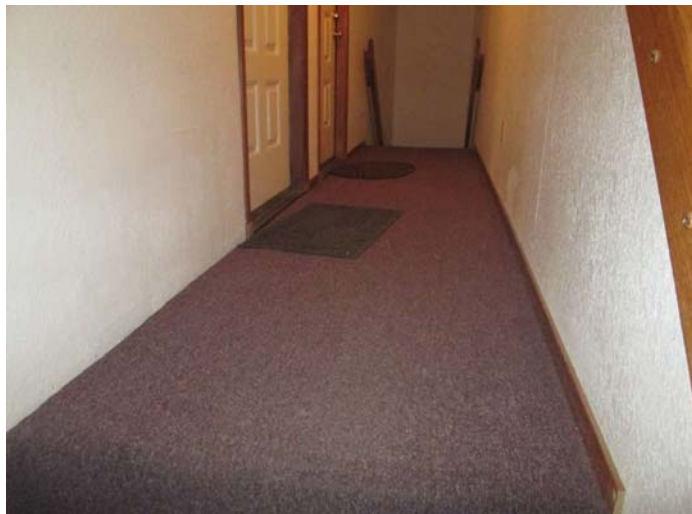
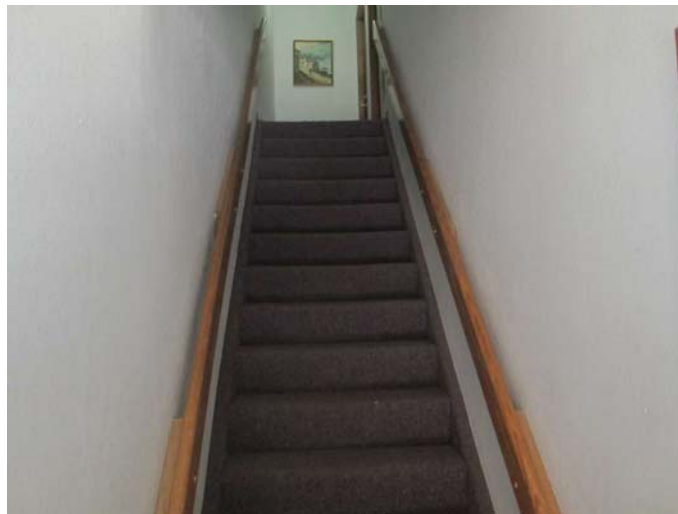
Comp #: 1501 Carpeting (Dept B) - Replace

- The carpet, though dated, appeared to be in good to fair condition at time of observation with wear patterns, impacted padding, and other forms of advanced deterioration noted in several areas.
- It is recommended that this work be aligned with other work in the common hallways to provide for the best cost estimates. As such, this work has been aligned with the hallway painting.
- This work was scheduled during this cycle as it's not likely that the current carpet will last an additional cycle.

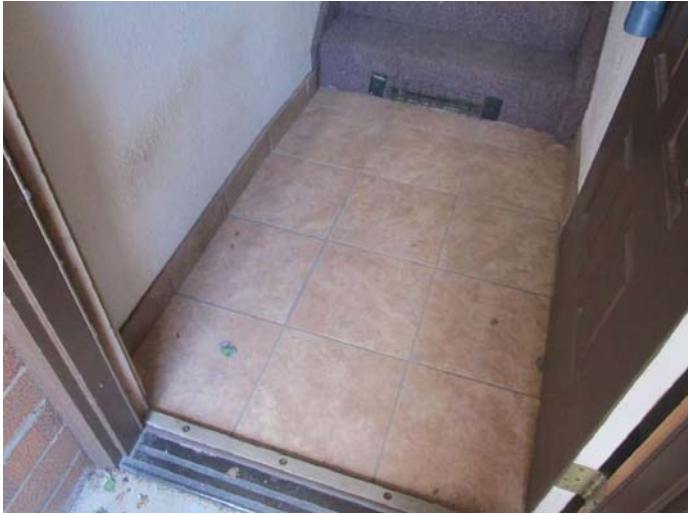
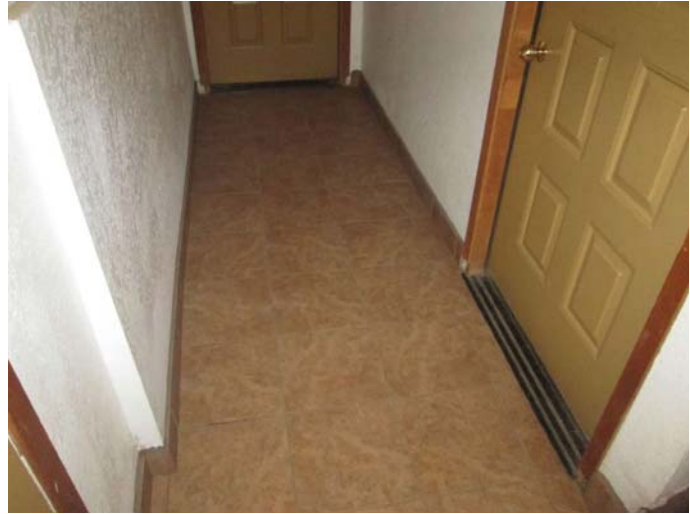
Comp #: 1503 Ceramic Tile (Dept B) - Replace

- As a whole, the tile in all of the entry ways appeared to be in good condition with no signs of advanced deterioration (cracked/missing grout or chipped/loose tiles) noted during observations.
- As with all other assets in these hallways, it's recommended that this work is aligned with other work to receive the best cost estimates and to ensure a cohesive design is used throughout the property.
- Repairs, or replacement, to the tile should be completed with operating funds, as needed.

\$12/GSF: Estimate to replace

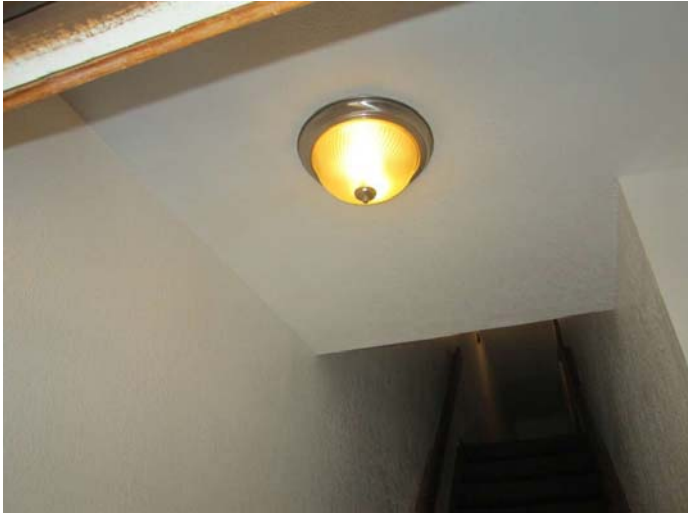
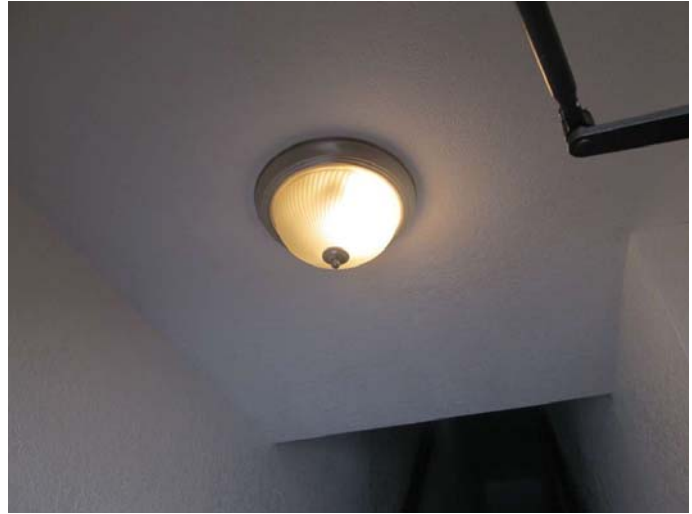
Comp #: 1601 Interior Hallway Lighting (Dept B) - Replace

- These fixtures appeared to be in good condition during observations with no issues noted or reported.
- Funding isn't recommended as replacements for these fixtures as similar replacements are relatively easy to find. It is recommended that broken fixtures are replaced, as needed, with new fixtures.
- If so determined, to take advantage of new technology and to conform with current design trends, funding for complete replacement of these fixtures could be added to future reserve studies.

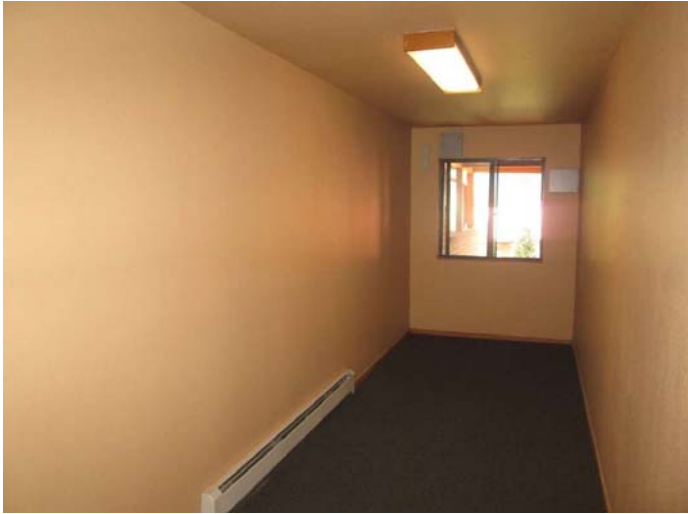
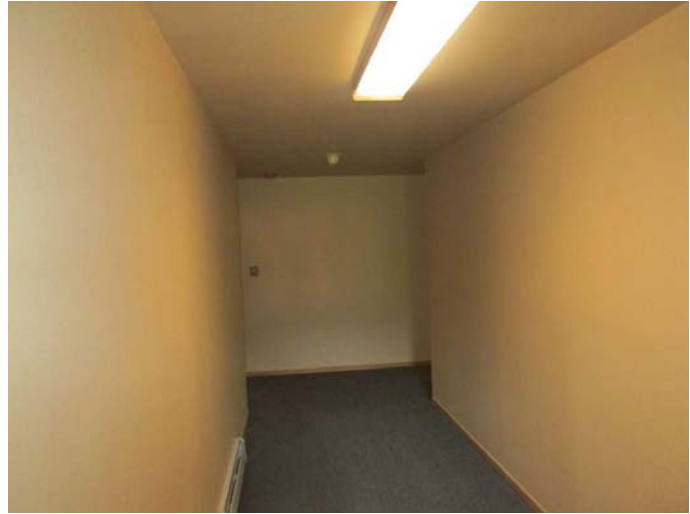
Comp #: 216 Interior Hallways (Dept C) - Repaint

- Though dated, the interior hallways appeared to be in good to fair condition with no significant issues noted. There were signs of prior repairs noted throughout the building...as would be expected in a building like this.
- In addition to providing a uniform appearance throughout the interior hallways, painting is recommended to conform with current design trends and to provide a pleasing arrival experience.
- Regular repairs should continue to take place, as needed, with operating funds, between paint cycles.

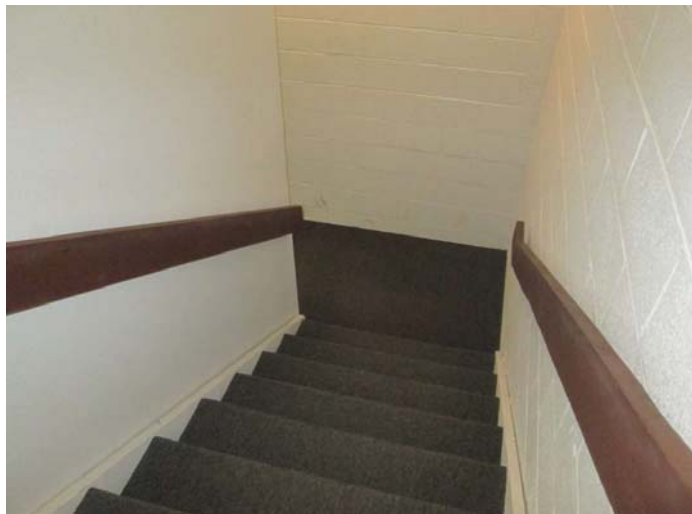
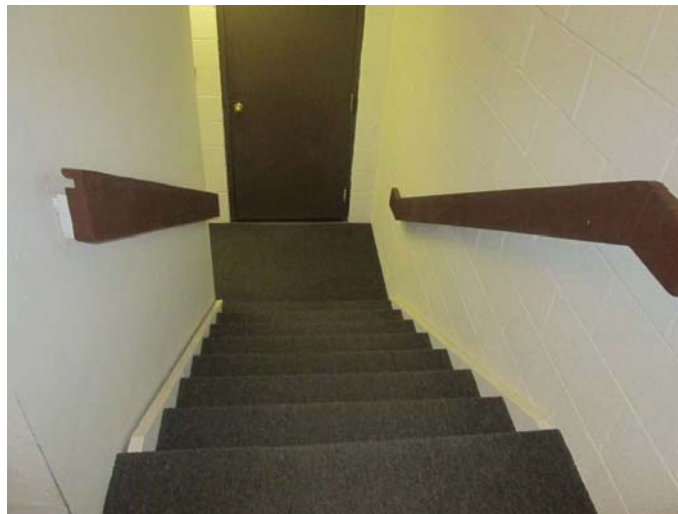
Comp #: 218 Interior Stairwells (Dept C) - Repaint

- As expected, lower floors showed more wear as they're more likely to be used by residents. Overall, the hallways appeared to be in good condition with no real issues, or unexpected conditions, noted during observation.
- As stairs are used less regularly than hallways, it is recommended that funding be provided to paint the stairwell every other painting cycle to ensure a uniform appearance and provide a pleasing arrival experience.
- As will hallways, regular repairs should be performed, as needed, with operating funds.

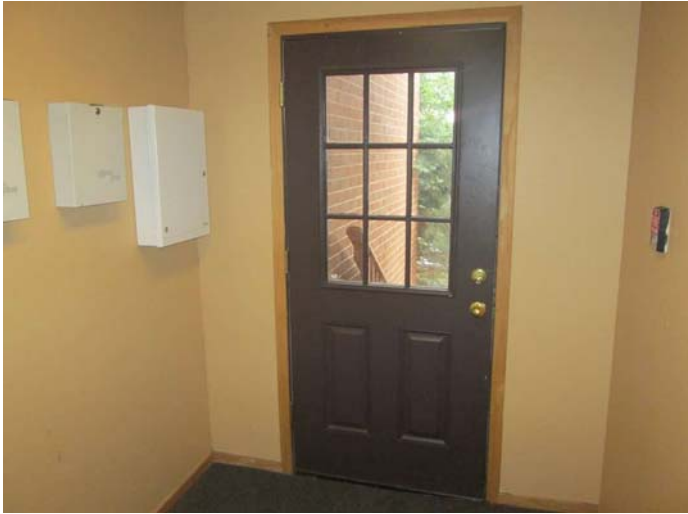
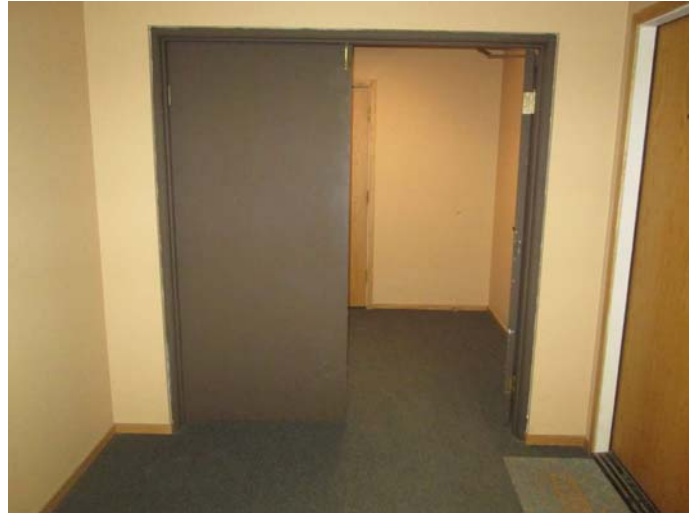
Comp #: 503 Utility doors (Dept C) - Replace

- In general, the doors throughout the property appeared to be in good to fair condition with only a few issues noted.
- Due to the quantity of doors, and the unlikelihood of all doors needing replacement at the same time (due to varied usage patterns), it is recommended that funding to replace 1/3 of the doors every 8 years.
- This funding model allows for complete replacement of all doors every 24 years while allowing for the replacement of doors experiencing advanced deterioration, due to high usage, on a more frequent basis, as is expected.

\$500/door; Estimate to replace 8 doors

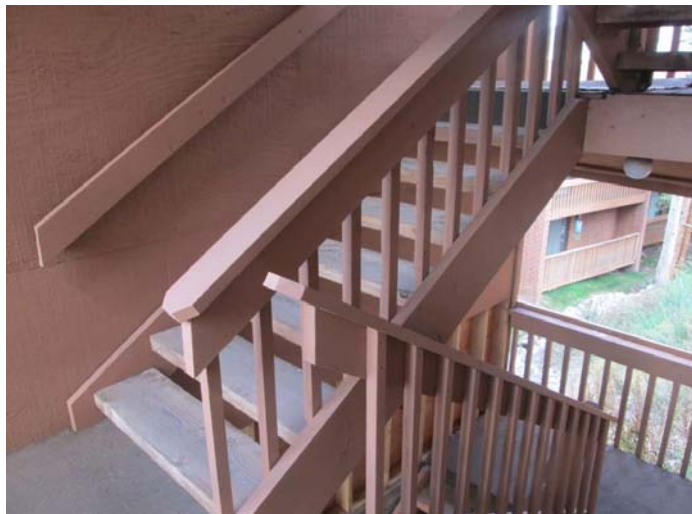
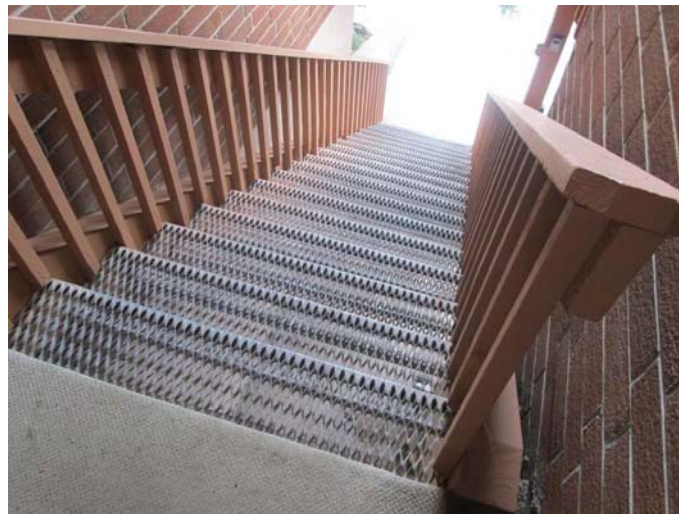
Comp #: 611 Stairway Systems - Major Repairs

- During observation, The stairwell systems on this building, in general, appeared to be in fair condition with a few areas on the back stairs showing advanced deterioration.
- With regular annual maintenance, utilizing operating funds, and the funding provided here, for regular major repairs to these systems, these stairs should have an extended useful life and won't need complete replacement.
- If regular maintenance is neglected, there is a chance that complete replacement will be needed to ensure safety.

Allowance to perform major repairs

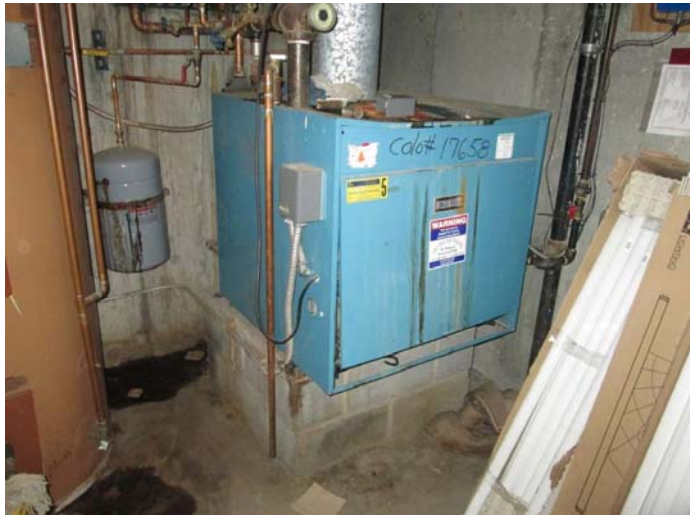
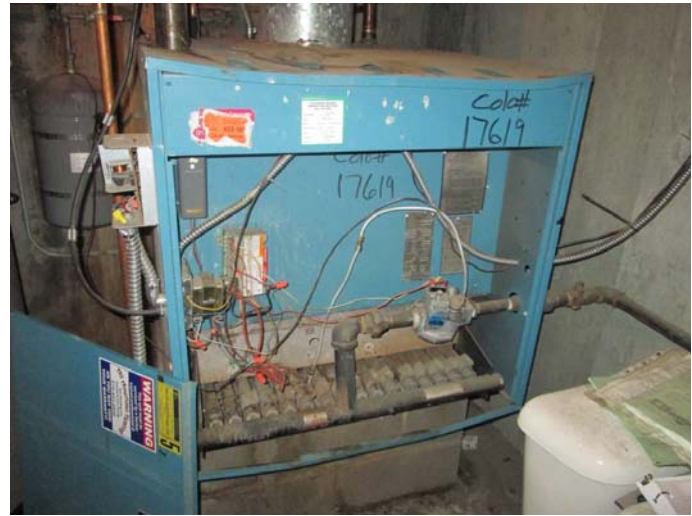
Comp #: 702 Heating Boilers (Dept C) - Replace

- The three boilers that have yet to be replaced in this building appeared to be in poor condition at time of observation with prior leaking, corrosion, and other signs of advanced deterioration noted.
- Old cast iron boilers like this typically have a useful life of around 30 years prior to failure. As with the boiler replaced in Mech. Room A, it is recommended that high efficiency boilers are installed in the future.
- Future updates will need to adjust the useful lives of these boilers (down to 20 years) and the estimated replacement costs (future boiler replacement costs will be reduced as additional plumbing work will not be needed).

(3) - Burnham 808B-WI heating boilers -
Input - 462 kBtu
Mfg - 1989

\$60,000/boiler; estimate to replace boilers

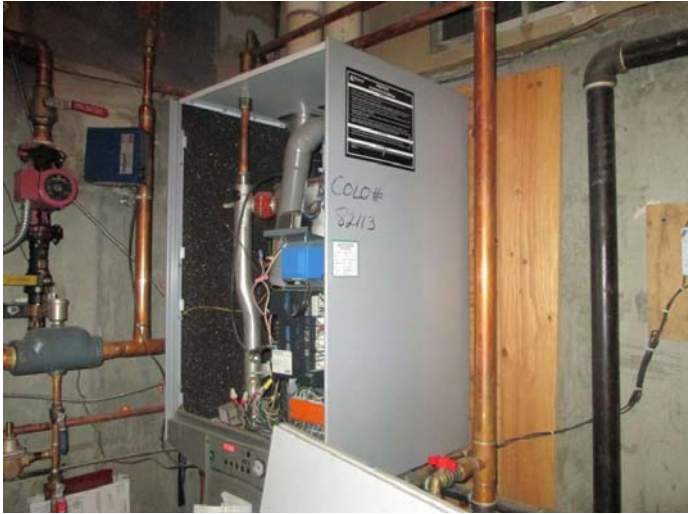
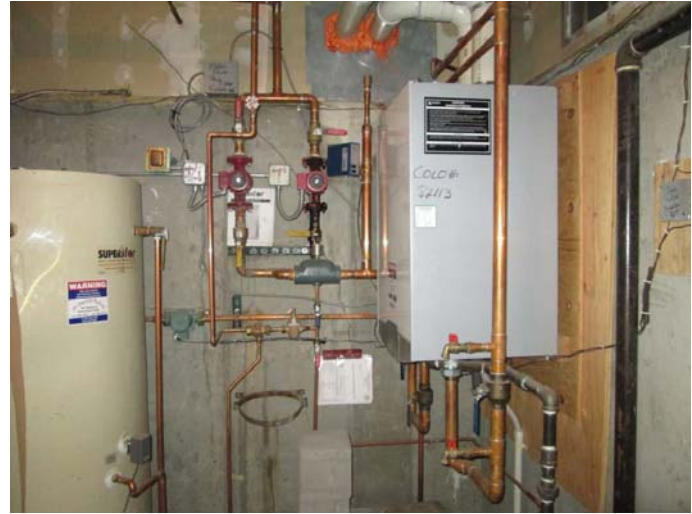
Comp #: 702 Heating Boilers (Dept C) - Replace

- This new boiler appeared to be in good condition, at time of observation, with no issues noted or reported.
- It is recommended that this boiler, and all boilers, are inspected annually with regular repairs handled with operating funds. This is in addition to the funding provided to replace misc. equipment on a regular basis.
- Future replacement of this high efficiency boiler is significantly less than replacing older boilers with this type of boiler. As such, funding for replacement of this boiler has been reduced.

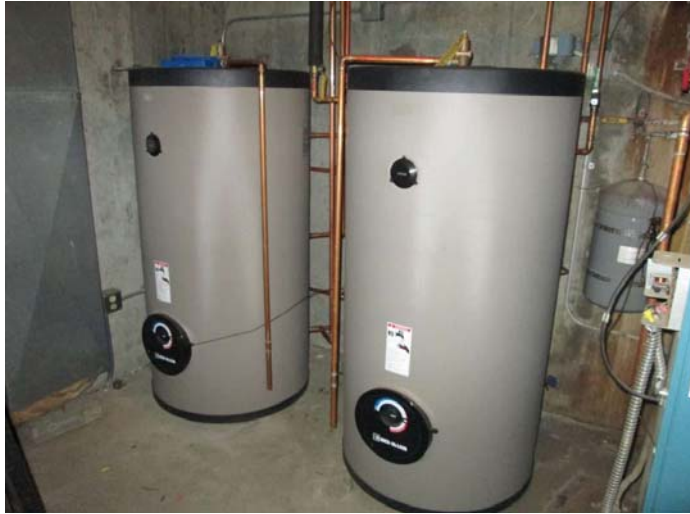
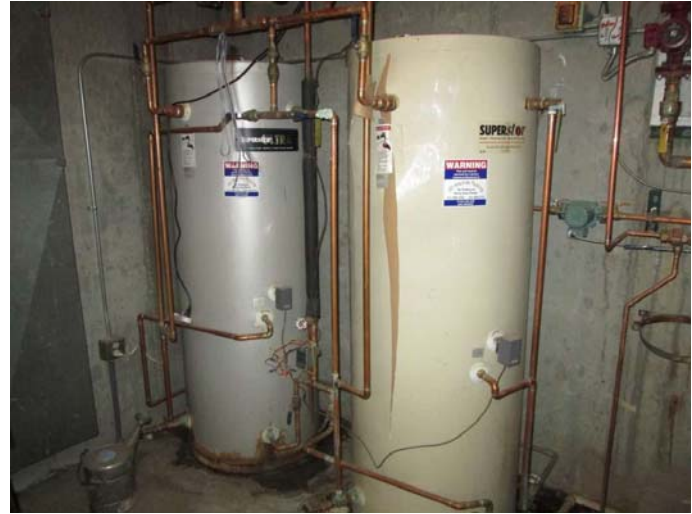
Comp #: 703 Water Heaters (Dept C) - Replace

- The conditions of these boilers varied from fair to good with no only a few signs of prior leaks noted.
- As there are two heaters in each boiler room (redundancy), a more conservative approach to funding can be taken. As such, it's recommended that funding be provided to replace two heaters every 5 years.
- This funding method allows the association to replace the heaters on a regular basis and allows them to deal with unexpected failures, during the winter months, without losing the ability to provide hot water to the residents.

\$8,000/heater; estimate to replace 2 heaters

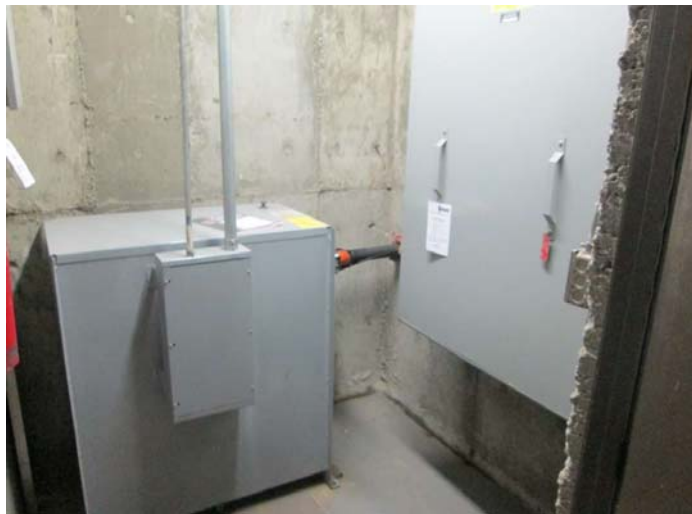
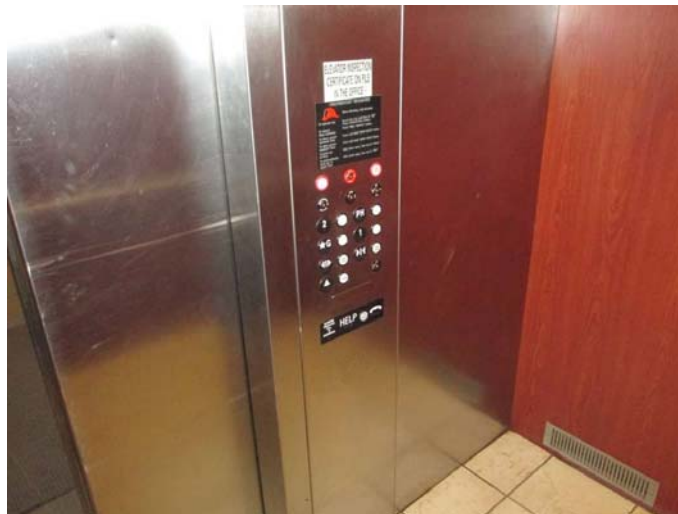
Comp #: 707 Elevator - Rebuild/Upgrade

- The elevator equipment appeared to be in good condition with no issues noted, or reported, during observations.
- It is recommended that funding be provided to replace the controls, major equipment, door sensors, etc. every 35 years as parts become hard to find and regular annual maintenance costs continue to rise.
- These repairs do not cover repairs to the jack. These repairs are for upgrades to the electrical, hydraulic, safety and operating systems that would be considered part of a standard elevator controls upgrade.

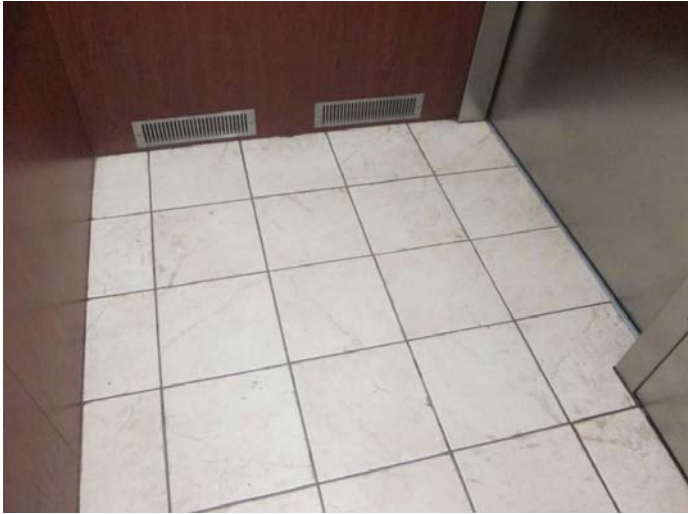
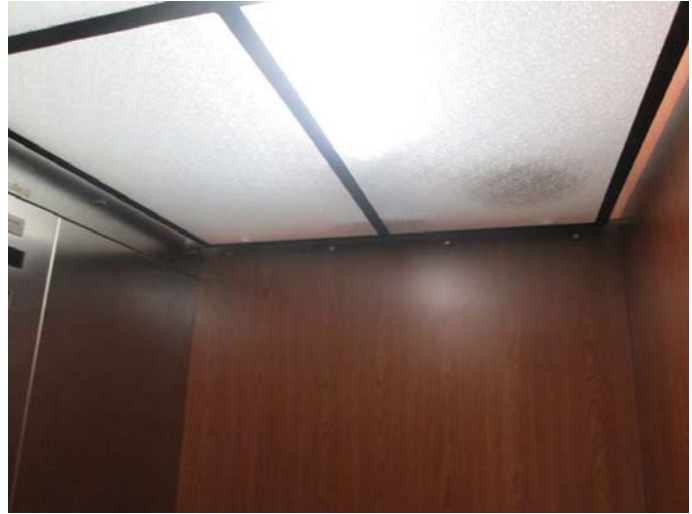
Comp #: 709 Elevator Cab - Remodel

- Though dated, the elevator cab appeared to be in good condition with no issues noted.
- It is recommended that the elevator cab is remodeled periodically to conform with current design trends, to take advantage of new technology, and to provide an enjoyable arrival experience.
- Funding has been provided to replace with a similar, basic, design. If so desired, the cab could be upgraded with better, more durable and classily designed, finishes. Expect to double the cost of the remodel if this occurs.

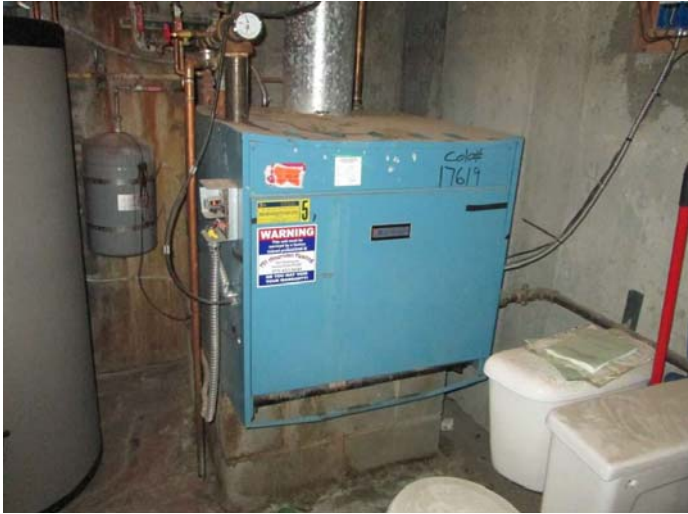
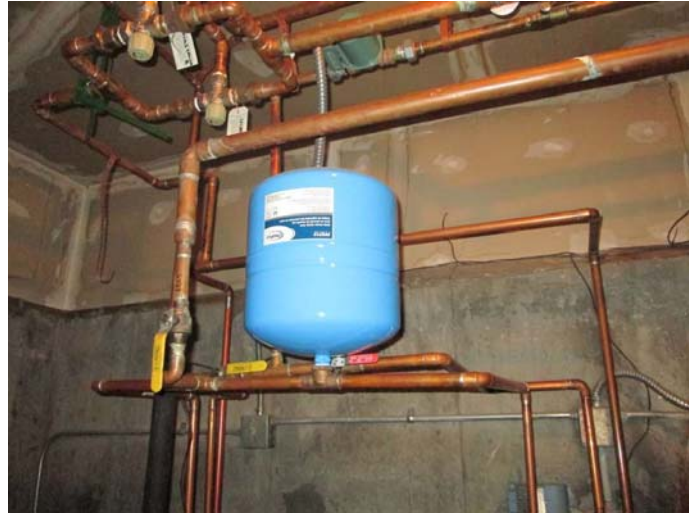
Comp #: 725 Misc Mech Equipment (Dept C) - Replace

- The condition of the mechanical equipment varied from new to poor during observation.
- In addition to annual inspections, and the repairs associated with these repairs, it is recommended that funding be provided to replace failing, or failed, equipment, with reserve funds, on a regular basis.
- This funding is provided to replace pumps, valves, expansion tanks, fans, motors, boiler assemblies, or any other component of the system that meets the threshold requirements for a reserve/capital expenditure.

Allowance to replace failing equipment

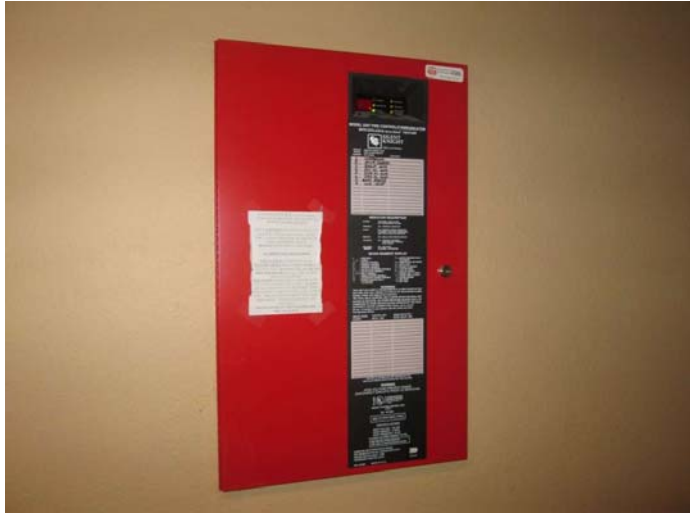
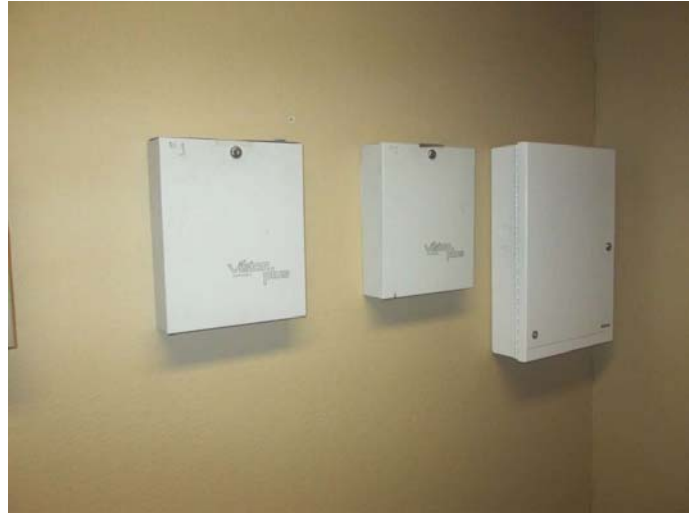
Comp #: 901 Fire/Freeze Protection System - Replace

- The protection system was not observed in operation. The association's contractor recommended that funding be provided to replace this system, and bring it to code, in the near future.
- Funding for replacement of life safety systems is recommended on a regular basis as components become obsolete and new technology makes itself available.
- It should be noted that this system contains monitored freeze protection, in addition to standard fire protection.

Estimate to replace system & bring to code

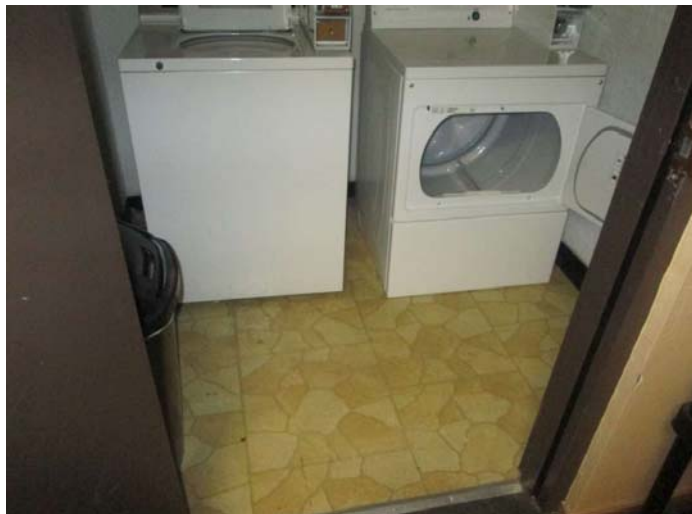
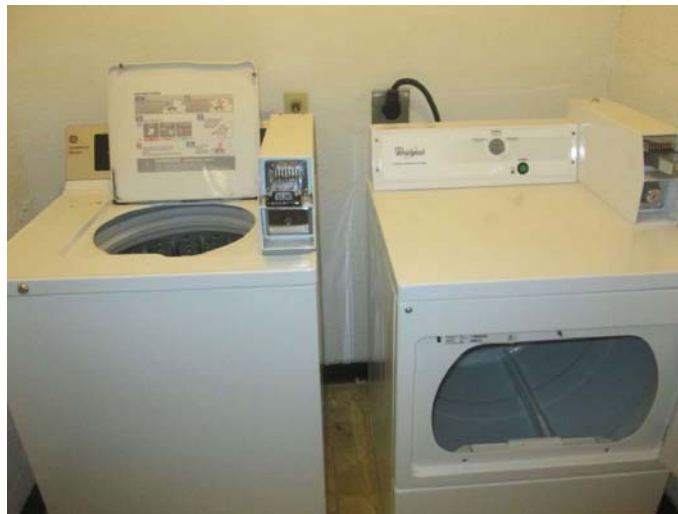
Comp #: 1401 Laundry Equipment (Dept C) - Replace

- The washer and dryer appeared to be in fair condition with no unusual, or significant, issues reported.
- Though it was reported that the income generated from these machines covers repair costs and is expected to fund their replacement, reports detailing the income v. repair/replacement costs were not supplied.
- As such, funding is not recommended at this time as leased commercial machines, in our experience, typically have a better ROI, and less down time, than owned machines.

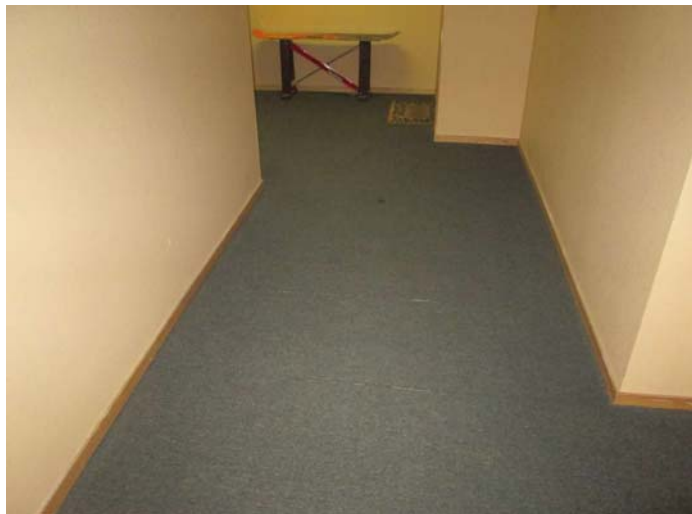
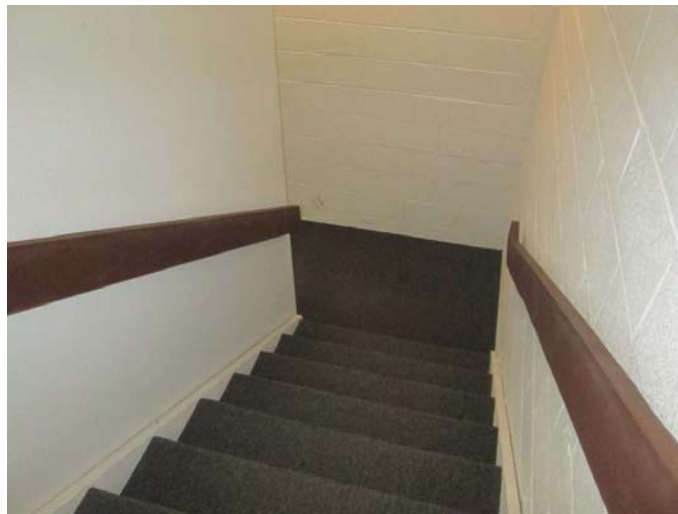
Comp #: 1501 Carpeting (Dept C) - Replace

- The carpet throughout, generally, appeared to be in good to fair condition with wear patterns and staining noted in only a few areas.
- Due to the reported use of this building, and observed conditions, it is recommended that funding be provided to replace the carpet every other painting cycle.
- During future replacement, it may behoove the association to look for more durable flooring in higher traffic areas.

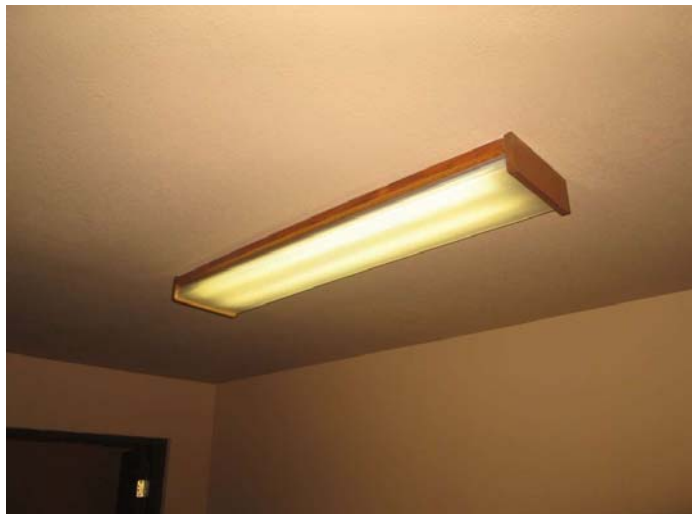
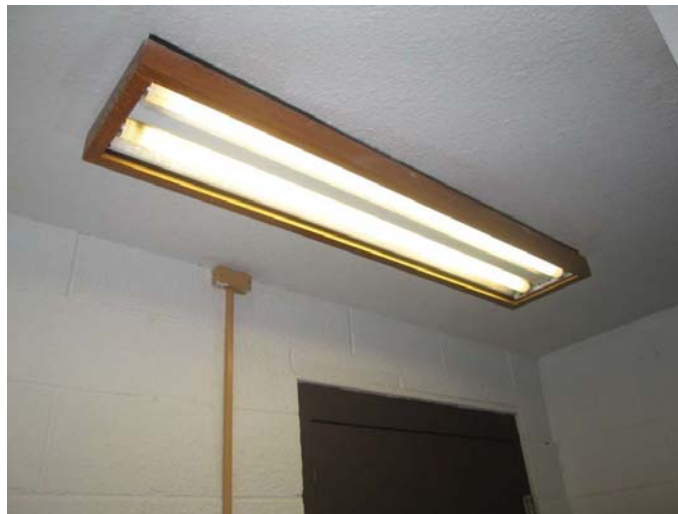
Comp #: 1601 Interior Hallway Lighting (Dept C) - Replace

- The lighting appeared to be in fair to poor condition, during observations, with yellowing noted on diffusers, some diffusers missing and low lighting levels noted in darker areas of the hallways.
- As replacement of these fixtures, with similar quality fixtures, is relatively simple, funding is not recommended at this point.
- If the association were to look at higher efficiency fixtures throughout, funding could be provided for this work.

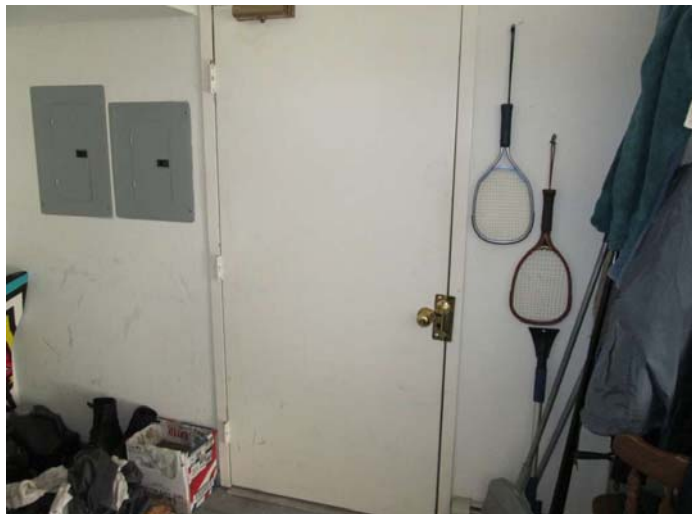
Comp #: 503 Utility doors (Dept D) - Replace

- The utility doors, appeared to be in good condition, despite their age.
- As these doors are inside an owner's garage and are unlikely to be damaged beyond repair, it is recommended that funding be provided to replace both doors at the end of their projected useful lives.
- If a door is damaged beyond repair, prior to the end of their estimated useful life, it is recommended that operating funds are used for replacement as the projected replacement cost for a single door doesn't hit the reserve threshold.

\$850/door; Estimate to replace doors

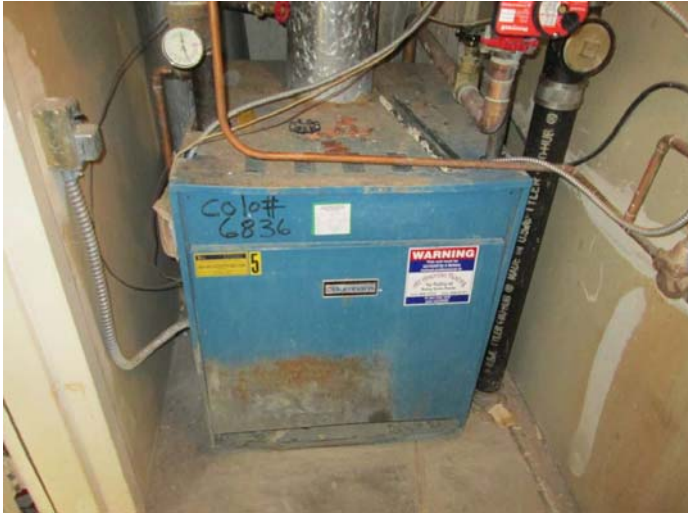
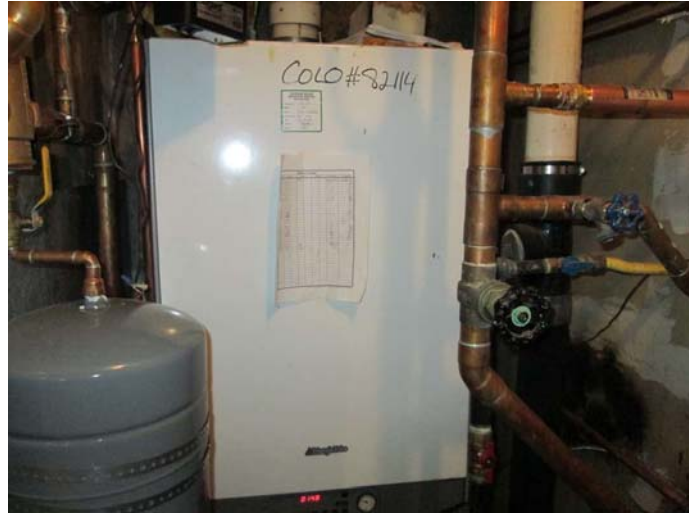
Comp #: 702 Boilers (Dept D) - Replace

- The two boiler vary in condition due to one of them having been replaced in 2008. Outside of the age difference, both boilers showed conditions consistent with their ages and no signs of unexpected deterioration.
- Due to the age different between the two boilers, we recommend that the older boiler is replaced in the near term with the other boiler being replaced at the end of it's useful life.
- Future updates will need to adjust the useful life of these boilers to take into account the UL of the new boiler (it is anticipated that the UL will need to be set at 10 years). It is also anticipated that the estimated replacement cost will need to be adjusted as the new, high efficiency, boilers will not need as much plumbing work in the future.

Building 743, Unit D Garage -
(1) - Burnham 808B-WI 396k Btu boiler
Serial # - 9590
CO # - 06836
Mfg Date - 1990

\$55,000/boiler; Estimate to replace 1 boiler

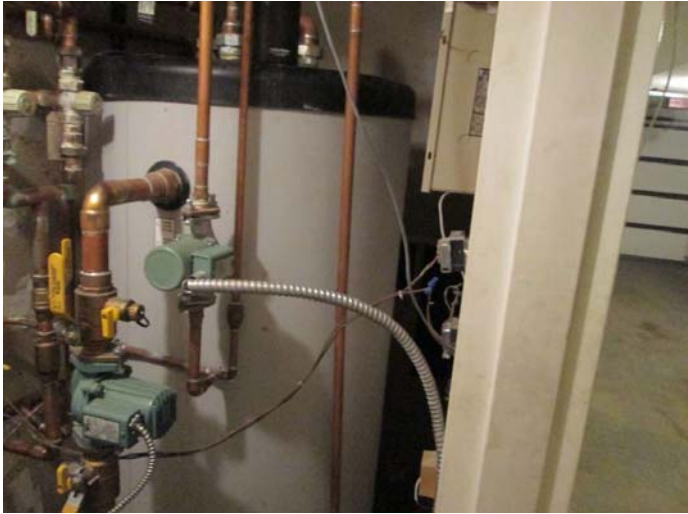
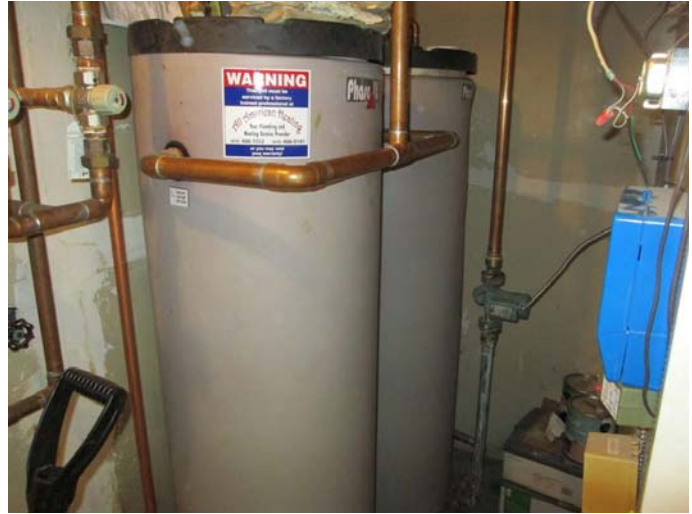
Comp #: 703 Water Heaters (Dept D) - Replace

- Though the boilers appeared to be in good to fair condition at time of observation, it is recommended that funding be provided to replace the water heaters when the new boilers are installed.
- Indirect fired water heaters, of this design, typically have an anticipated useful life of 10 - 15 years before irreparable damage occurs to the heat exchanger.
- It is recommended that future updates plan for replacement of both heaters at the same time.

Estimate to replace 1 building's heaters
