Lagoon TH Condominium Association, Inc.
700 Meadow Creek Drive
Frisco, CO 80443

Level 1, Platinum Reserve Analysis

Report Period – 07/01/15 – 06/30/16

Final Draft
Version

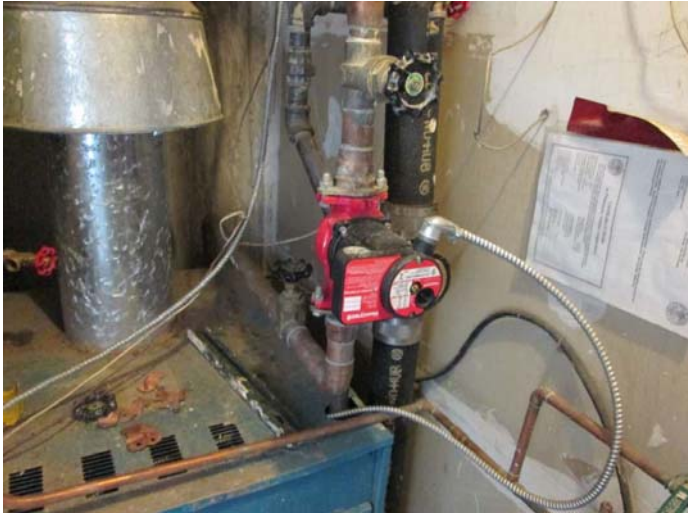
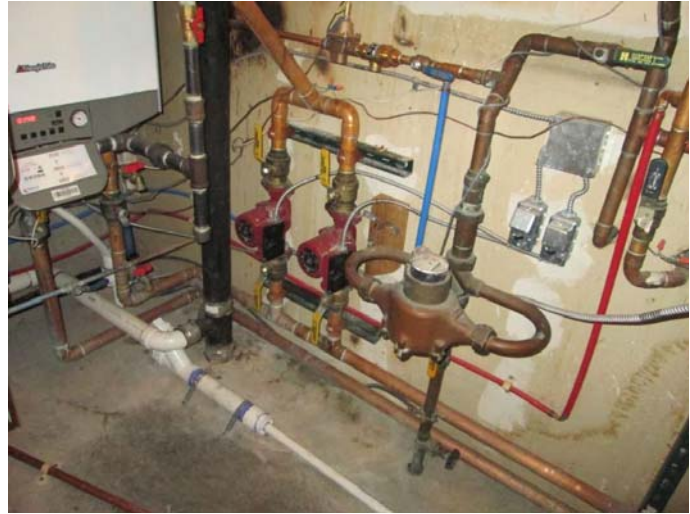
Comp #: 725 Misc Mech Equipment (Dept D) - Replace

- The condition of the mechanical equipment varied from good to poor at time of observation.
- As it is recommended that the boilers are inspected annually, with needed repairs being performed with operating funds, we also recommend that funding is provided, on a regular basis, for unanticipated repairs.
- As components are replaced, and new technology is utilized, funding for this component may need to be adjusted, in future updates, to align with experienced costs and frequency of replacements.

Estimate to replace failing equipment
